## Notice of Intent to Remove Asbestos

# Limited Asbestos Inspection Report

La Center Community Center Kitchen

Terracon Project No. 82227169

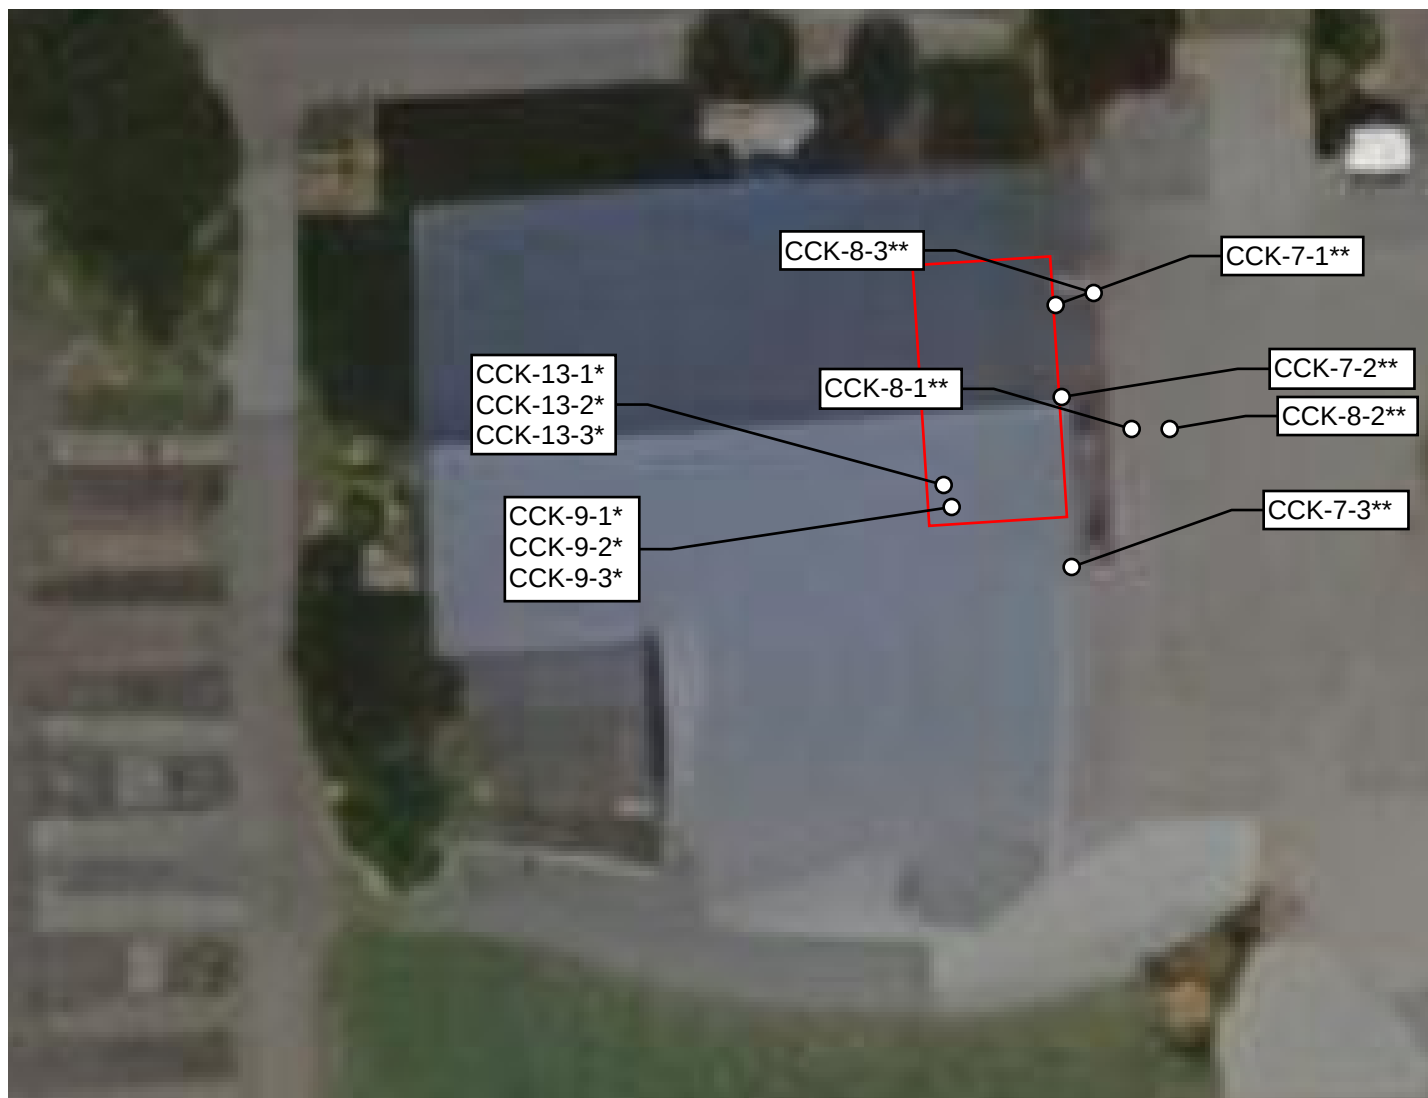
A summary of all samples collected including the type of material, general location, and results, is included as Table 1 in Appendix B. Locations of bulk ACM samples collected throughout the project areas are presented in Appendix C.

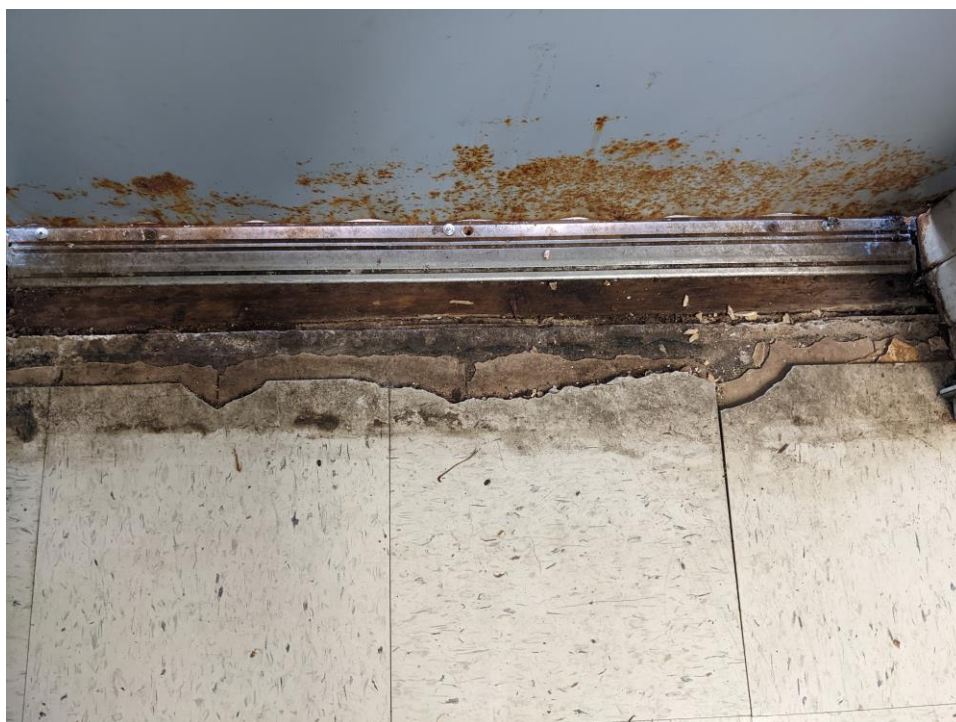
- HA-3: 8"x8" tan vinyl floor tile (2% Chrysotile) and black mastic (4% Chrysotile)
- HA-6: Black sink undercoat (3% Chrysotile)

**Photo 4** HA-3: 8"x8" tan vinyl floor tile (2# Chrysotile) and black mastic (4% Chrysotile).

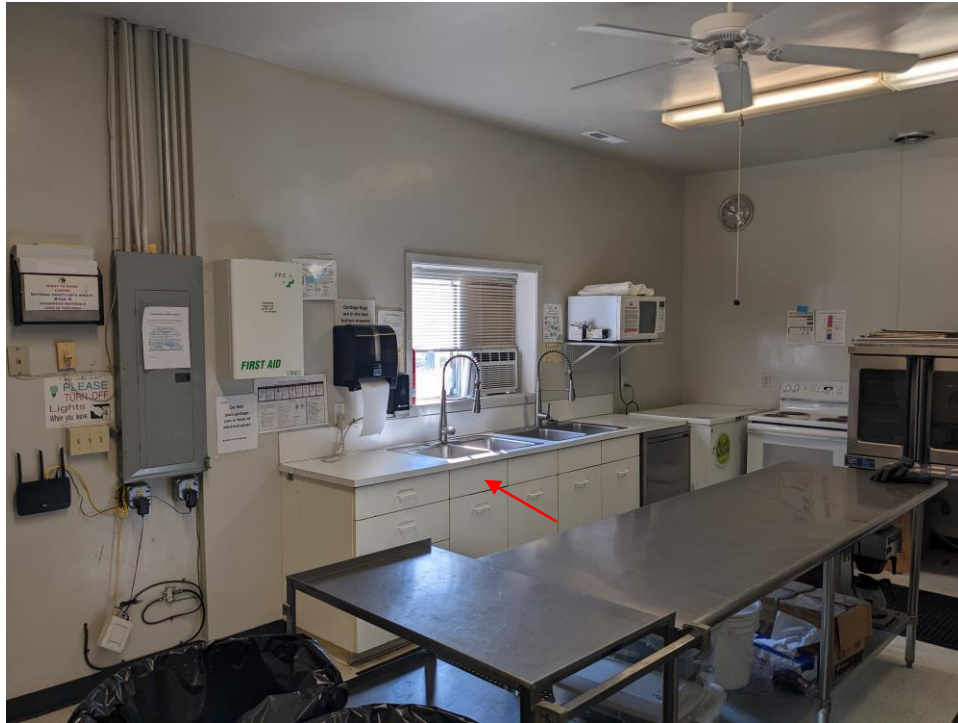
**Photo 5** General view of the project area with HA-6: Black sink undercoat (3% Chrysotile).
