LIMITED ASBESTOS SURVEY

For Unit 7, Unit #8, and Unit #9 located at:

**125 MORSE PARK WAY
LONGVIEW, WASHINGTON**

Photographic Log

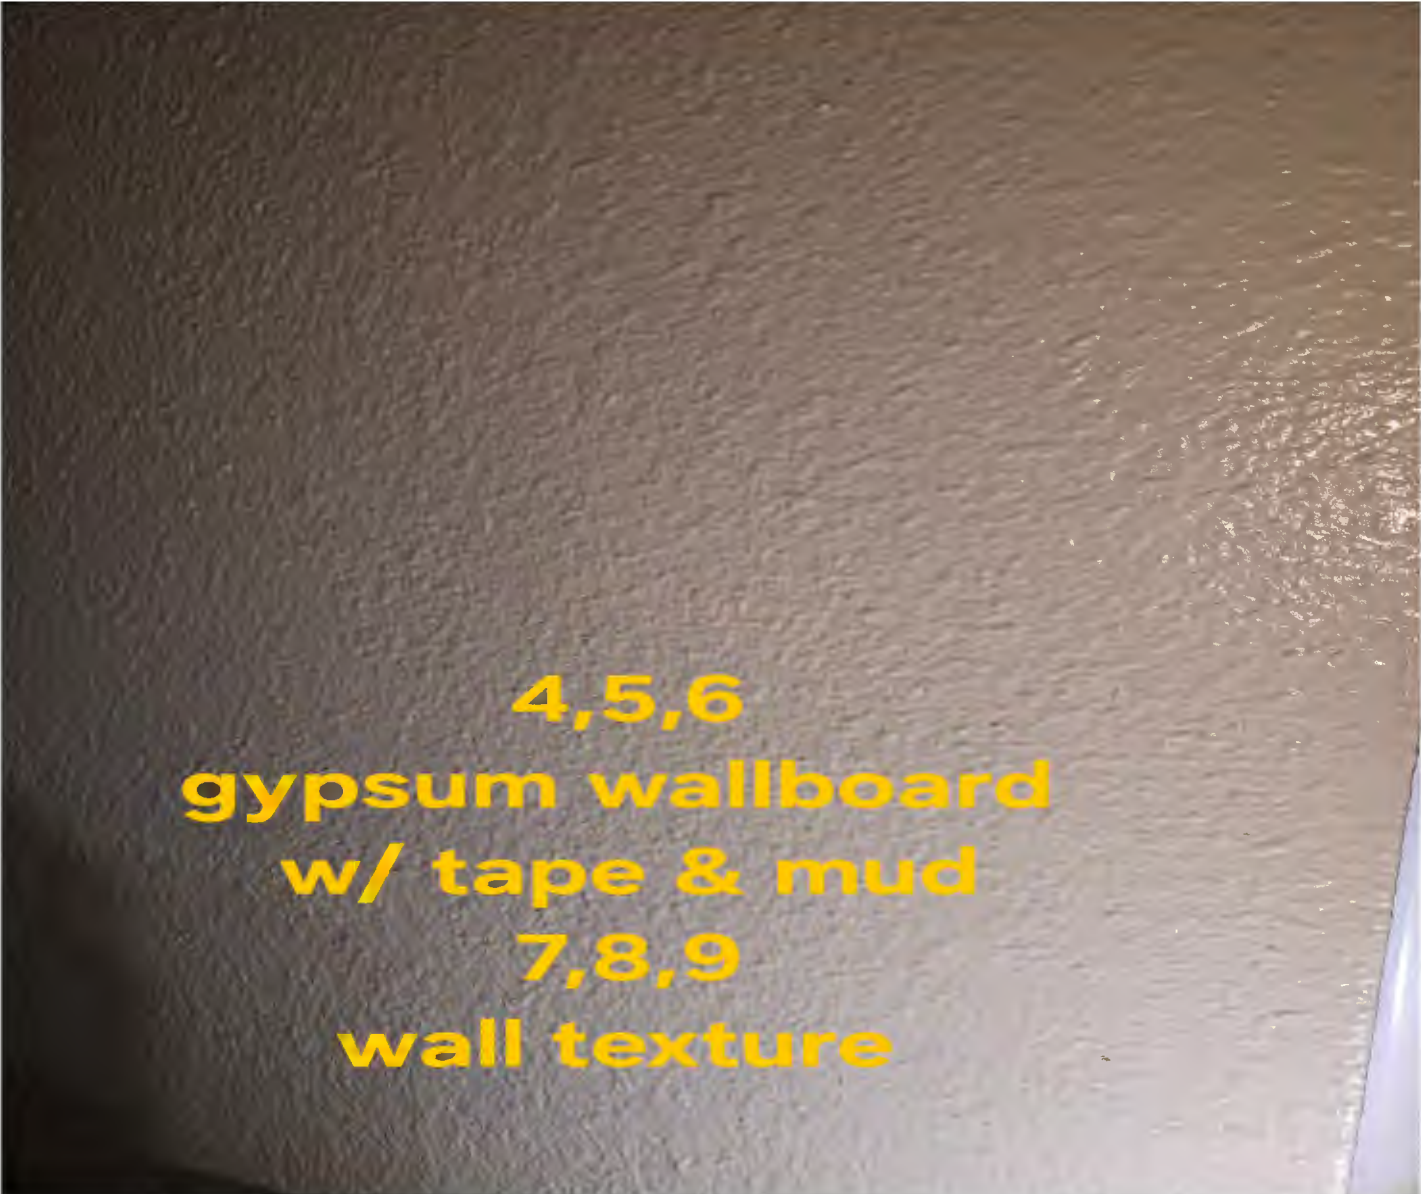
**4,5,6
gypsum wallboard
w/ tape & mud
7,8,9
wall texture**
