## Notice of Intent to Remove Asbestos

# Asbestos Inspection

4913 NE 34<sup>TH</sup> St

CES: 24-7177

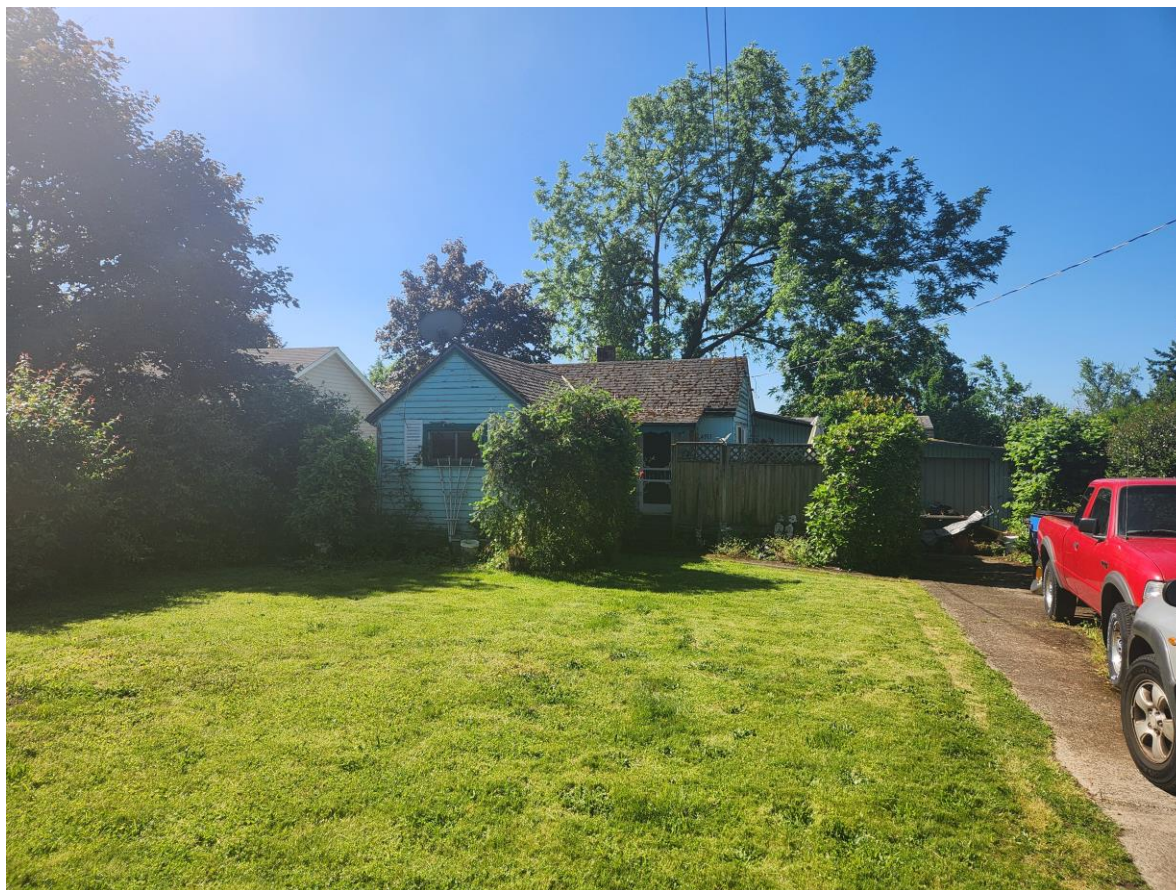
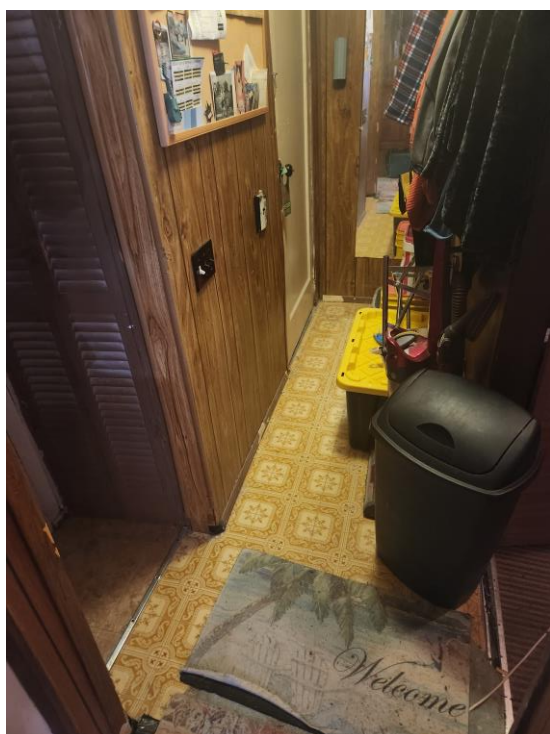
***(F-1) 3% CRYSTOTILE / ASBESTOS 9X9 TILE– ENTRANCE +/- 50 SQ/FT***
