## Notice of Intent to Remove Asbestos

## **Asbestos Survey Report**

**Survey Location: 20532 NE 194th Ave, Battle Ground, WA 98604**

**Inspection Date: December 19th 2023**

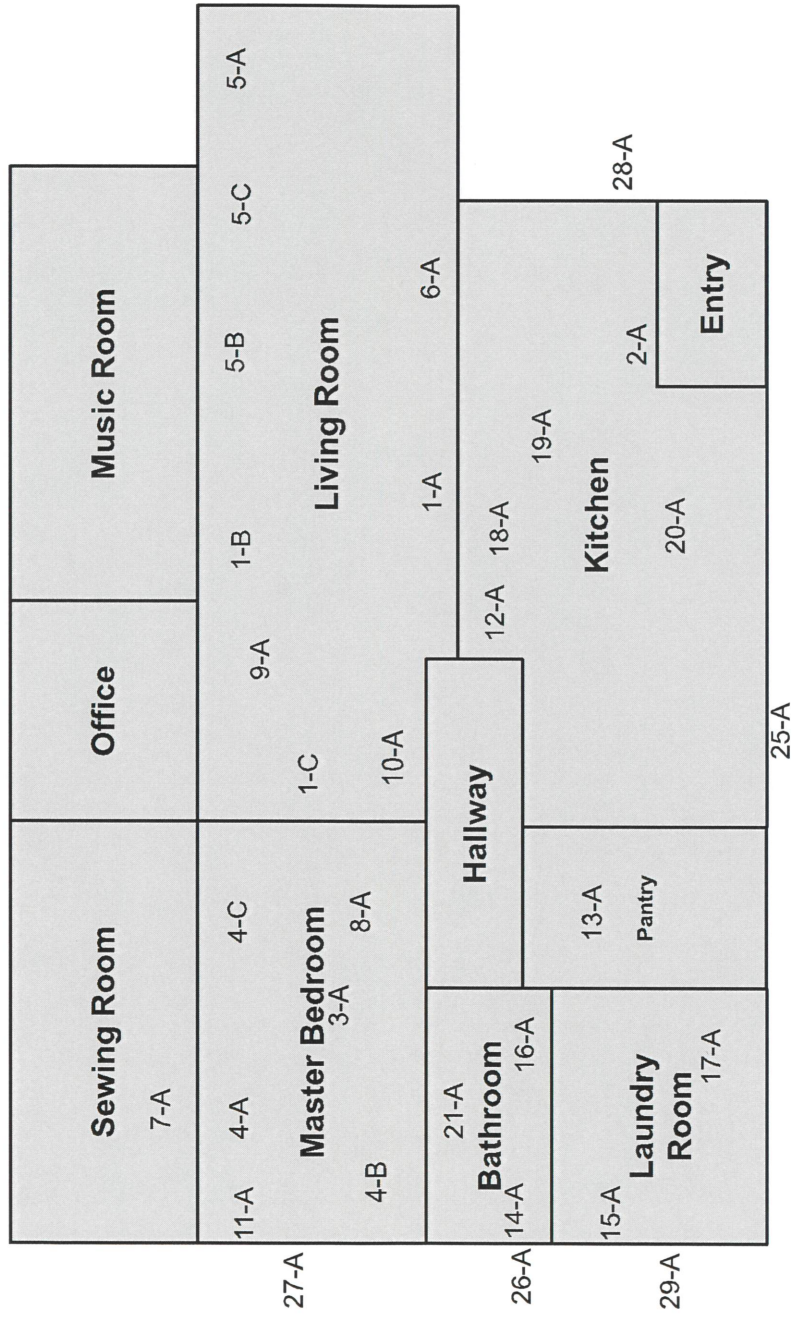
20532 NE 194th Ave Battle Ground, WA 98604 - Main Level

Suspect Asbestos Containing Sample Locations

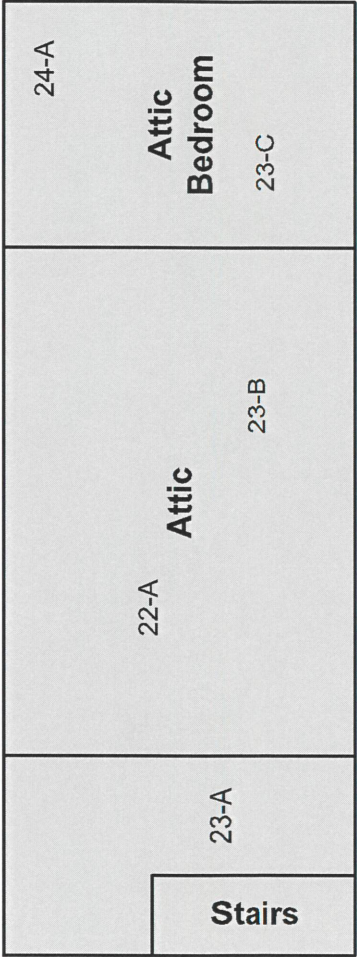
20532 NE 194th Ave Battle Ground, WA 98604 - Attic

Suspect Asbestos Containing Sample Locations
