Notice of Intent to Remove Asbestos

Asbestos Survey Report

Project Name: Sanchez Demolition

Survey Location: 22401 NE 28th St, Camas, WA 98607

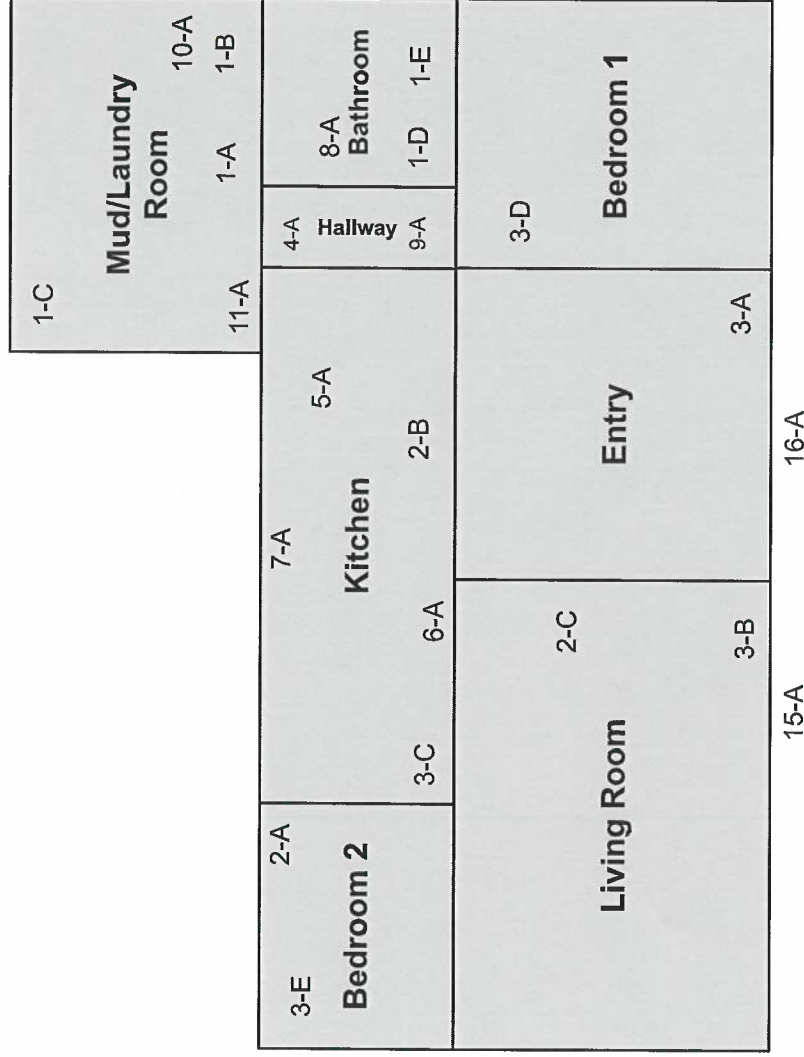
Suspect Asbestos Containing Sample Locations

Sample #	Location	Asbestos Containing Material	Asbestos %	Approx. Sq. Footage	Friable Y/N	Condition
2-A Layer 4	Bedroom 2 Ceiling	2nd Layer Texture (Tan)	4% Chrysotile	750'	Y	Good
2-A Layer 5	Bedroom 2 Ceiling	2nd Layer Joint Compound (Tan)	3% Chrysotile	—	Y	Good
2-B Layer 3	Kitchen Ceiling	2nd Layer Texture (Tan)	3% Chrysotile	—	Y	Good
2-C Layer 4	Living Room Ceiling	2nd Layer Texture (Tan)	3% Chrysotile	—	Y	Good
2-C Layer 5	Living Room Ceiling	2nd Layer Joint Compound (Tan)	3% Chrysotile	—	Y	Good
3-B Layer 3	Living Room Wall	2nd Layer Texture (Red)	3% Chrysotile	1,700'	Y	Good
3-B Layer 4	Living Room Wall	Joint Compound (Tan)	3% Chrysotile	—	Y	Good
3-C Layer 3	Kitchen Wall	2nd Layer Texture (Tan)	3% Chrysotile	—	Y	Good
3-C Layer 4	Kitchen Wall	Joint Compound (Tan)	3% Chrysotile	—	Y	Good
3-E Layer 3	Bedroom 2 Wall	2nd Layer Texture (Blue)	2% Chrysotile	—	Y	Good
3-E Layer 4	Bedroom 2 Wall	Joint Compound (Tan)	3% Chrysotile	—	Y	Good

5-A Layer 4	Kitchen Floor	VCT (Yellow)	5% Chrysotile	160'	Y	Good
5-A Layer 5	Kitchen Floor	Mastic (Black)	2% Chrysotile	—	Y	Good
7-A Layer 1	Under Kitchen Sink	VCT (Red)	3% Chrysotile	8'	Y	Fair
7-A Layer 2	Under Kitchen Sink	Mastic (Black)	2% Chrysotile	—	Y	Fair
12-B Layer 2	Attic Wall	Texture (White)	3% Chrysotile	950'	Y	Good
12-C Layer 2	Attic Wall	Texture (White)	4% Chrysotile	—	Y	Good
