# Asbestos Containing Materials Inspection

Good Faith Inspection

Project: 4801 NE 68<sup>th</sup> Street  
Vancouver, WA 98668

RE: Good Faith Asbestos Survey

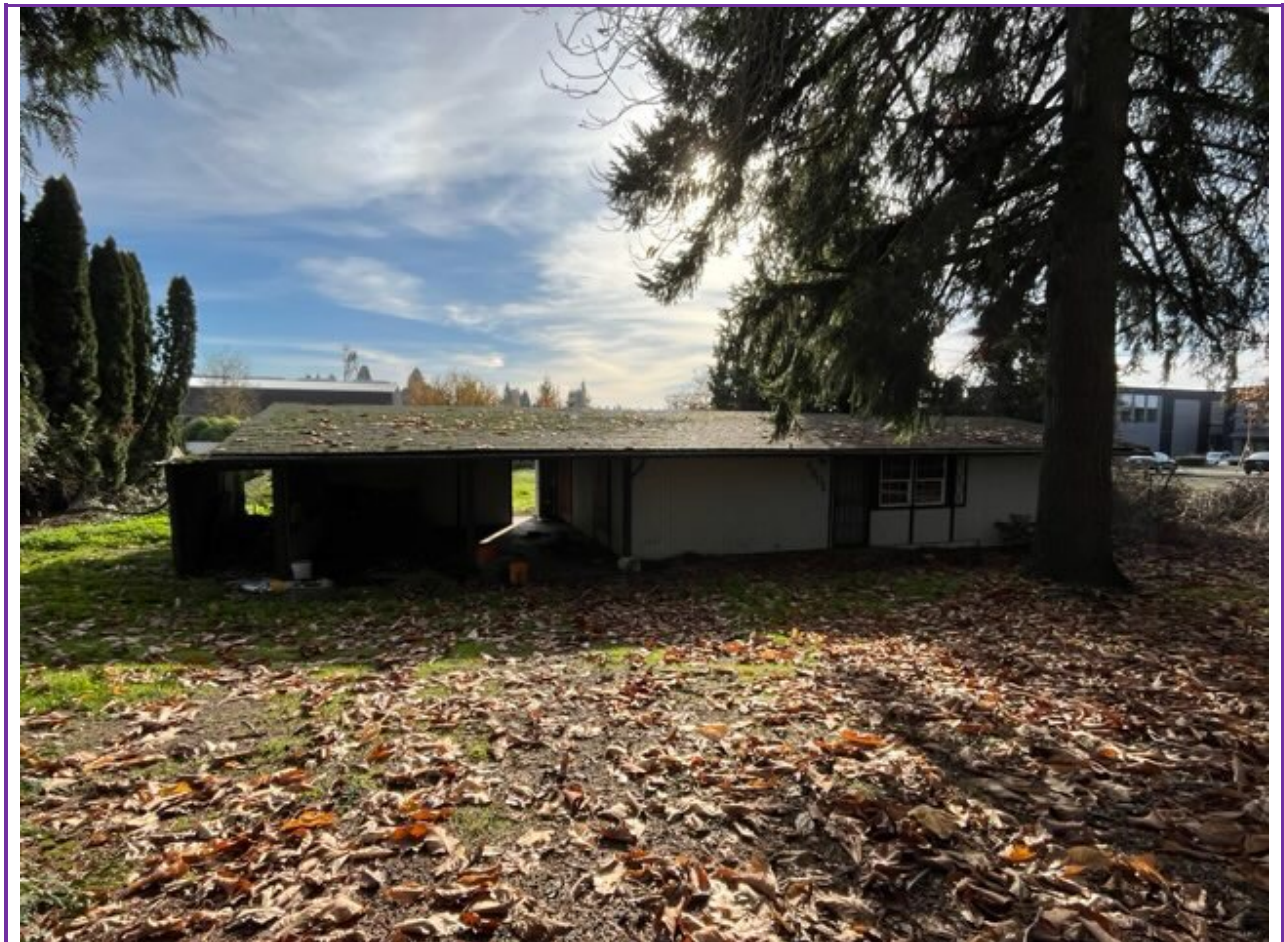
### **FRONT OF STRUCTURE**

The residential structure was a single-story building with attached carport. The majority of the building was on a concrete foundation with sections on wood. Total building square footage is approximate 1,000 SF, approximate date of construction was 1961.

The exterior of the building was wood siding with composition roofing.
