NOTICE OF INTENT TO REMOVE ASBESTOS

BULK ASBESTOS SAMPLES

Centralia Monument

502 S Tower Ave

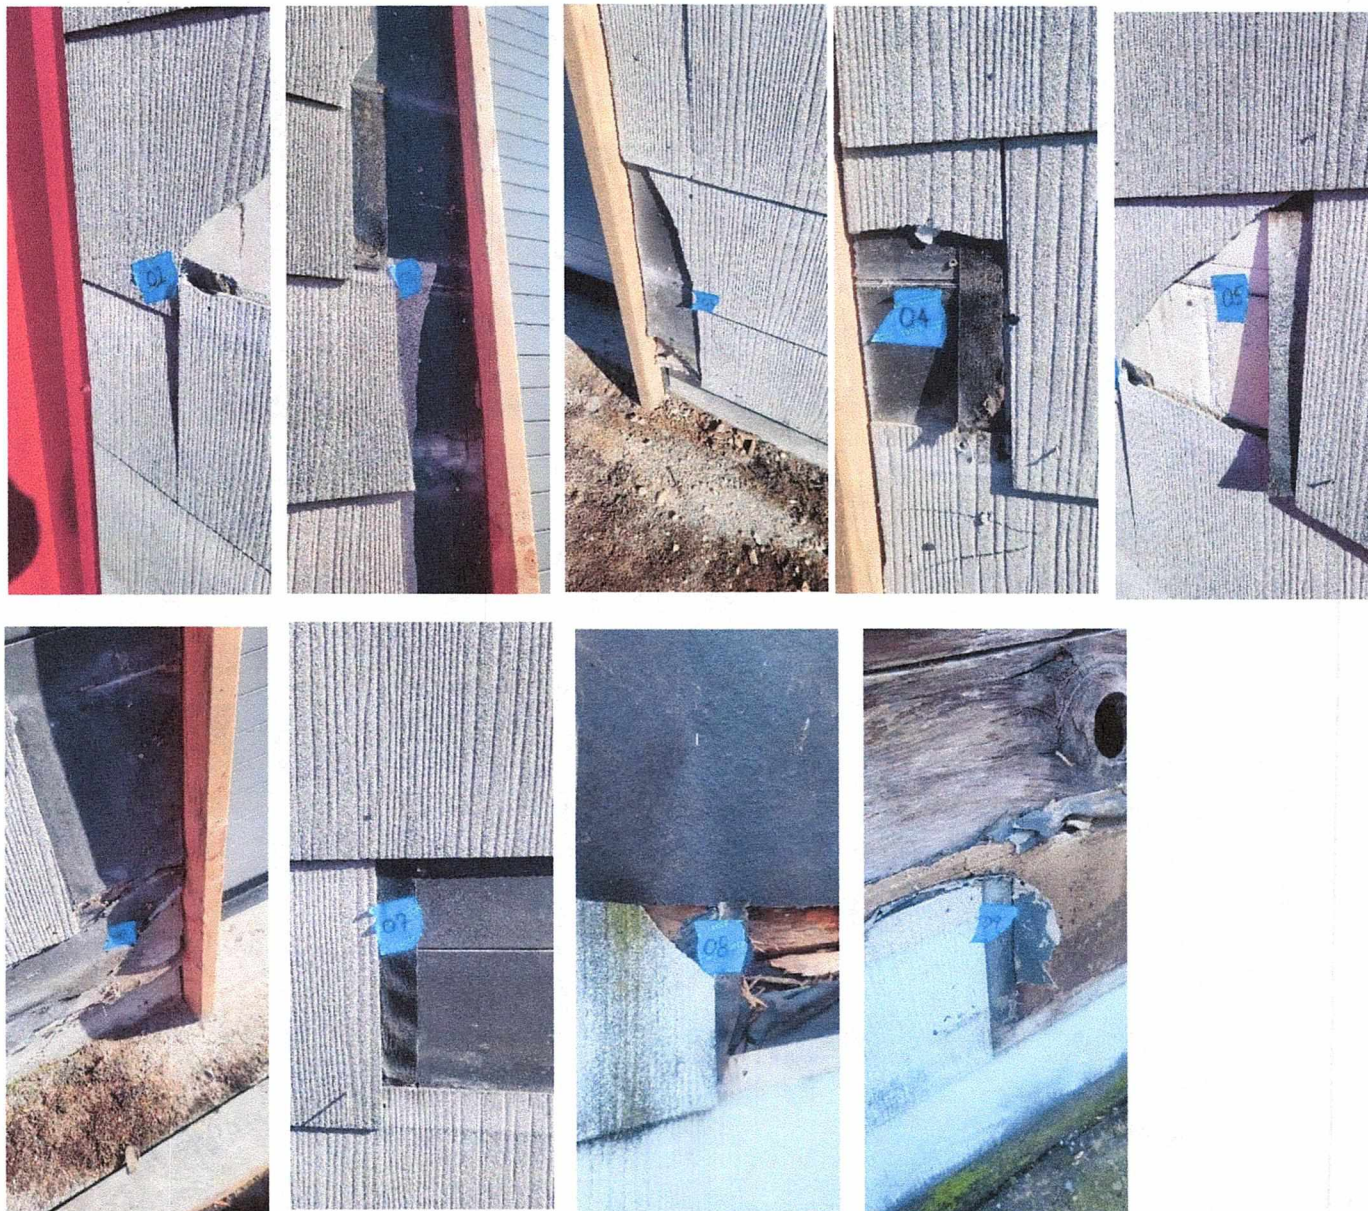
Sample location photographs

Asbestos was found in the White Composite Siding on the exterior of the Garage area. These materials will need to be removed by an Asbestos Contractor, prior to any further Remodeling, Construction or Demolition. If any material is found not identified in this report, previous reports, or subsequent reports, then another Inspection will be required. Air Samples are required after all asbestos containing materials have been removed per Southwest Clean Air Agency and your local county.

Material	Location/ Functional Space/Homoge nous Area ID	Sample Quantity	Friable/Non- Friable	Disturbance / Potential Damage	Asbestos Content %	ACBM Type /Comments
Composite Siding	Garage Walls Exterior	3	Friable	PSD	10%	Chrysotile Asbestos
Gypsum Board	Garage Walls Exterior	3	Friable	PSD	0	NAD
Siding Joint Paper	Garage Walls Exterior	3	Friable	PSD	0	NAD

Any Renovation, Construction or demolition of the Garage area as discussed can commence after all Asbestos Containing Materials have been removed by a Certified Asbestos Contractor.
