## Notice of Intent to Remove Asbestos

As requested for planned demolition of the Concession Building at Archie Anderson Park located at 275 21st Avenue in Longview, Washington, this letter report serves as a summary of suspect asbestos containing materials that could be impacted even to the extent of full demolition. Additionally, this report identifies other hazardous or regulated materials within the structure that should be removed prior to demolition as well as information on paints applied to the structure.

ARCHIE ANDERSON PARK  
CONCESSION BUILDING  
ASBESTOS & OTHER MATERIALS PHOTOS

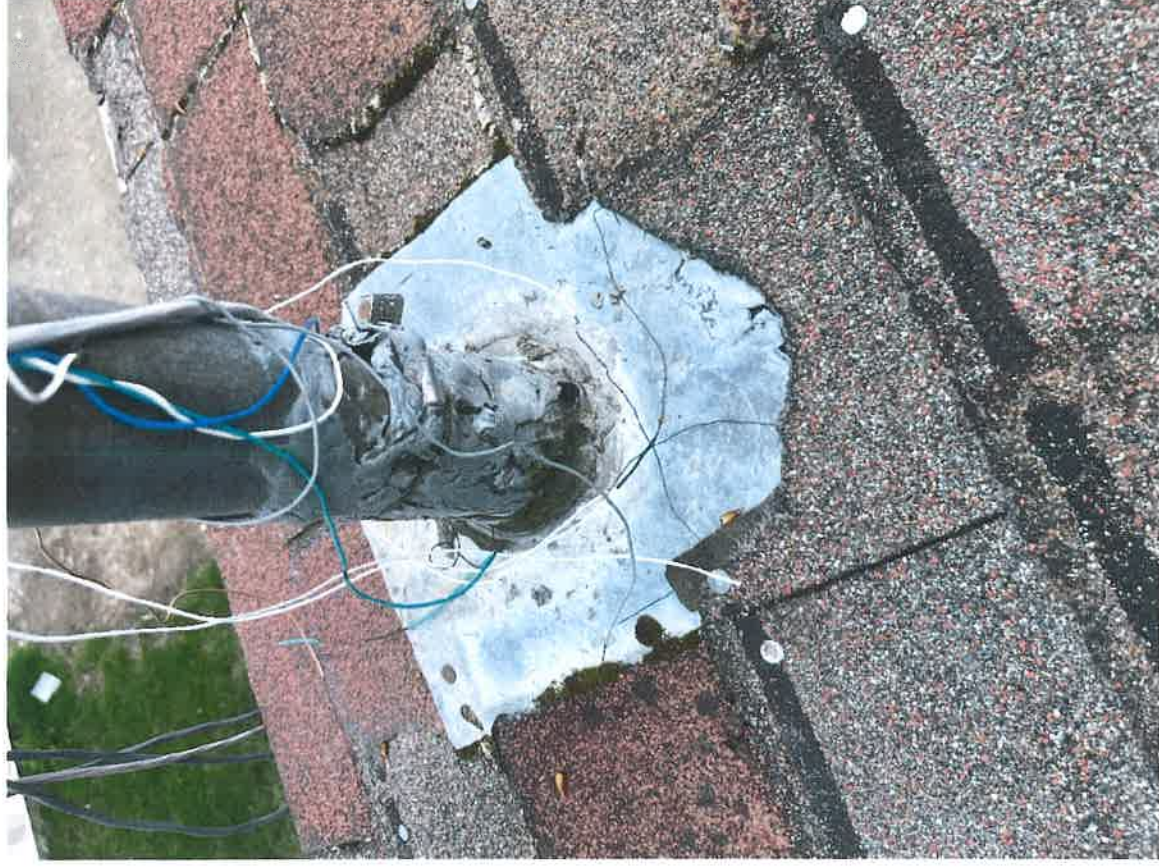
Photo shows black penetration mastic (gray oxidized outer surface) located and adhered to a pipe, roof flashing made of lead, and 3-tab roofing. This material contains 5% chrysotile asbestos.

- Black roof penetration mastic, located at a pipe penetration on the Northeast side of the building on the roof adjacent to the outer edge. The penetration mastic is also adhered to a one (1) foot or less square foot flashing made of lead for the pipe penetration. This material is 5% chrysotile asbestos. Sample # AACB-04-01. An abatement contractor should field verify quantities and conditions to be abated prior to providing abatement cost. The estimated quantity is one square foot or less. See the enclosed Photo Log showing some the lead flashing and this ACM.

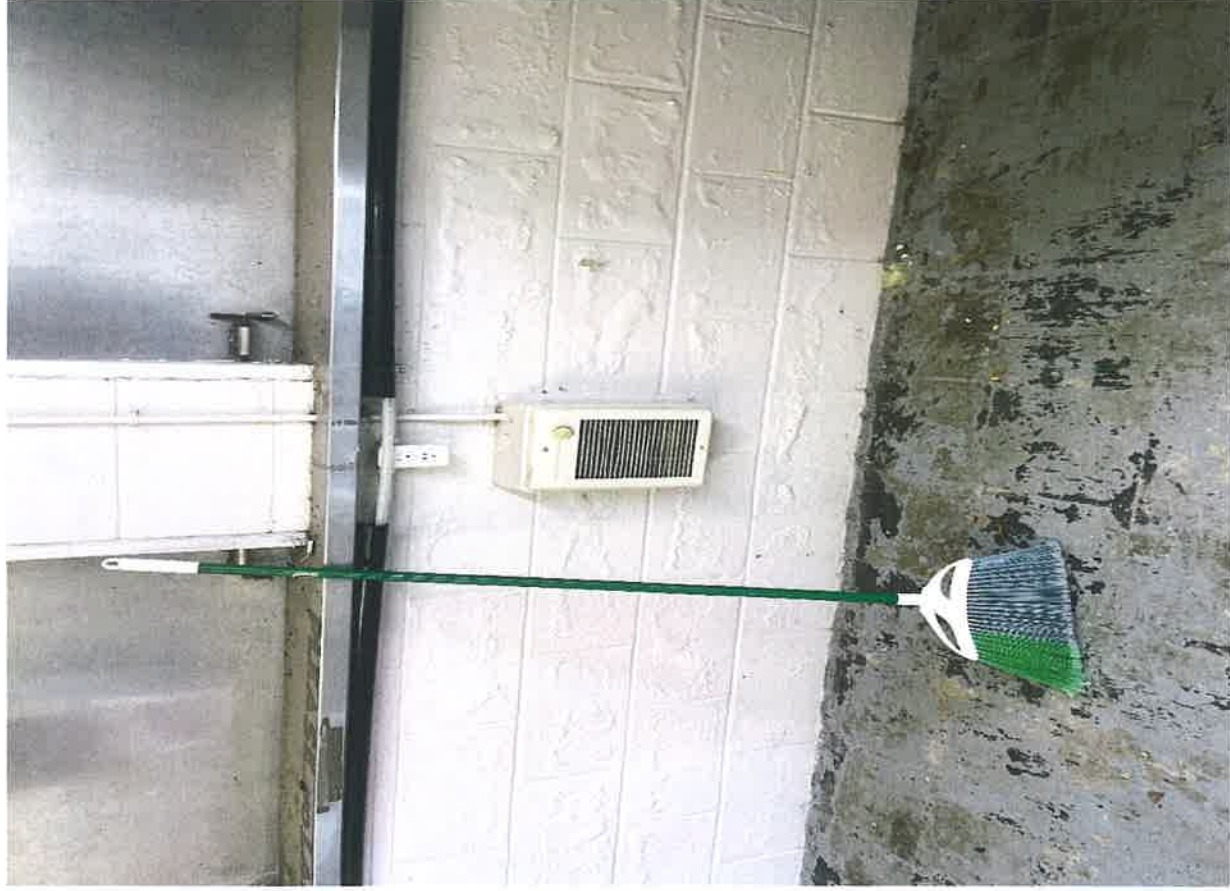
Photo shows black asbestos-containing floor mastic from former floor tile application.  
Note: Much of the black mastic has a paint like coating on top of it as seen in the photo.  
This material contains 5-6% chrysotile asbestos.

- Black mastic associated with former floor tiles, located on the concrete floor of the food preparation and concession serving area. This material is 5-6% chrysotile asbestos. Sample #'s AACB-02-01, AACB-02-02, and AACB-02-03. An abatement contractor should field verify quantities and conditions to be abated prior to providing abatement cost. The estimated quantity is 300 square feet, some items (i.e., cabinets) may be placed over the top of this ACM. Additionally, a paint type coating has been applied on top of this ACM black mastic. See the enclosed Photo Log showing some portions of this ACM.

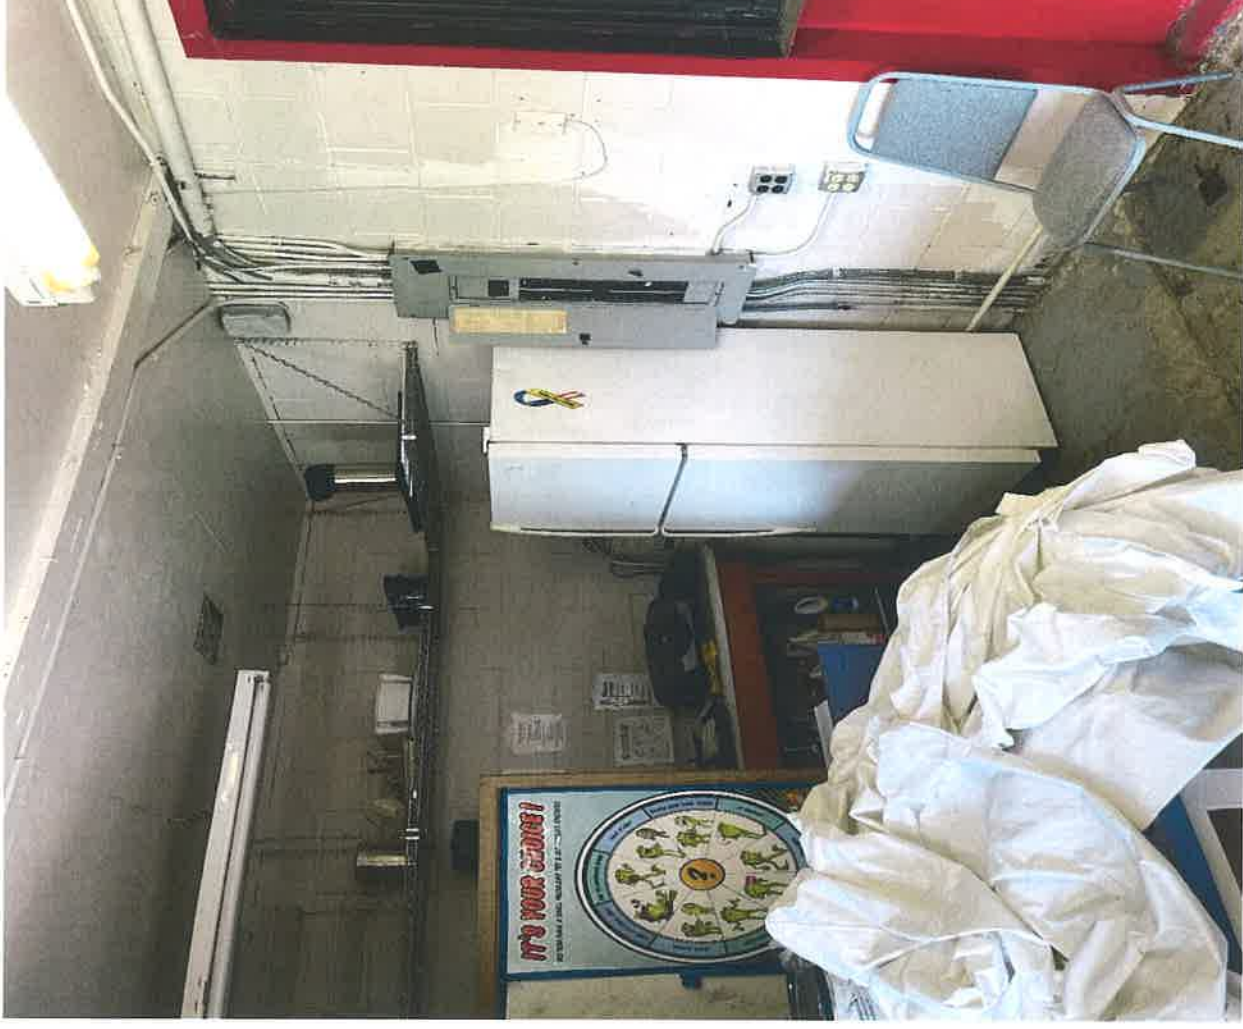
Photo shows the same black asbestos-containing floor mastic from a former floor tile application, where it ends just past the chair. Note: Much of this black mastic has a paint like coating on top of it. This material contains 5-6% chrysotile asbestos.

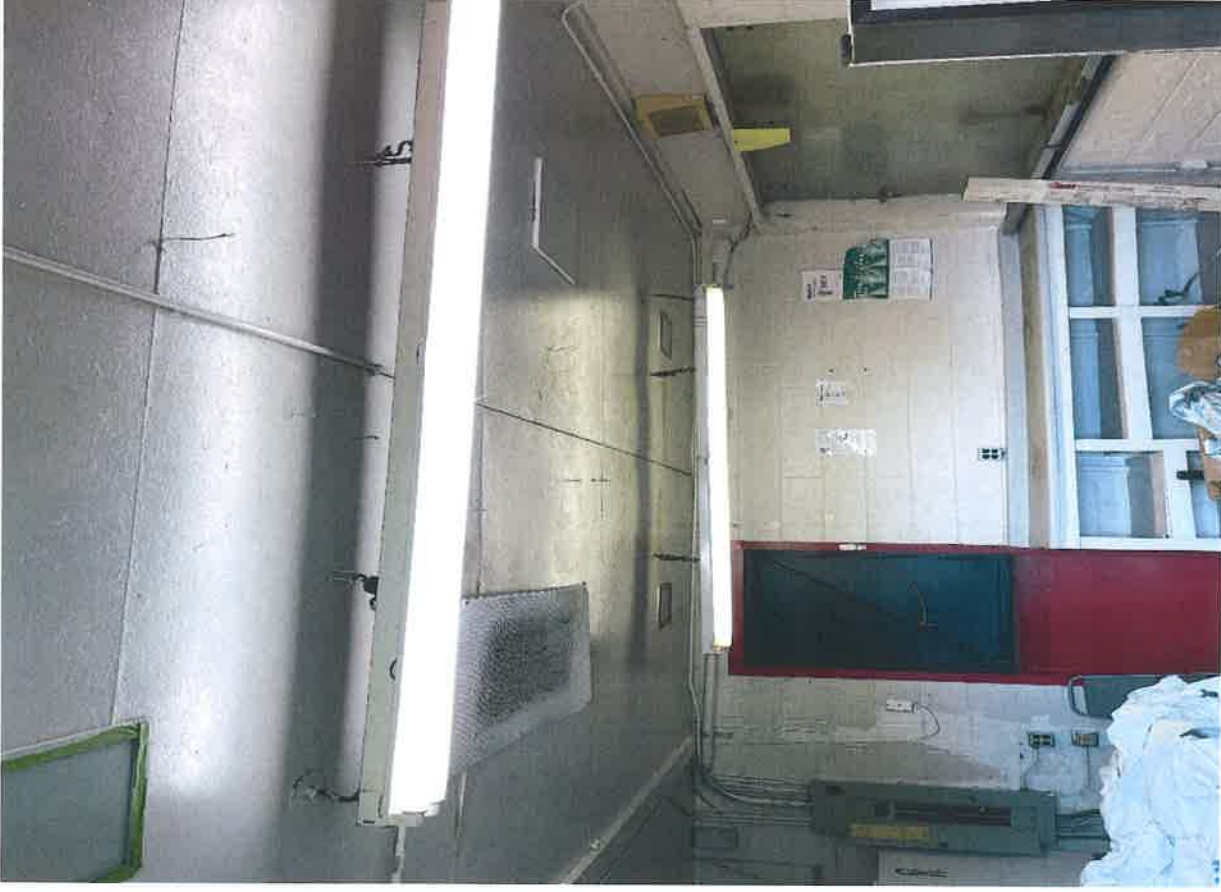
Photo shows four (4) 8 feet long fluorescent light tubes and two fixtures. These tubes and ballast will need to be recycled or disposed of as universal waste. There are a total of eight (8), eight-foot tubes and 8 to 12 light ballast from 4 fixtures. The ballast will need to be checked to determine if they are PCB-containing or not for proper disposal. Check label to see if the ballast indicates Non-PCB Containing.

6. The contractor or anyone disposing of fluorescent light tube ballasts should determine if PCBs are present in light fixture ballasts by reading the labels indicating "No PCBs" or research. See the enclosed document under "Miscellaneous" from the EPA entitled "TSCA Disposal Requirements for Fluorescent Light Ballasts."

7. Remove and properly dispose of all identified hazardous or regulated materials including but not limited to light bulbs containing mercury vapor, dangerous waste, and universal waste prior to demolition. Making dangerous waste determinations, profiling to a permitted disposal site, packaging, labeling, manifesting, and transporting should be performed by those with adequate training and experience even if being recycled. Transportation of hazardous materials, dangerous waste, or other regulated waste shall be performed by those who are licensed and certified to accept and transport these materials.

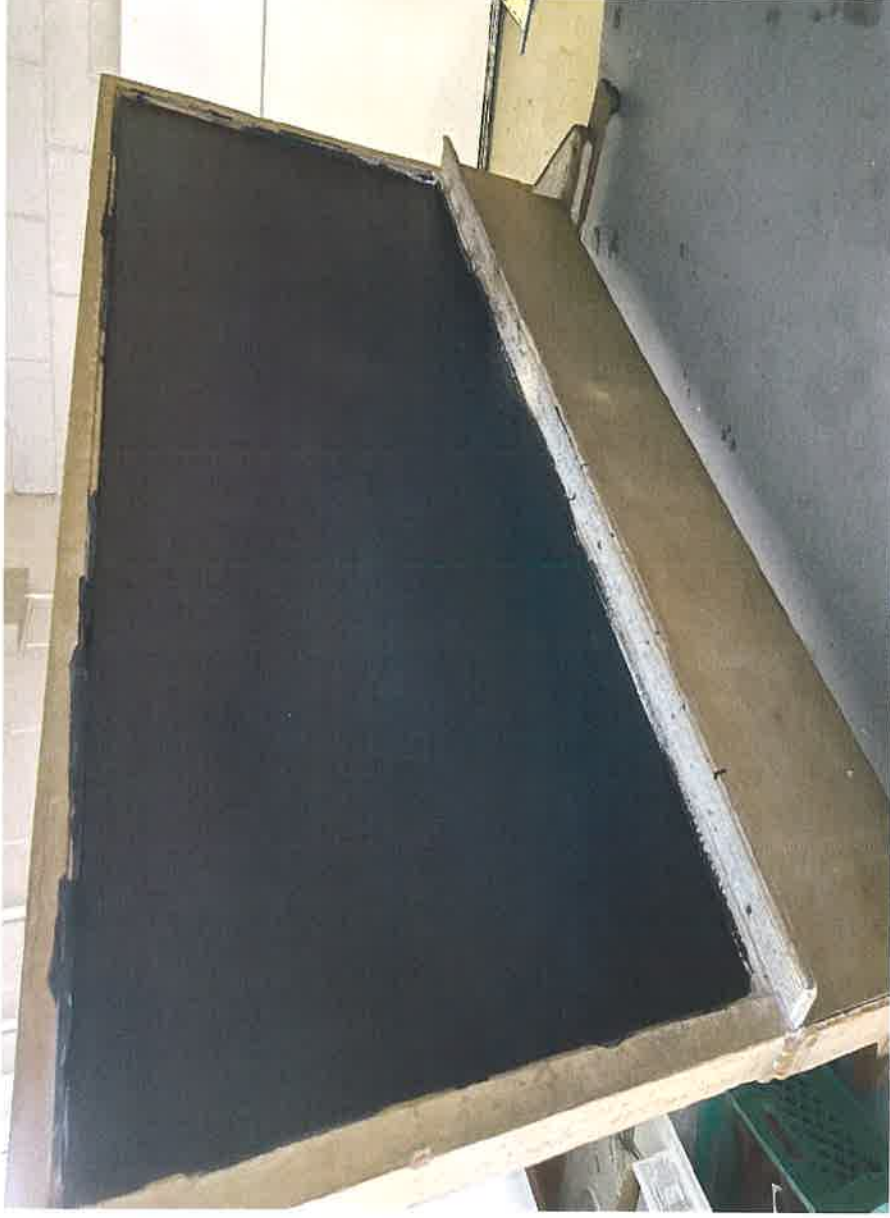
Photo shows a large chalk board within a rolling frame located inside the Concession building. The black board portion is presumed to be asbestos-containing material (ACM) and should be removed prior to demolition.

- **Black chalk board within a wood frame and rollers to be moved around; a typical school like chalk board that are known to contain asbestos greater than 1% asbestos. This material was presumed considering it is difficult to obtain a sample without cracking the board and it can be reused or donated for reuse. The material is not friable, and the outer black coating protects from exposure to ACM.**
