# **NESHAP Asbestos Survey Report**

## **Building System ID #10976**

**Microwave Tower Building**  
**Davis Road and Headquarters Road**  
**Castle Rock, Washington 98611**  
**Latitude 46.254813 Longitude -122.849881**

NESHAP Asbestos Survey Report  
BNSF System ID #10976  
Microwave Tower Building  
Castle Rock, Washington 98611

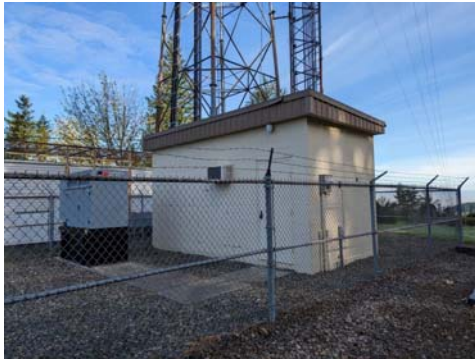
Southeast exterior elevation viewing northwest

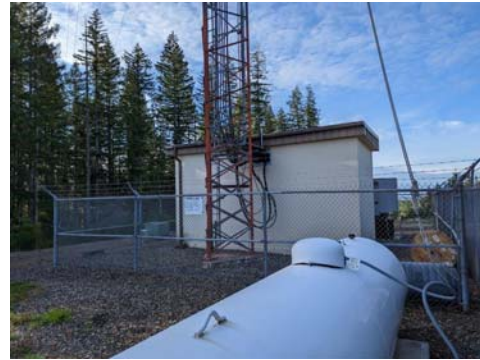
Northwest exterior elevation viewing southeast

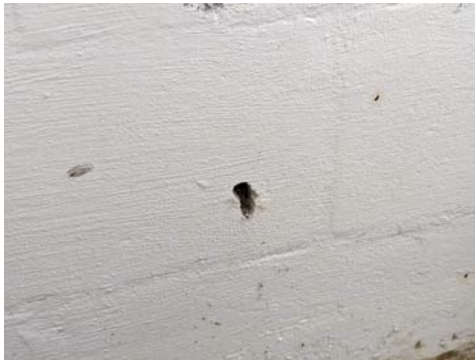
| Homogenous Materials | | | | Location(s) and Condition(s) of Homogeneous Materials | | | | | | | | Sample Information | | | |
|---|---|---|---|---|---|---|---|---|---|---|---|---|---|---|---|
| HAG | Vermiculite | Brown/Gold | Miscellaneous | Interior, within cinder block walls | Friable | Good | In-Place | Confirmed | 0 | 550 | Square Feet | Yes | HAG-001, 002, 003 | <= 1% | <0.25%-0.25% Actinolite |

HA9, Vermiculite, <0.25%-0.25% Actinolite
