Notification of Demolition

Case #: 24-260

Commercial Name or Description: Fircrest Meadows

RE: Asbestos Survey for Demolition at 12301 SE 18th Street Avenue (Fircrest Meadows).

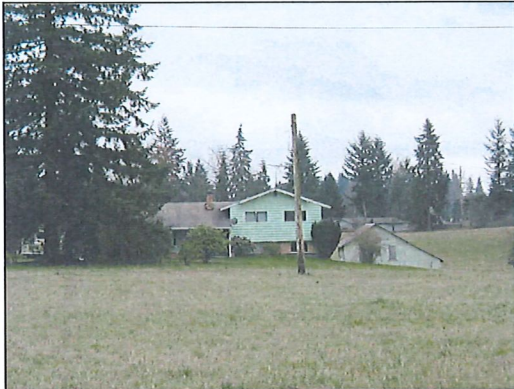
Property Photo

Photo Date: 03/05/2002
