DNR Chehalis Work Center, Building PC0602 1405 Rush Road Chehalis, WA 98532

State of Washington Department of Natural Resources
Pacific Cascade Region - Lewis County
DNR 24-PC-TM-003 PC0602 Asbestos Abatement
Limited Public Works Contract

Limited Asbestos and Lead Inspection Report

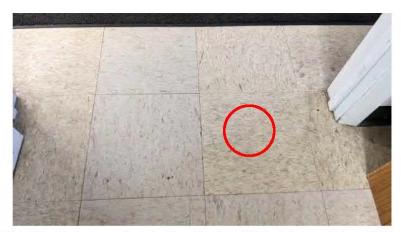
Photo 1 - HA-1: Off-white, gray-streaked vinyl floor tiles (4% Chrysotile) with black mastic (3% chrysotile), located throughout the project area.

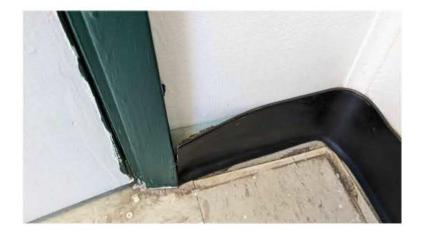
Photo 2 — HA-4: Off-white, brown-mottled vinyl floor tiles (non-ACM) with tan mastic (non-ACM) and residual black mastic (3% chrysotile), located in the western offices and as patching throughout the project area

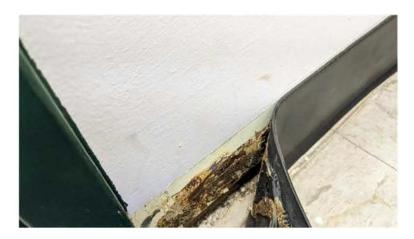
Photo 3 – White on light green paint on gypsum wallboard and wood associated with walls throughout Building PC0602 (Sample: PC0602-PC-3, 340 ppm).
