# Notification of Demolition

Case #: 24-273

## REGULATED BUILDING MATERIALS SURVEY

**Green Buildings 1, 2, 3  
East Mill Road  
Longview, WA 98632**

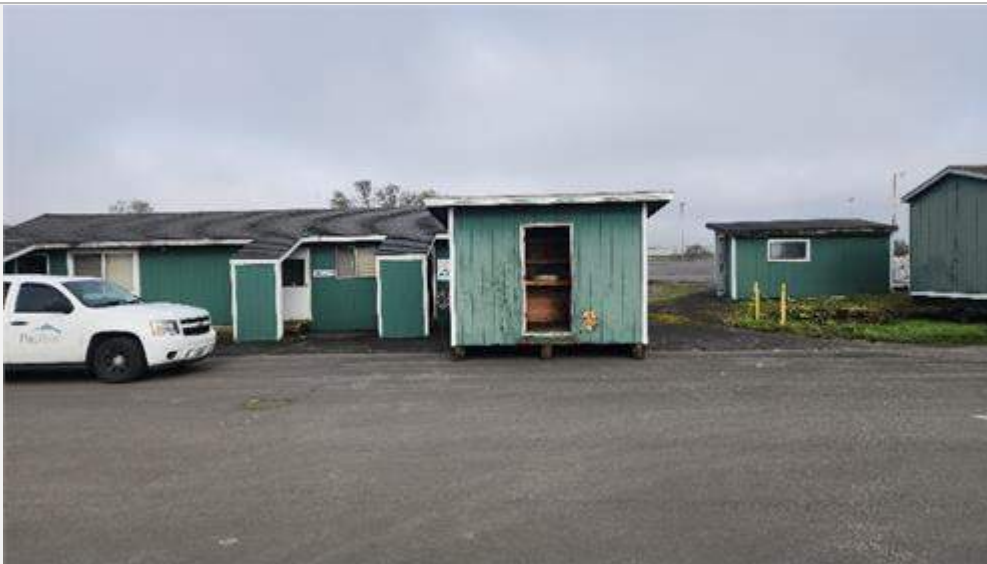
<b>Technician Project Description:</b>	Building, shed 1 and shed 2. Approximately built in 1967 Electrical panel in EC shed states installed in 1967.
<b>Turnaround Requested:</b>	3-5 Days

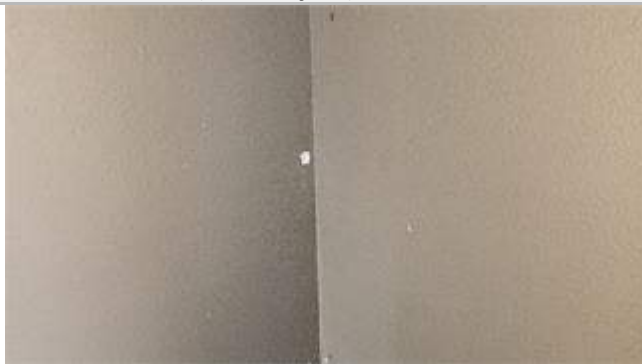
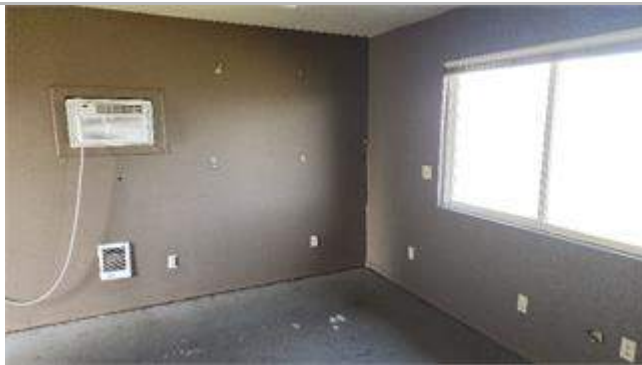
Asbestos Sample		Sample Date: 10-Apr-2024	
Project Name	Green Buildings 1, 2, 3		
Sample Type	Physical Sample	AHERA Category	Surfacing
Sample Number	A410-01	Homogenous Material Number	1
Material Description	Texture on GWB		
Building Component	Wall	Substrate	Drywall
Homogenous Mtl Area	Rooms 1 and 2 walls and ceilings, rooms 3 and 4 ceilings		
Sample Location	Room 1 wall		
Quantity	1300	Unit of Measure	Square Feet
Asbestos Type/%	None Detected (Both Layers)		
Sample Photo

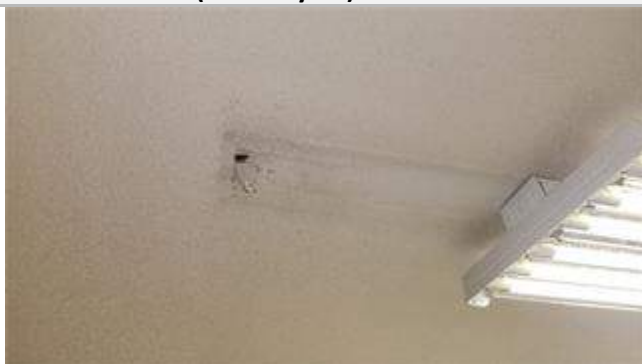
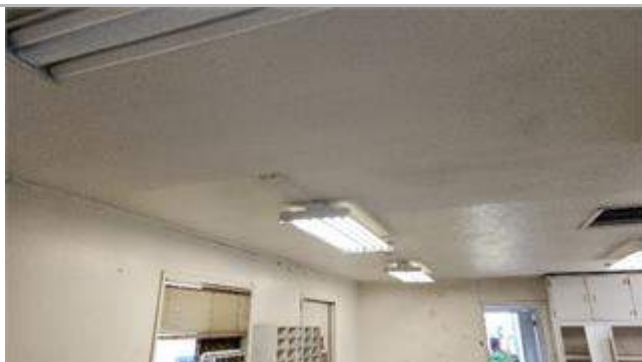
Asbestos Sample		Sample Date: 10-Apr-2024	
Project Name	Green Buildings 1, 2, 3		
Sample Type	Physical Sample	AHERA Category	Surfacing
Sample Number	A410-04	Homogenous Material Number	1
Material Description	Texture on GWB		
Building Component	Ceiling	Substrate	Drywall
Homogenous Mtl Area	N/A		
Sample Location	Room 3 ceiling		
Quantity	1300	Unit of Measure	Square Feet
Asbestos Type/%	None Detected (Both Layers)		
Sample Photo

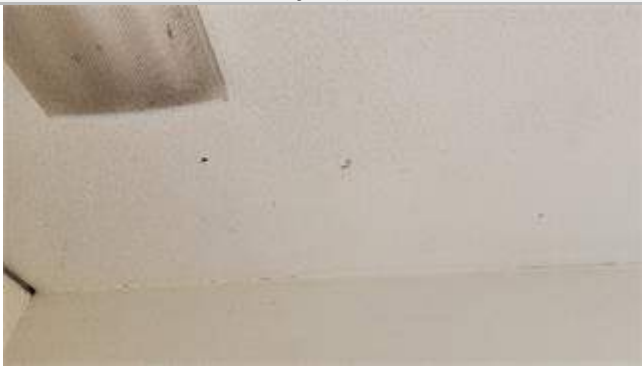
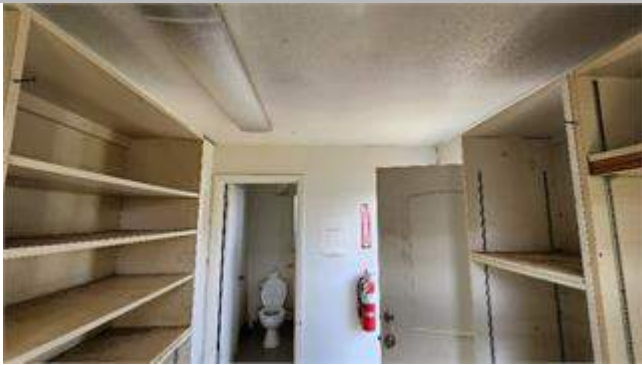
Asbestos Sample		Sample Date: 10-Apr-2024	
<b>Project Name</b>	Green Buildings 1, 2, 3		
<b>Sample Type</b>	Physical Sample	<b>AHERA Category</b>	Surfacing
<b>Sample Number</b>	A410-05	<b>Homogenous Material Number</b>	1
<b>Material Description</b>	Texture on GWB		
<b>Building Component</b>	Ceiling	<b>Substrate</b>	Drywall
<b>Homogenous Mtl Area</b>	N/A		
<b>Sample Location</b>	Room 4 ceiling		
<b>Quantity</b>	1300	<b>Unit of Measure</b>	Square Feet
<b>Asbestos Type/%</b>	<b>None Detected (Both Layers)</b>		
<b>Sample Photo</b>

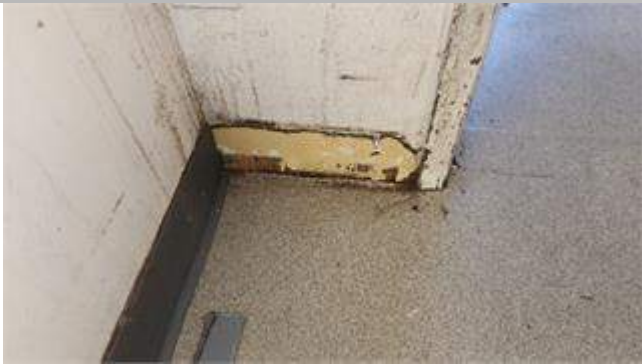
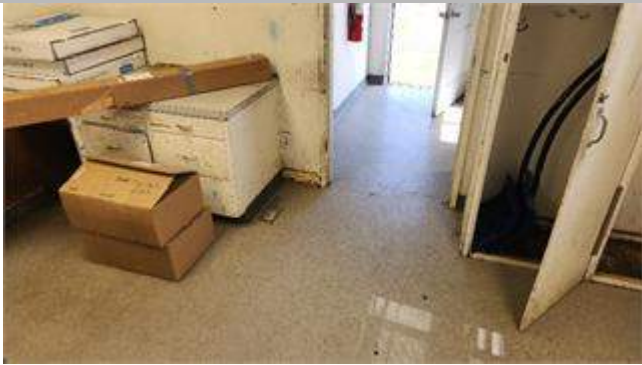
Asbestos Sample		Sample Date: 10-Apr-2024	
<b>Project Name</b>	Green Buildings 1, 2, 3		
<b>Sample Type</b>	Physical Sample	<b>AHERA Category</b>	Miscellaneous
<b>Sample Number</b>	A410-06	<b>Homogenous Material Number</b>	2
<b>Material Description</b>	4 inch grey cove base and mastic		
<b>Building Component</b>	Wall	<b>Substrate</b>	Wood
<b>Homogenous Mtl Area</b>	Room 3, room 4, and bathroom		
<b>Sample Location</b>	Room 3 wall		
<b>Quantity</b>	130	<b>Unit of Measure</b>	Lineal Feet
<b>Asbestos Type/%</b>	<b>None Detected (Both Layers)</b>		
<b>Sample Photo</b>

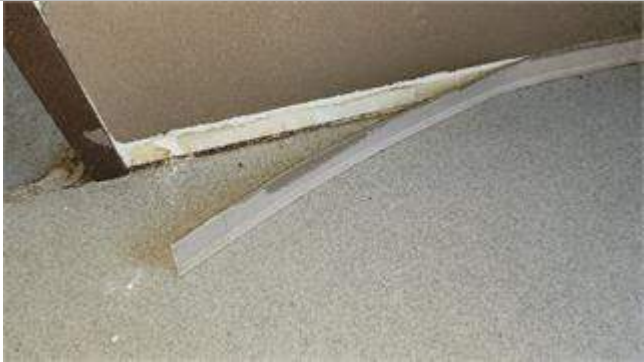
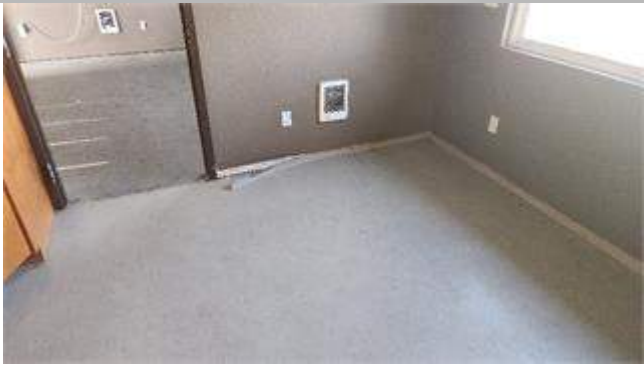
Asbestos Sample		Sample Date: 10-Apr-2024	
<b>Project Name</b>	Green Buildings 1, 2, 3		
<b>Sample Type</b>	Physical Sample	<b>AHERA Category</b>	Miscellaneous
<b>Sample Number</b>	A410-07	<b>Homogenous Material Number</b>	4
<b>Material Description</b>	2 inch cove base and mastic		
<b>Building Component</b>	Wall	<b>Substrate</b>	Drywall
<b>Homogenous Mtl Area</b>	Room 1 and room 2		
<b>Sample Location</b>	Room 2		
<b>Quantity</b>	80	<b>Unit of Measure</b>	Lineal Feet
<b>Asbestos Type/%</b>	<b>None Detected (All Layers)</b>		
<b>Sample Photo</b>

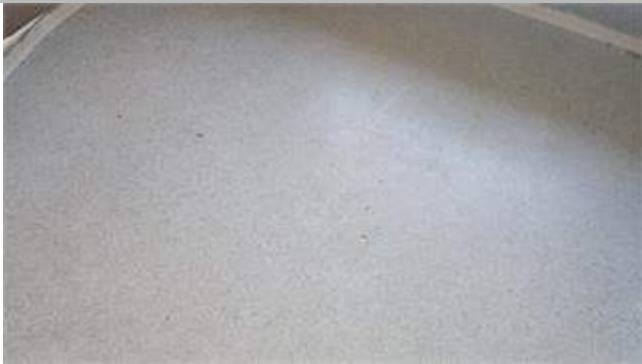
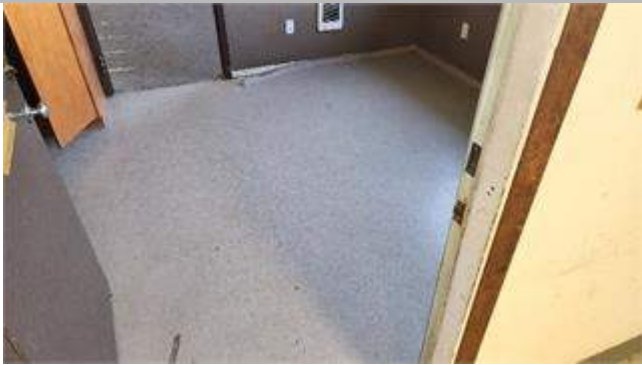
Asbestos Sample		Sample Date: 10-Apr-2024	
<b>Project Name</b>	Green Buildings 1, 2, 3		
<b>Sample Type</b>	Physical Sample	<b>AHERA Category</b>	Miscellaneous
<b>Sample Number</b>	A410-08	<b>Homogenous Material Number</b>	3
<b>Material Description</b>	Sheet Vinyl Flooring		
<b>Building Component</b>	Floor	<b>Substrate</b>	Concrete
<b>Homogenous Mtl Area</b>	Rooms 2, 3, 4, and bathroom		
<b>Sample Location</b>	Room 2		
<b>Quantity</b>	630	<b>Unit of Measure</b>	Square Feet
<b>Asbestos Type/%</b>	<b>None Detected (All Layers)</b>		
<b>Sample Photo</b>

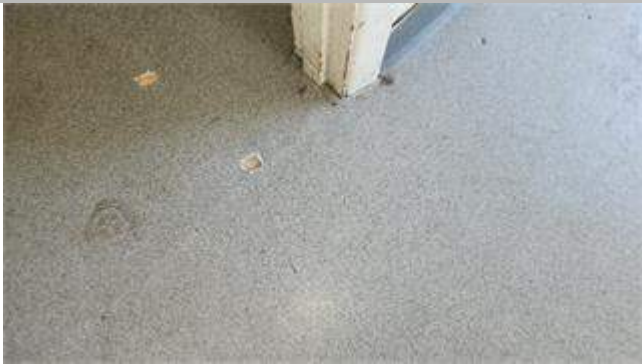
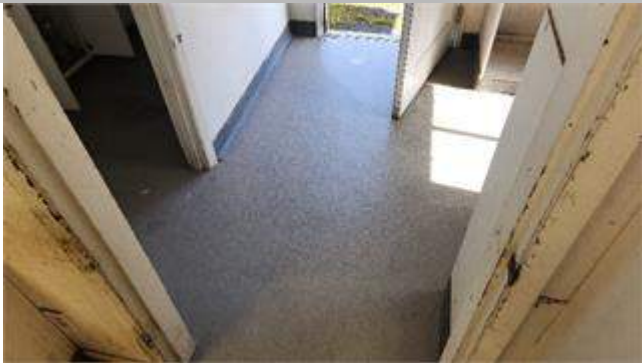
Asbestos Sample		Sample Date: 10-Apr-2024	
<b>Project Name</b>	Green Buildings 1, 2, 3		
<b>Sample Type</b>	Physical Sample	<b>AHERA Category</b>	Miscellaneous
<b>Sample Number</b>	A410-09	<b>Homogenous Material Number</b>	3
<b>Material Description</b>	Sheet Vinyl Flooring		
<b>Building Component</b>	Floor	<b>Substrate</b>	Wood
<b>Homogenous Mtl Area</b>	N/A		
<b>Sample Location</b>	Room 4		
<b>Quantity</b>	630	<b>Unit of Measure</b>	Square Feet
<b>Asbestos Type/%</b>	<b>None Detected (All Layers)</b>		
<b>Sample Photo</b>

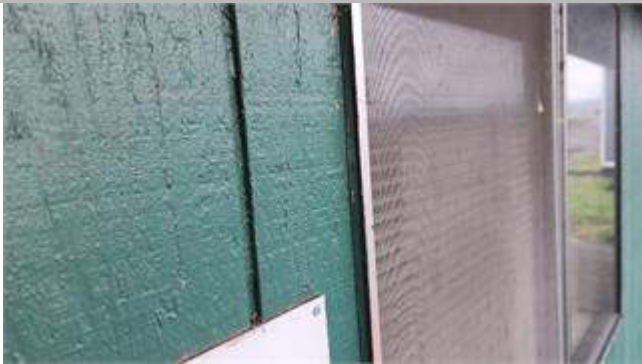
Asbestos Sample		Sample Date: 10-Apr-2024	
<b>Project Name</b>	Green Buildings 1, 2, 3		
<b>Sample Type</b>	Physical Sample	<b>AHERA Category</b>	Miscellaneous
<b>Sample Number</b>	A410-10	<b>Homogenous Material Number</b>	5
<b>Material Description</b>	Exterior caulk		
<b>Building Component</b>	Wall	<b>Substrate</b>	Wood
<b>Homogenous Mtl Area</b>	On original aluminum framed windows only		
<b>Sample Location</b>	Building exterior window of room 3		
<b>Quantity</b>	90	<b>Unit of Measure</b>	Lineal Feet
<b>Asbestos Type/%</b>	<b>None Detected</b>		
<b>Sample Photo</b>

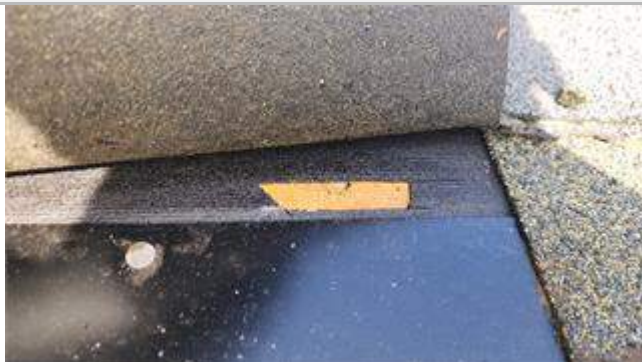
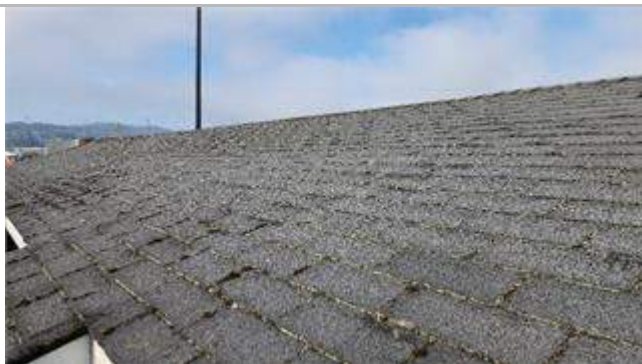
Asbestos Sample		Sample Date: 10-Apr-2024	
Project Name	Green Buildings 1, 2, 3		
Sample Type	Physical Sample	AHERA Category	Miscellaneous
Sample Number	A410-12	Homogenous Material Number	9
Material Description	Roofing tar paper		
Building Component	Roof	Substrate	Wood
Homogenous Mtl Area	N/A		
Sample Location	Building roof		
Quantity	1100	Unit of Measure	Square Feet
Asbestos Type/%	None Detected		
Sample Photo

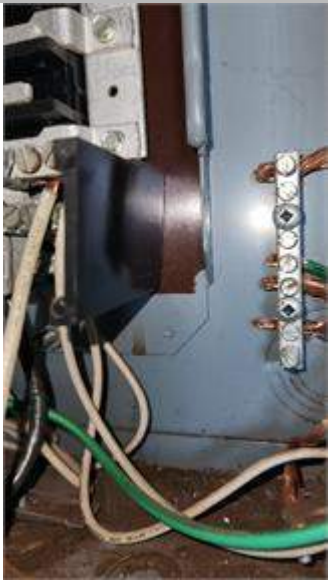
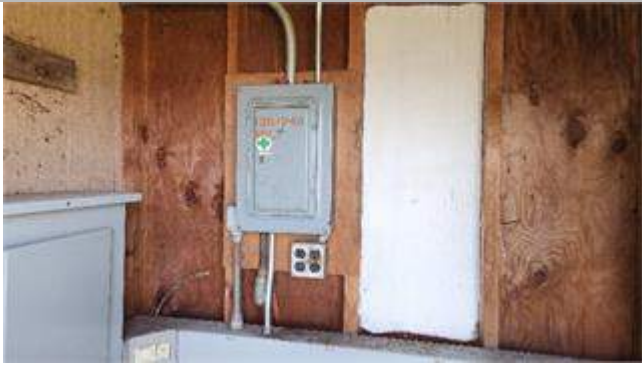
Asbestos Sample		Sample Date: 10-Apr-2024	
<b>Project Name</b>	Green Buildings 1, 2, 3		
<b>Sample Type</b>	Physical Sample	<b>AHERA Category</b>	Miscellaneous
<b>Sample Number</b>	A410-13	<b>Homogenous Material Number</b>	8
<b>Material Description</b>	Electrical backer board		
<b>Building Component</b>	Wall	<b>Substrate</b>	Metal
<b>Homogenous Mtl Area</b>	N/A		
<b>Sample Location</b>	EC shed		
<b>Quantity</b>	2	<b>Unit of Measure</b>	Square Feet
<b>Asbestos Type/%</b>	None Detected		
<b>Sample Photo</b>

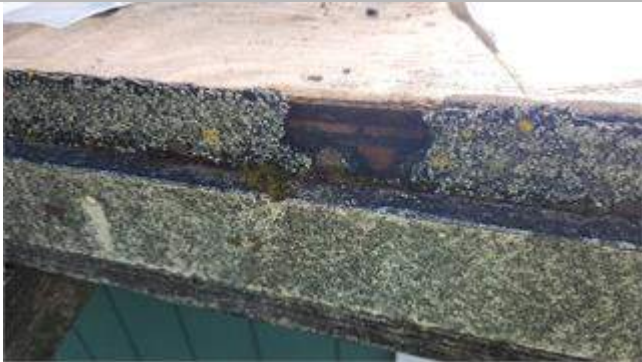
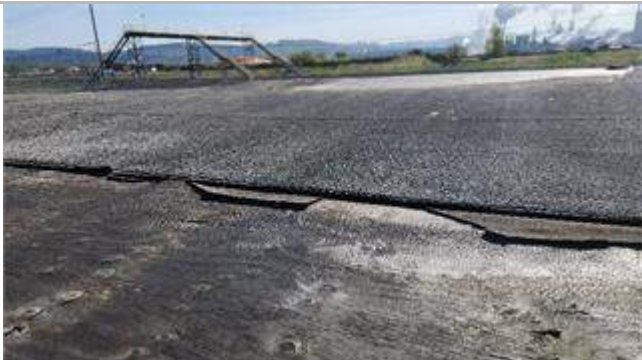
Asbestos Sample		Sample Date: 10-Apr-2024	
Project Name	Green Buildings 1, 2, 3		
Sample Type	Physical Sample	AHERA Category	Miscellaneous
Sample Number	A410-14	Homogenous Material Number	7
Material Description	Rolled roofing		
Building Component	Roof	Substrate	Wood
Homogenous Mtl Area	N/A		
Sample Location	Shed 1 roof		
Quantity	80	Unit of Measure	Square Feet
Asbestos Type/%	None Detected		
Sample Photo

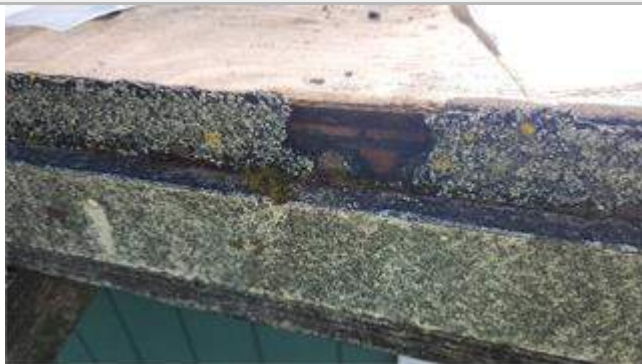
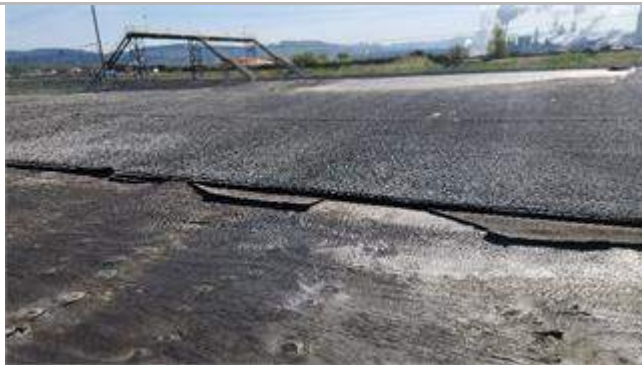
Asbestos Sample		Sample Date: 10-Apr-2024	
Project Name	Green Buildings 1, 2, 3		
Sample Type	Physical Sample	AHERA Category	Miscellaneous
Sample Number	A410-15	Homogenous Material Number	10
Material Description	Rolled roofing tar paper		
Building Component	Roof	Substrate	Wood
Homogenous Mtl Area	N/A		
Sample Location	Shed 1 roof		
Quantity	80	Unit of Measure	Square Feet
Asbestos Type/%	None Detected		
Sample Photo

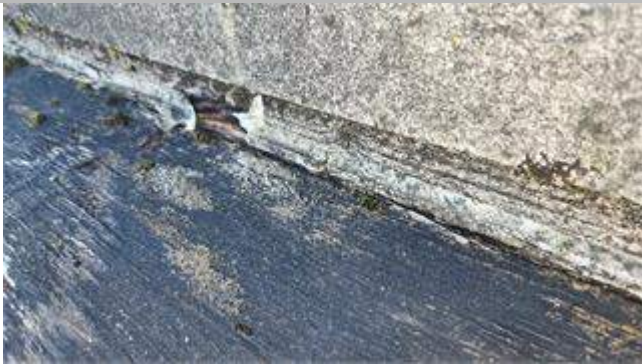
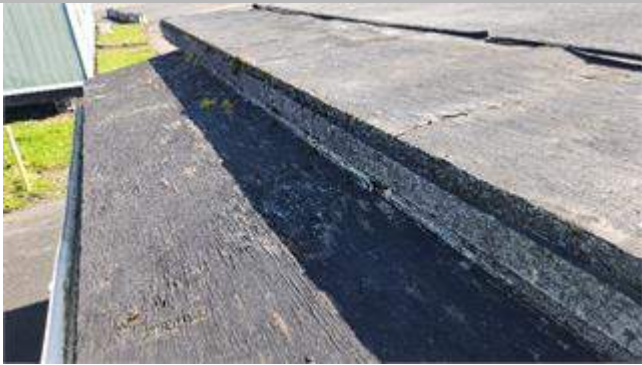
Asbestos Sample		Sample Date: 10-Apr-2024	
<b>Project Name</b>	Green Buildings 1, 2, 3		
<b>Sample Type</b>	Physical Sample	<b>AHERA Category</b>	Miscellaneous
<b>Sample Number</b>	A410-16	<b>Homogenous Material Number</b>	11
<b>Material Description</b>	Exterior caulk		
<b>Building Component</b>	Roof	<b>Substrate</b>	Wood
<b>Homogenous Mtl Area</b>	N/A		
<b>Sample Location</b>	Shed 1 opposite side from door on roof		
<b>Quantity</b>	11	<b>Unit of Measure</b>	Lineal Feet
<b>Asbestos Type/%</b>	None Detected		
<b>Sample Photo</b>

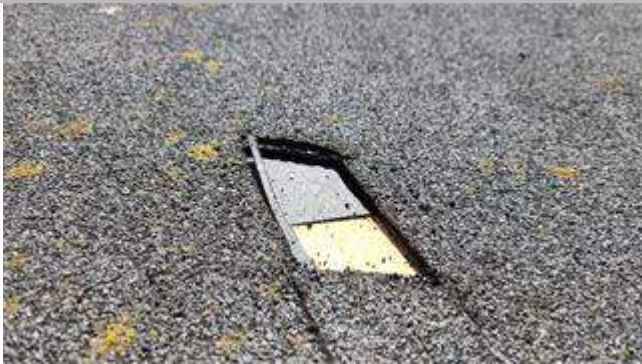
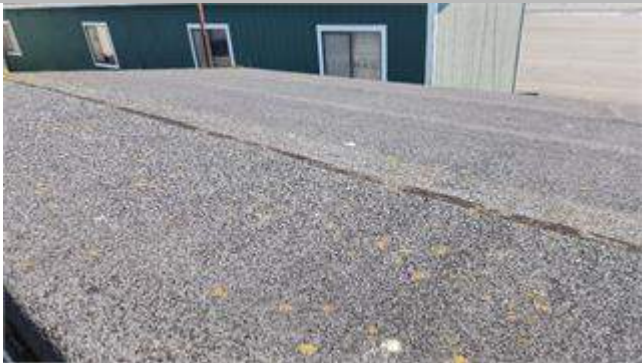
Asbestos Sample		Sample Date: 10-Apr-2024	
Project Name	Green Buildings 1, 2, 3		
Sample Type	Physical Sample	AHERA Category	Miscellaneous
Sample Number	A410-17	Homogenous Material Number	7
Material Description	Rolled roofing		
Building Component	Roof	Substrate	Wood
Homogenous Mtl Area	N/A		
Sample Location	Shed 2 roof		
Quantity	85	Unit of Measure	Square Feet
Asbestos Type/%	None Detected		
Sample Photo

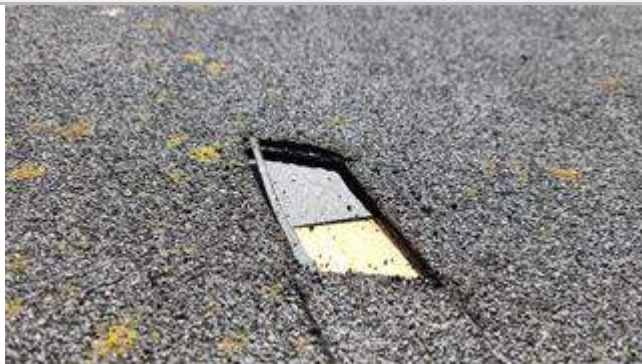
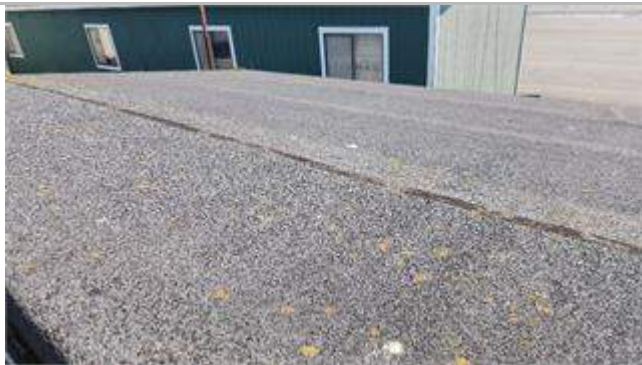
Asbestos Sample		Sample Date: 10-Apr-2024	
Project Name	Green Buildings 1, 2, 3		
Sample Type	Physical Sample	AHERA Category	Miscellaneous
Sample Number	A410-18	Homogenous Material Number	10
Material Description	Rolled roofing tar paper		
Building Component	Roof	Substrate	Wood
Homogenous Mtl Area	N/A		
Sample Location	Shed 2 roof		
Quantity	85	Unit of Measure	Square Feet
Asbestos Type/%	None Detected		
Sample Photo

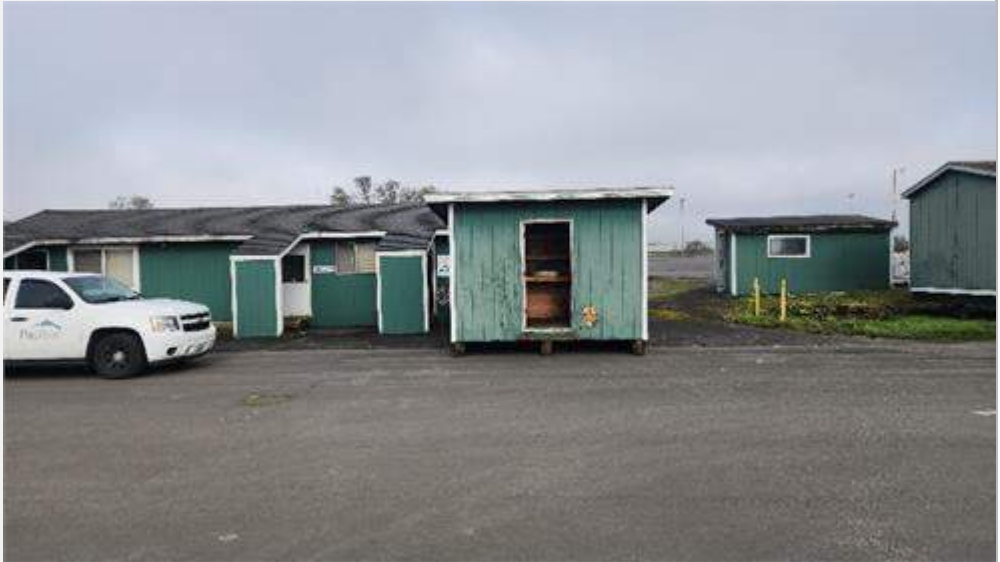
<b>Technician Project Description:</b>	Building, shed 1 and shed 2. Approximately built in 1967 Electrical panel in EC shed states installed in 1967.
<b>Turnaround Requested:</b>	3-5 Days

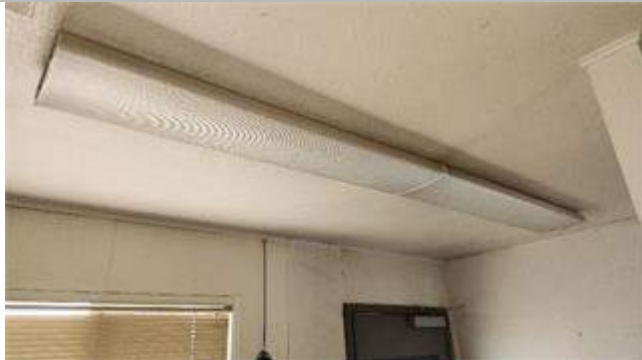
Universal Waste Sample		Sample Date: 10-Apr-2024	
Project Name	Green Buildings 1, 2, 3		
Sample Type	Universal Waste		
Sample Number	UW-A410-01		
Material Description	Light Ballast		
Quantity	13	Unit of Measure	Each
Sample Photo

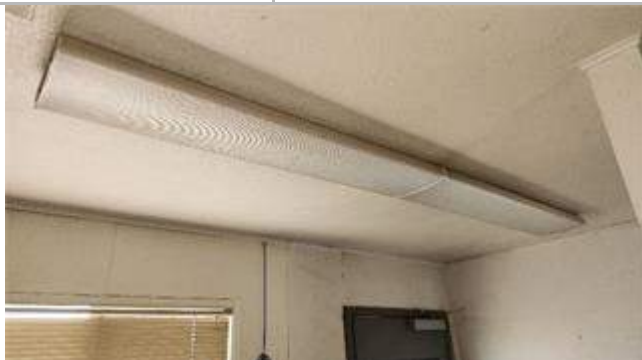
Universal Waste Sample		Sample Date: 10-Apr-2024	
Project Name	Green Buildings 1, 2, 3		
Sample Type	Universal Waste		
Sample Number	UW-A410-02		
Material Description	4' Fluorescent tubes		
Quantity	43	Unit of Measure	Each
Sample Photo
