## Notice of Intent to Remove Asbestos

Case #: 24-522

# **Asbestos Survey Report**

**102 S. Knoxville Way, Vancouver, WA 98664**

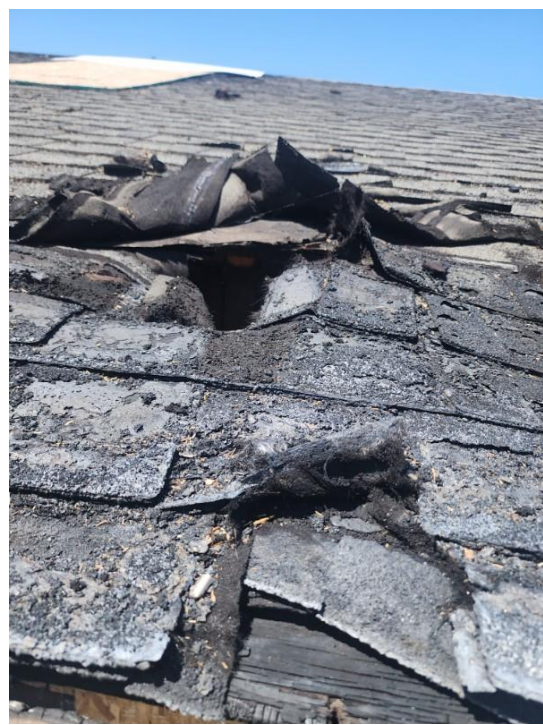
**01**

Sample ID	Material	Description	Location	Condition	Result
01	M	Tar Paper and Shingle	Exterior	P	NAD
02	M	Insulation-Light Grey	Interior	P	NAD
03	M	Insulation-Dark Grey	Interior	P	NAD
04	S	Drywall- Black	Interior	P	ACM
05	S	Drywall	Interior	P	NAD
06	S	Sheetrock	Interior	P	ACM
07	M	Flooring Tile	Interior	P	NAD
08	M	Siding Underlayment	Exterior	F	NAD
09	M	Chimney Mortar	Interior	F	NAD
10	M	Fire Brick	Interior	F	NAD
11	M	Wire Insulation	Interior	F	NAD
12	M	Wire Casing – Loosely Woven	Interior	F	NAD

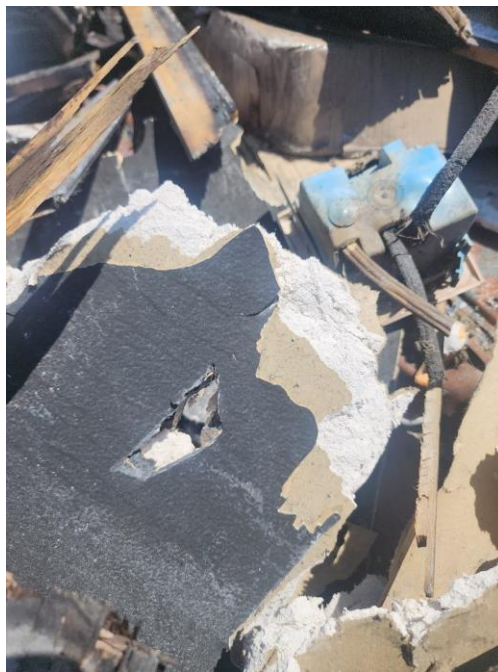
**04**

**The samples of the Drywall- Black and the Sheetrock were found to contain Asbestos.**

The materials identified in this report as asbestos containing should be monitored. If any of these materials are removed from the structure, notes should be made of the quantities. All activities impacting these materials should be conducted by a Licensed Asbestos Abatement Contractor in compliance with OAR 340-248 and using Certified Asbestos Workers under the direction of a Certified Asbestos Supervisor.

It is recommended that any impact to the Materials >1% listed as asbestos containing in this report be conducted using approved asbestos abatement methods including notification to the local air pollution authority (DEQ), wet removal methods, engineering controls to capture any asbestos fibers during removal. It is also recommended that a licensed Asbestos Abatement Contractor is used.
