Notice of Intent to Remove Asbestos

Site Name: Vacant Residence

Site address: 8004 NE 158th Avenue

RE: Asbestos Survey for Demolition at 8004 NE 158th Avenue in Vancouver, WA.

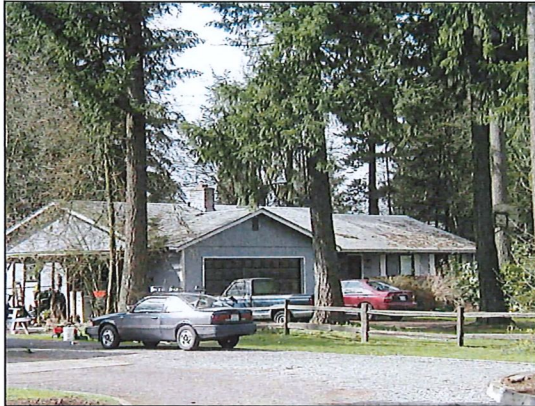
Property Photo

Photo Date: 03/21/2002
