## Notice of Intent to Remove Asbestos

# Asbestos Containing Materials Inspection

Project: Brush Prairie ACM Survey  
15824 NE 119<sup>th</sup> St  
Brush Prairie, WA 98606

RE: Pre-Demolition Good Faith Asbestos Survey

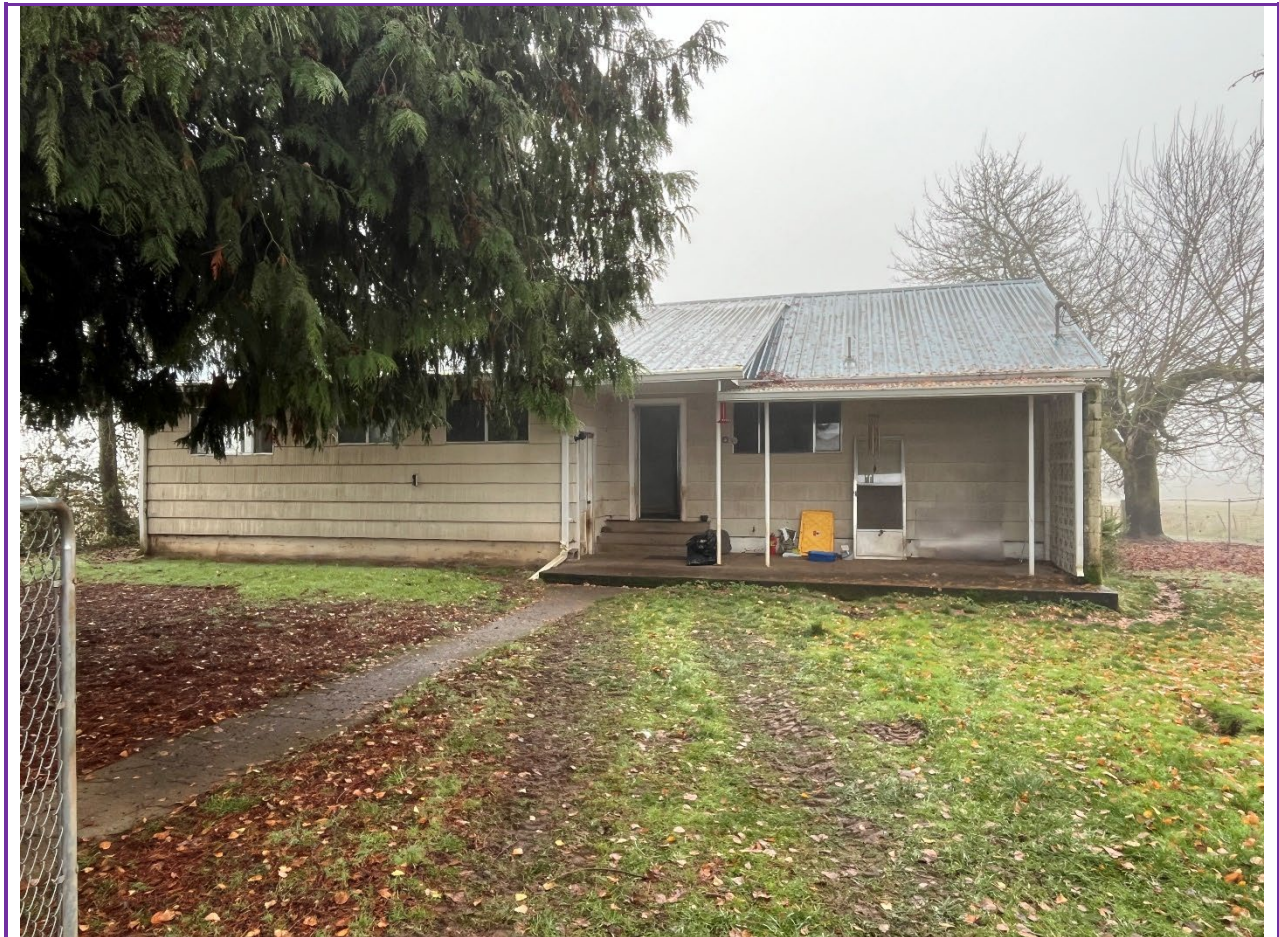
**FRONT OF STRUCTURE**

The structure was a wood framed single family residence with an unfinished basement. Per county assessor records, the structure was built in 1925 and was 2416 SF.

The exterior of the home consisted of aluminum windows, wood siding, wood trim and asphalt type roofing shingles concealed under a metal roof.

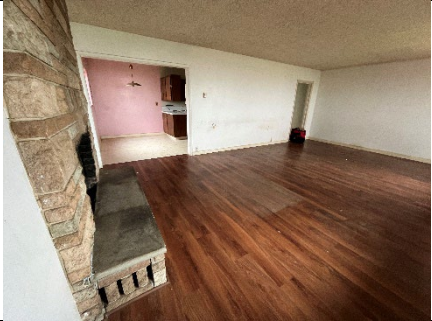
<p>Drywall with joint compound and texture is located throughout the structure, with the exception of the Fern Bedroom walls and ceilings, the entry and laundry room ceilings, and the living room ceiling.</p>
<p>No Photo Available</p>	<p>Pipe wrap is located in the basement, specific to the area in the crawlspace access.</p>
<p>No Photo Available</p>	<p>Multicolor sheet vinyl was non detect for asbestos, but the associated black mastic</p>

tested positive for asbestos. This material is present throughout the attic.

3 Kings Environmental, Inc. recommends that any ACM or PACM to be impacted during the course of the renovation or demolition be removed by a licensed, bonded, and insured asbestos abatement firm. Removal and disposal of asbestos containing materials should only be performed by certified firms following all local, state, and federal guidelines. Should materials not noted in this report be discovered during the course of the work, stop all demolition and have the newly discovered materials tested for asbestos or treat the materials as an asbestos containing material. Be sure to notify the governing authorities and clean-air agencies prior to disturbing materials over the recordable limits.

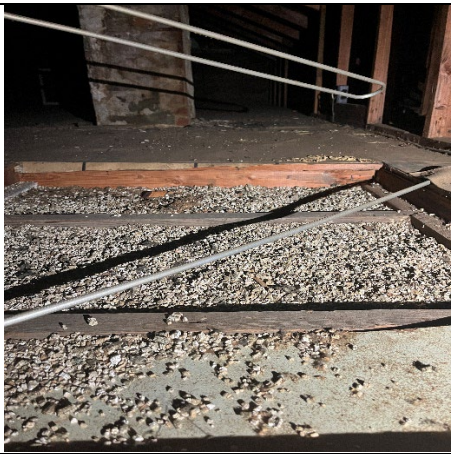
Vermiculite insulation observed throughout attic space was not tested, presumed asbestos-containing material.
