## Notice of Intent to Remove Asbestos

## Roger Shea Project Report

Possible irrigation sprinkler burst. Basement flooded approximately 1000SF at 2 inches. EMS techs have been dispatched.  
Shut off valve and back flow valve failed.

| Sprinkler broke outside flooding the basement | Category 3 | |

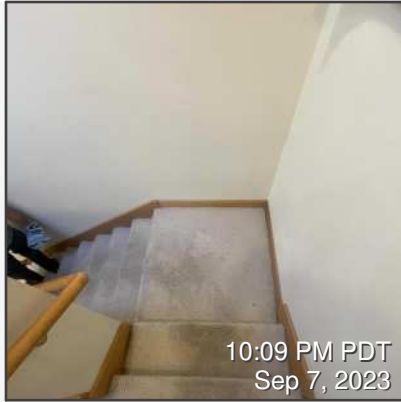
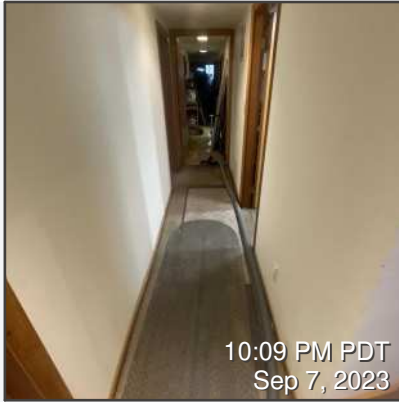
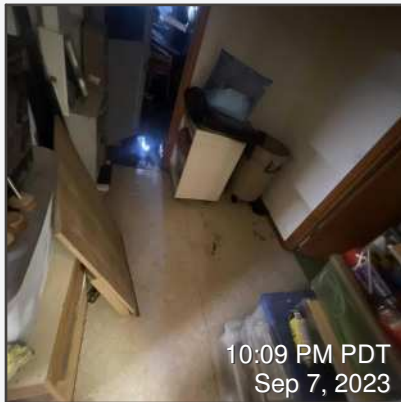
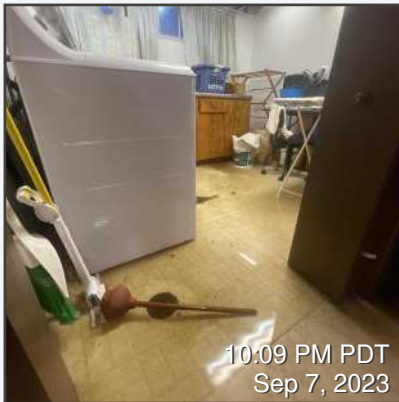
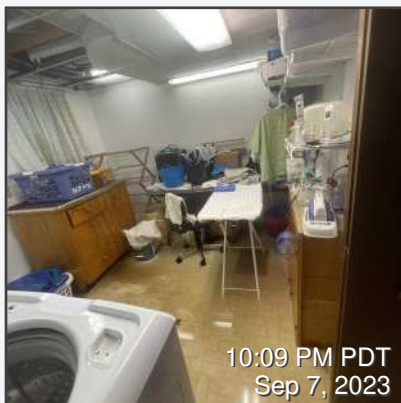
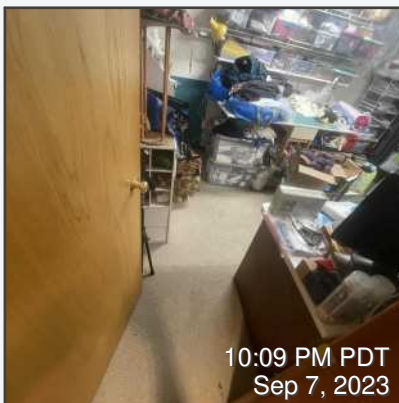
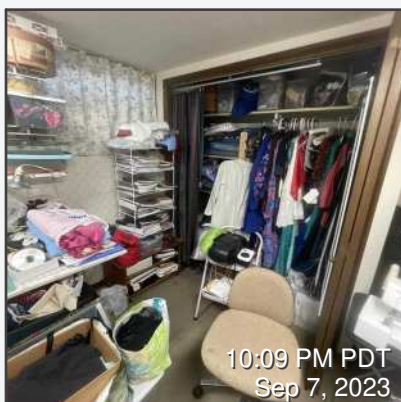
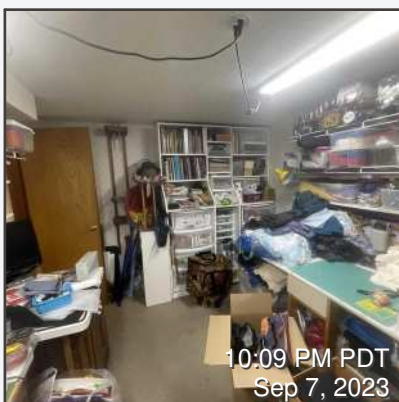
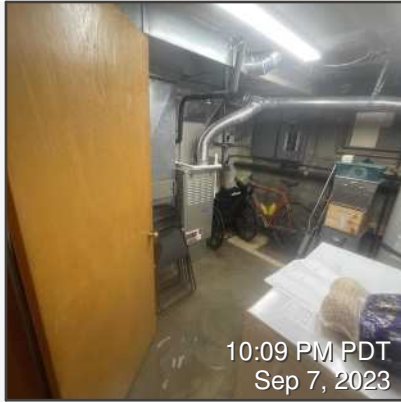
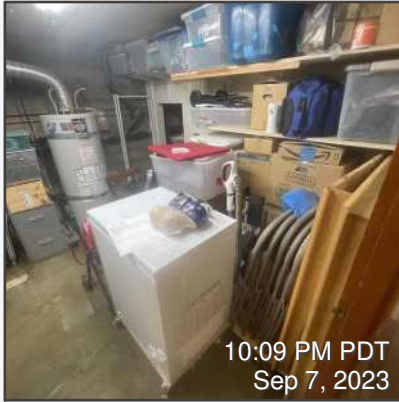
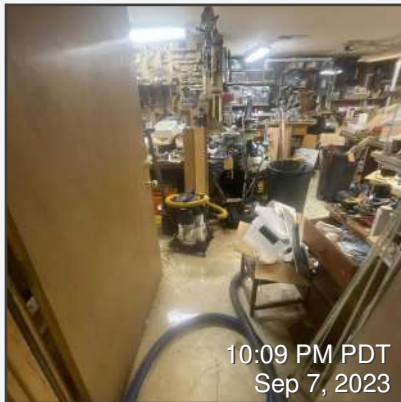
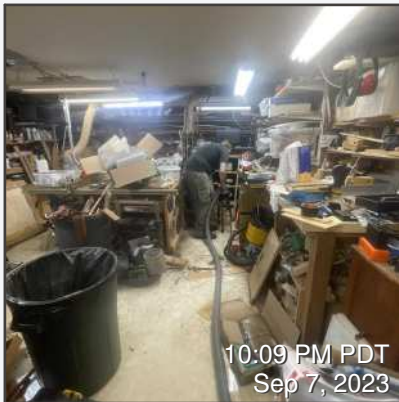
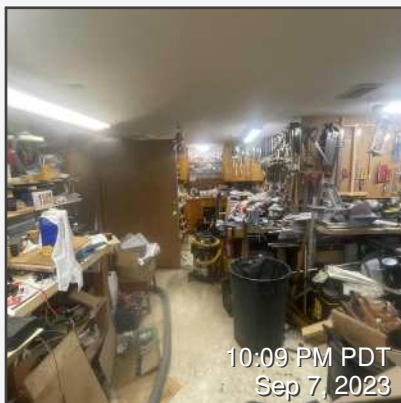
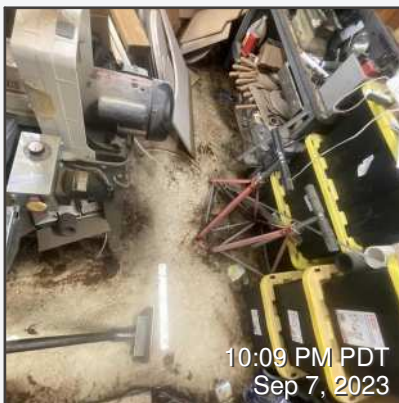
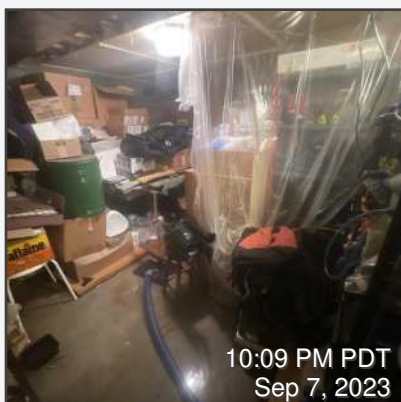
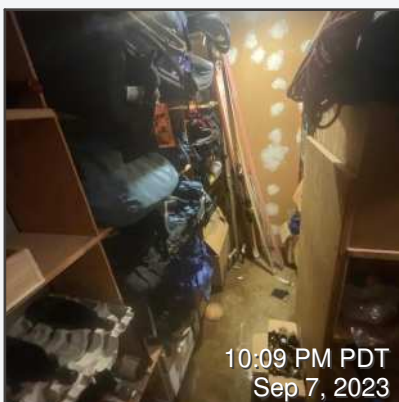
#### Emergency extraction 9/7/23

Chris called us because a sprinkler system had burst outside the laundry room window in basement causing water to flood entire floor. There are a lot of contents that will need to be moved and stored in garage or pod in order to evaluate and mitigate affected areas properly. We extracted 2" of standing water through out all rooms in basement (1275 SF). 13 air movers and 1 dehumidifier onsite.

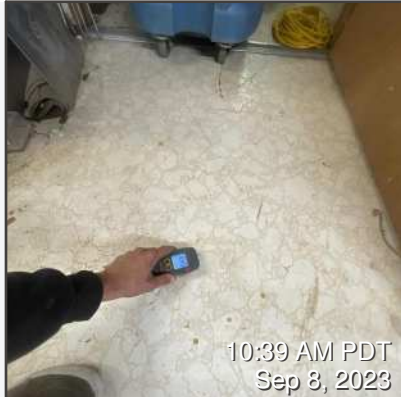
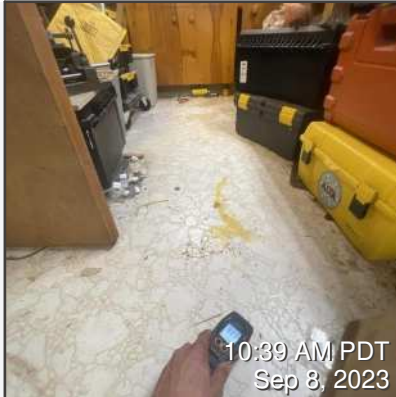
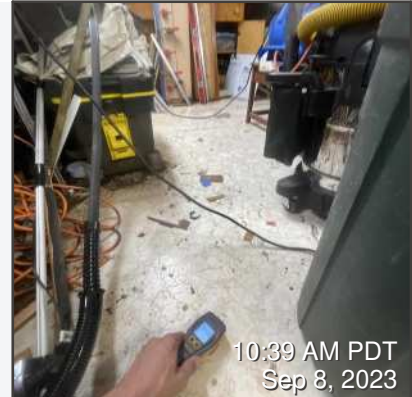
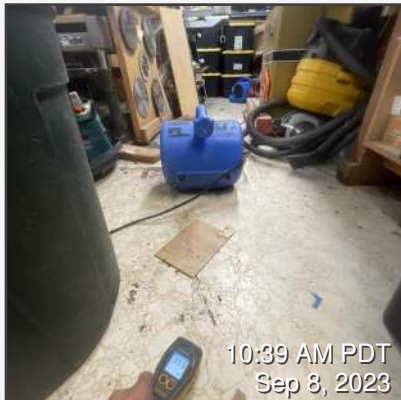
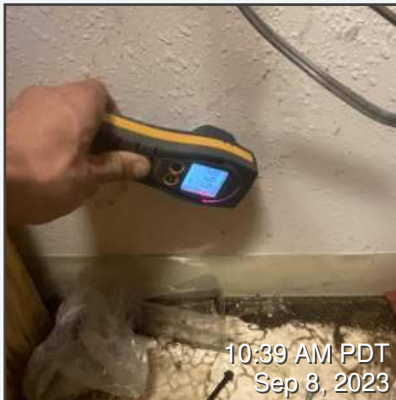
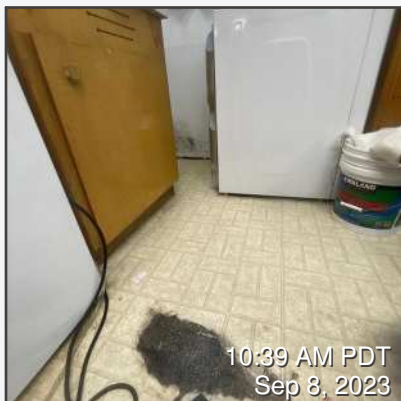
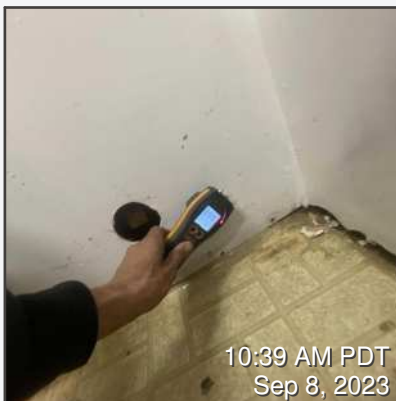
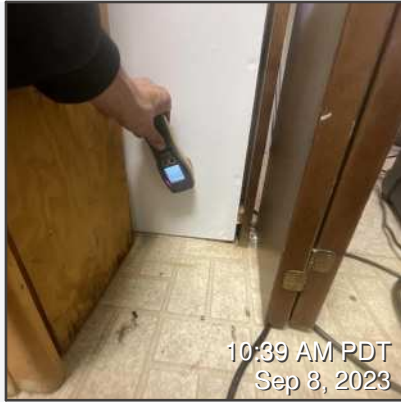
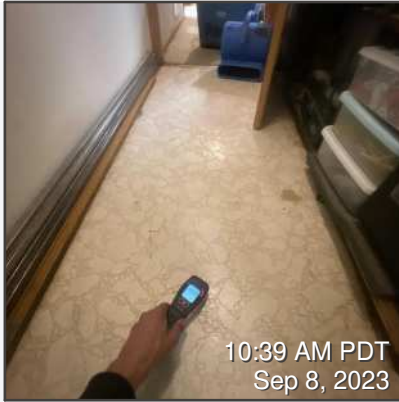
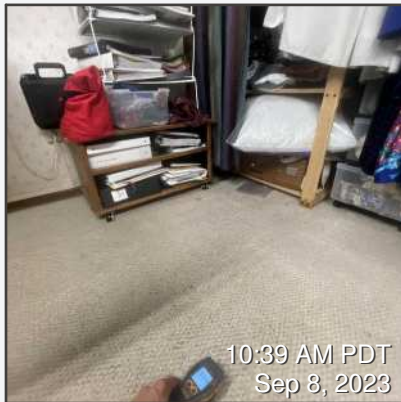
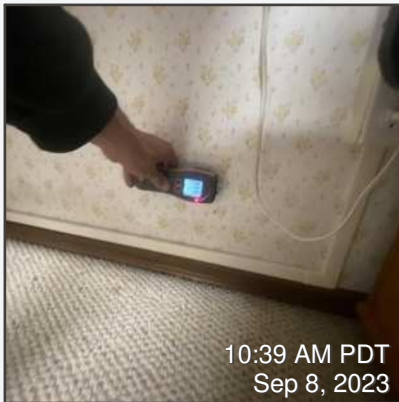
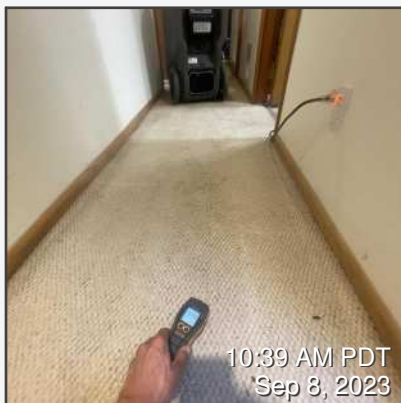
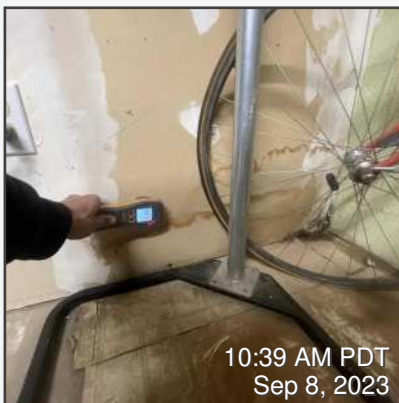
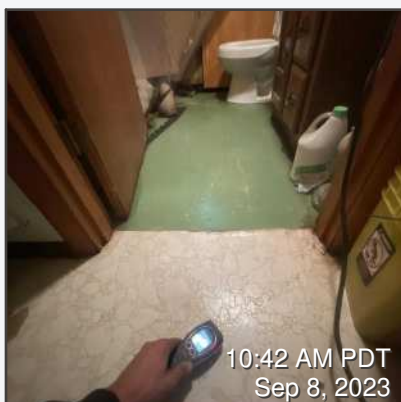
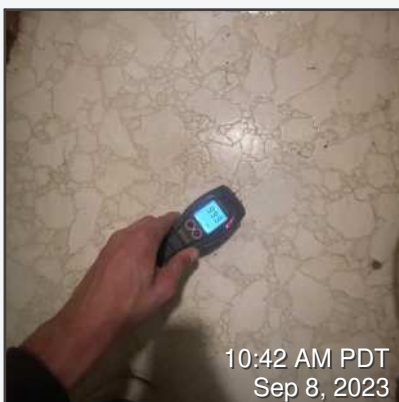
### Monitor / place equipment 9/8/23

Arrived onsite and began monitoring moisture points through out basement finding everything to still be fully saturated. Water has risen about 1' up each wall in basement. We installed 2 more dehumidifiers and 4 more air movers. We will want more equipment placed after contents have been moved out of all rooms. Had to plug our power distributor box in laundry room in order to run all equipment. 17 air movers and 3 dehumidifiers onsite. Will be back tomorrow to monitor material and equipment.

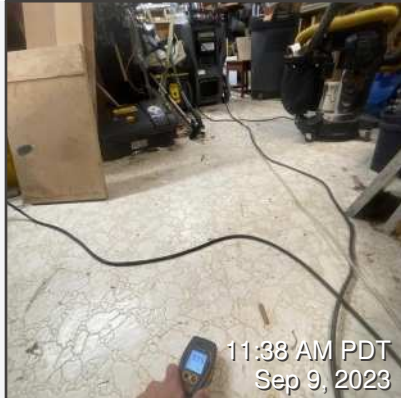
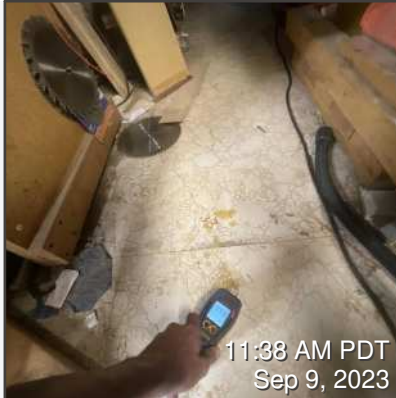
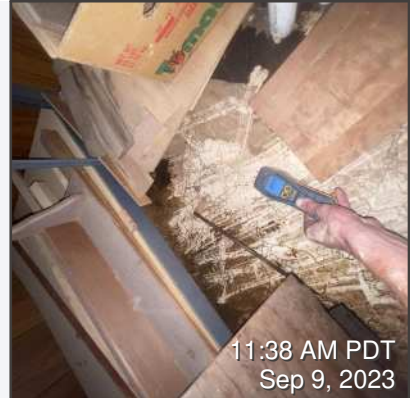
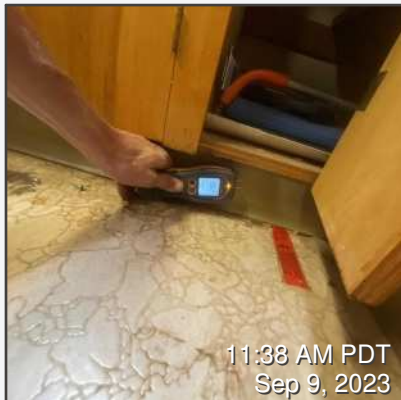
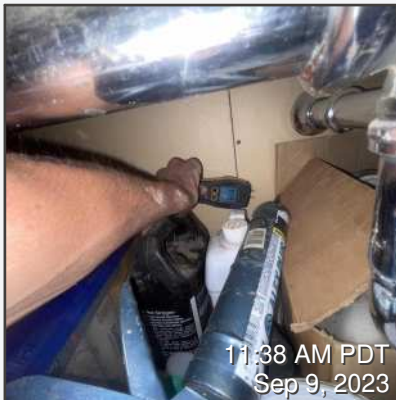
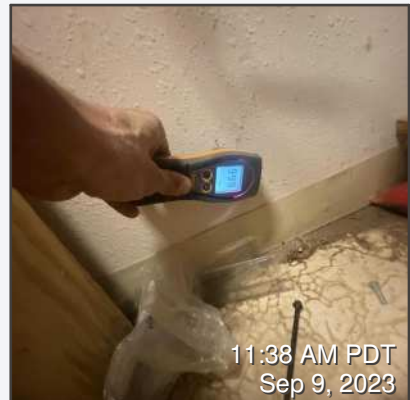
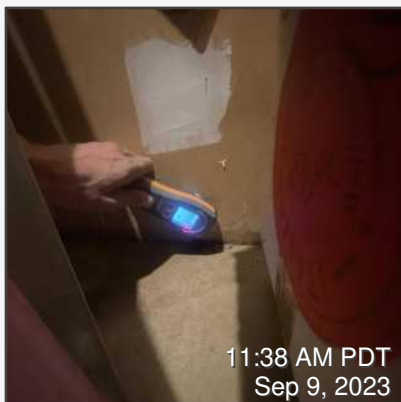
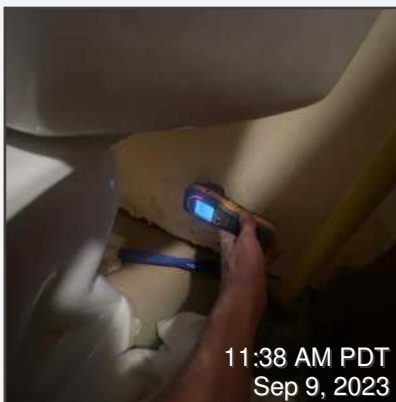
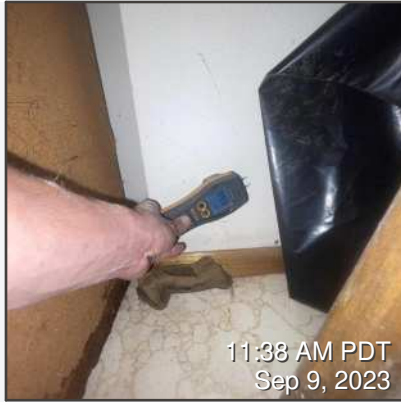
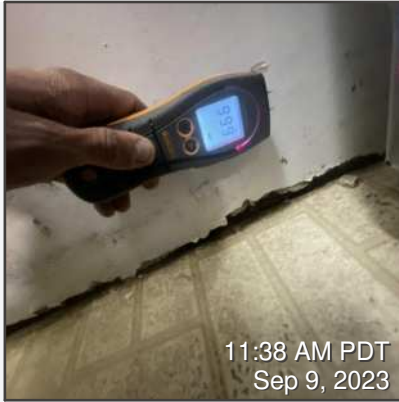
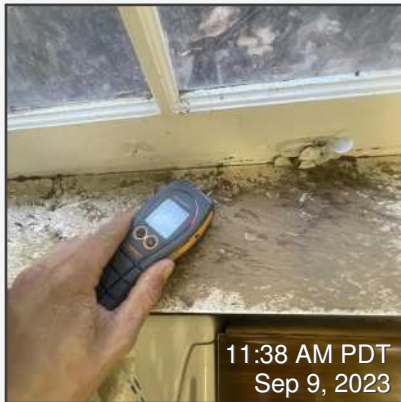
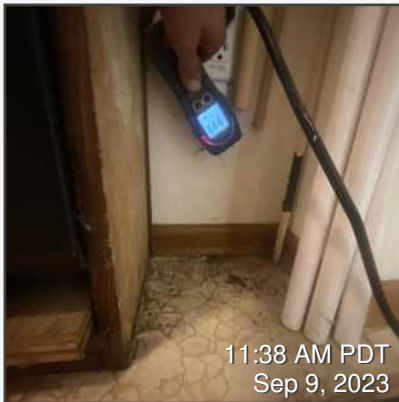
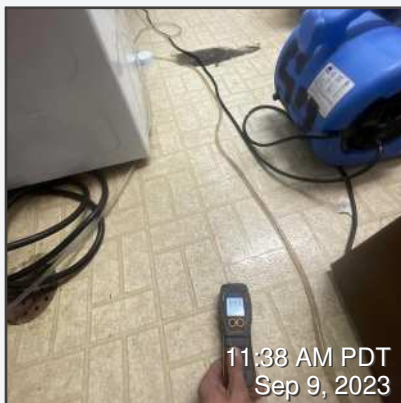
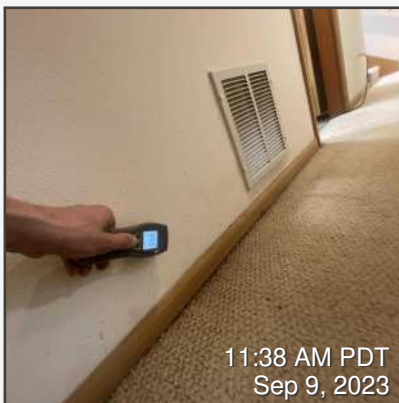
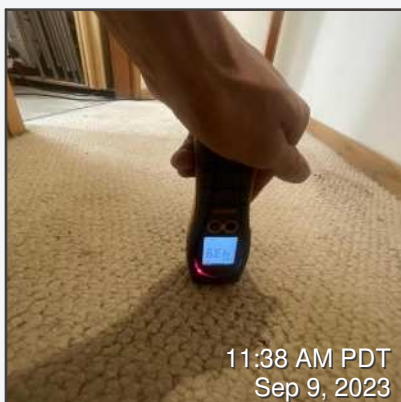
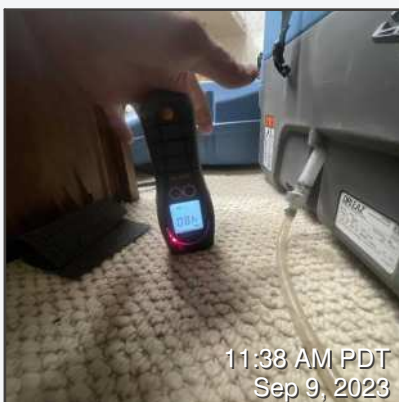
### Monitor visit 9/923

Arrived onsite and began monitoring moisture points through out affected areas finding everything to still be saturated. Will need to move all contents from rooms in order to remove necessary material and place equipment on said areas. All exterior walls will need to have flood cuts and remove any wet insulation that may be trapped inside.

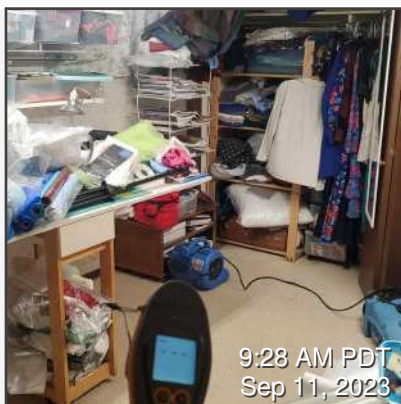
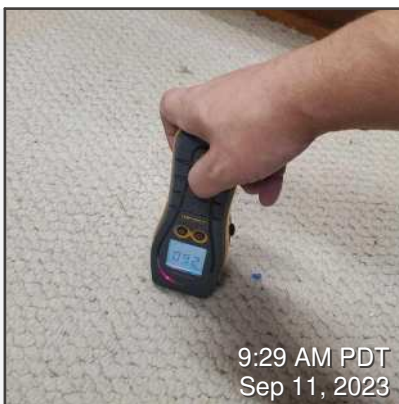
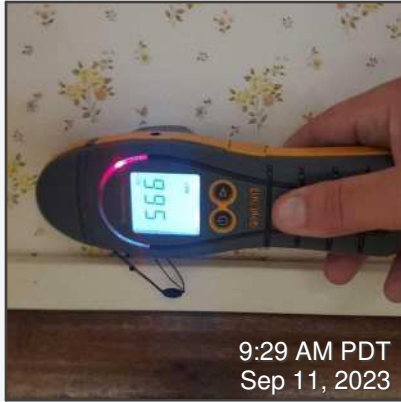
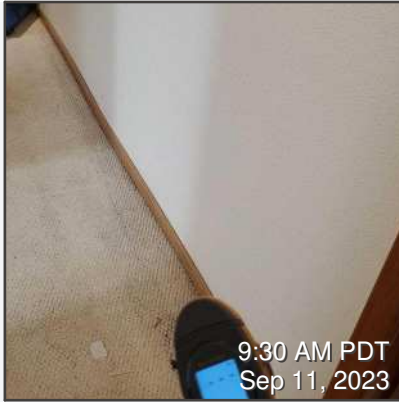
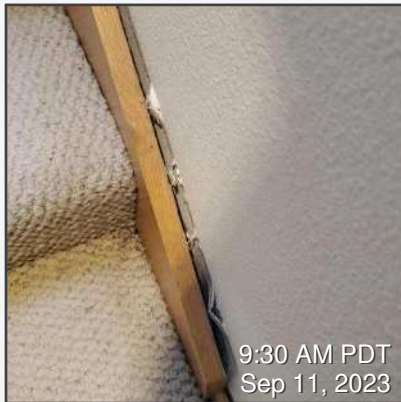
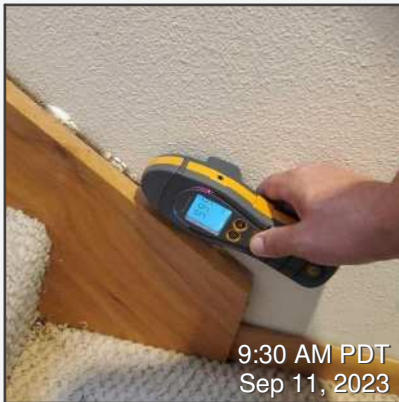
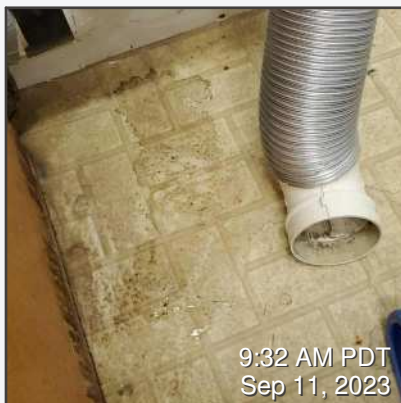
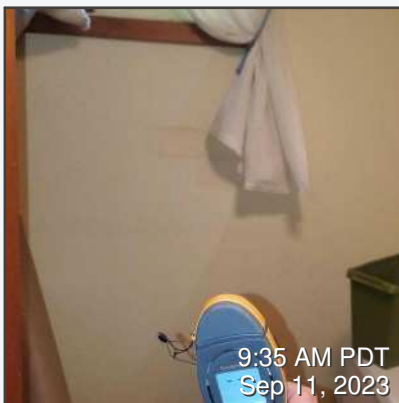
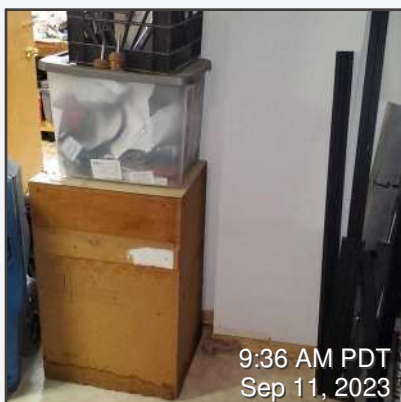
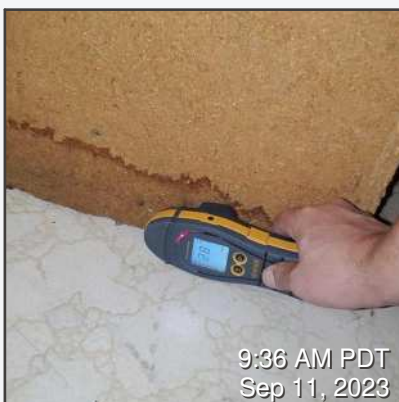
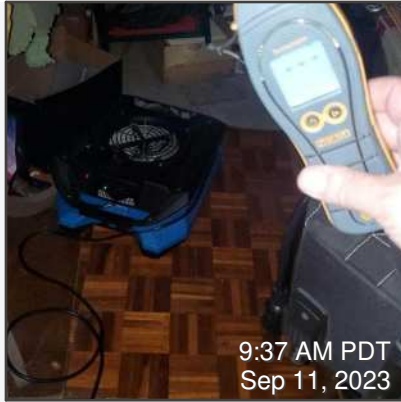
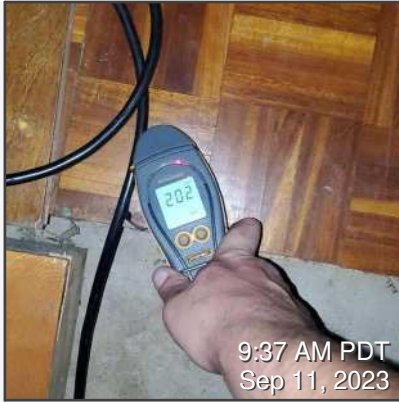
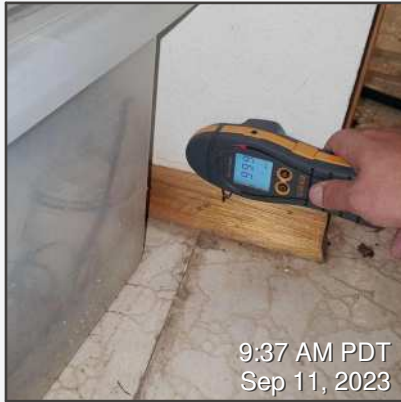
### Monitor 9/11/2023

Monitored moisture points and found all materials to still be highly saturated. Shannon with Restoration 1 will be by later today to walk the homeowners through the pack out process of moving their contents. PNW will be back tomorrow to monitor. 3 dehus 17 air movers 1 spider box onsite

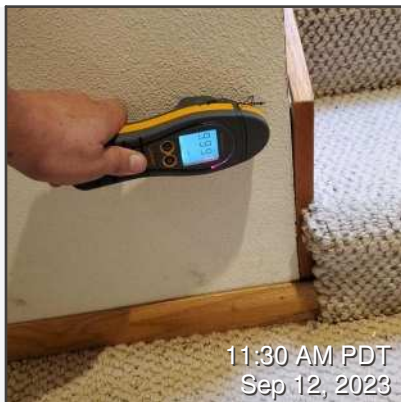
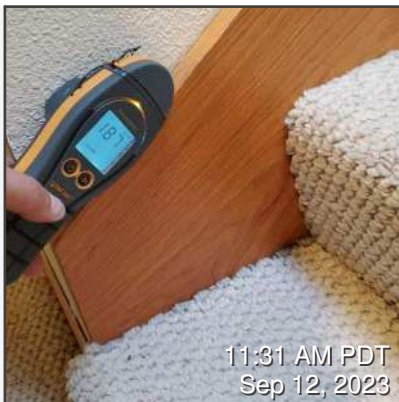
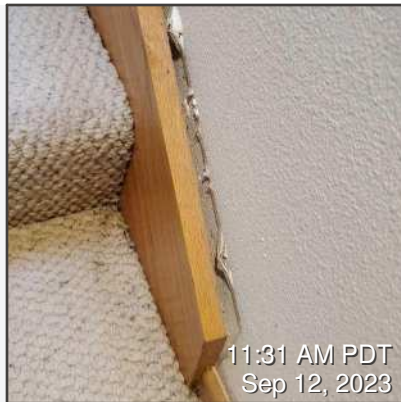
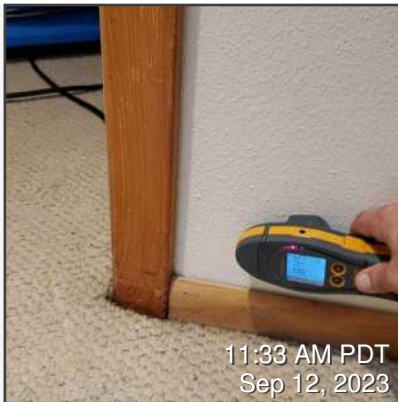
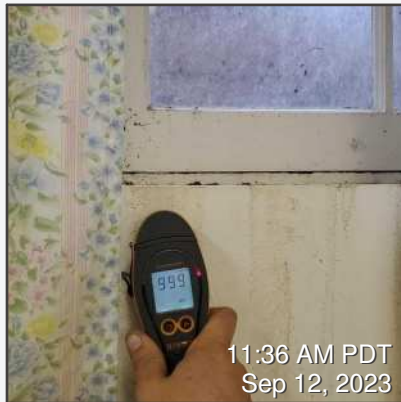
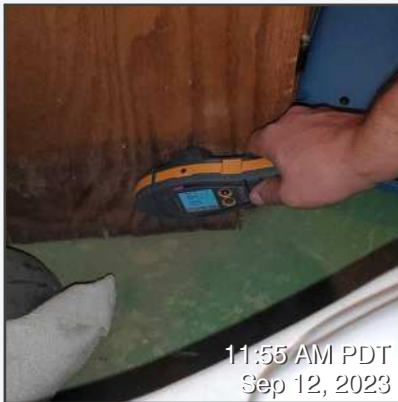
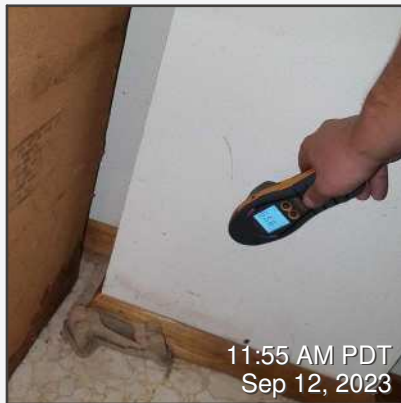
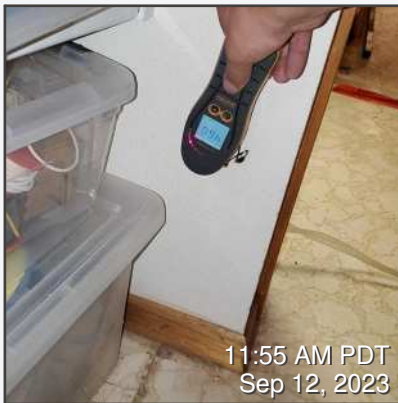
### Monitor 9/12/2023

Monitored moisture points Finding everything to still be highly saturated. A strong odor is now present. Sprayed decon 30 anitmicrobial on the carpeted areas. Rearranged the power to the breakers downstairs so that the home owner could use their laundry room. Still waiting on contents to be moved. Will return to continue monitoring.

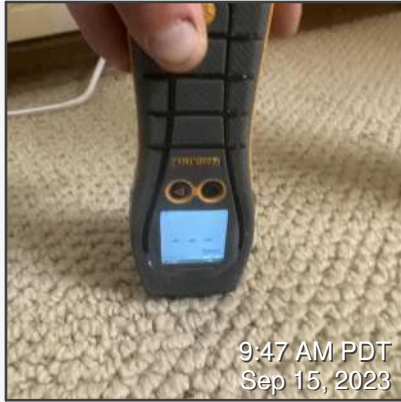
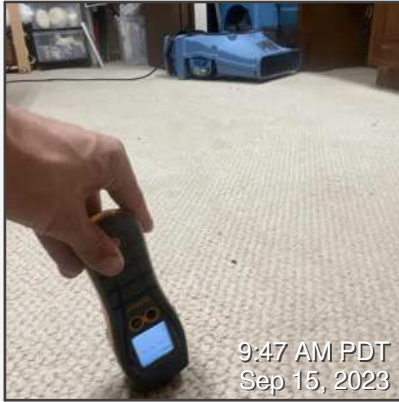
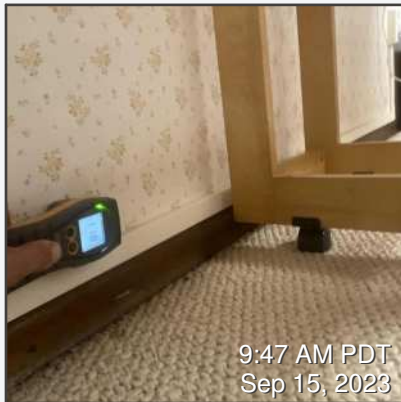
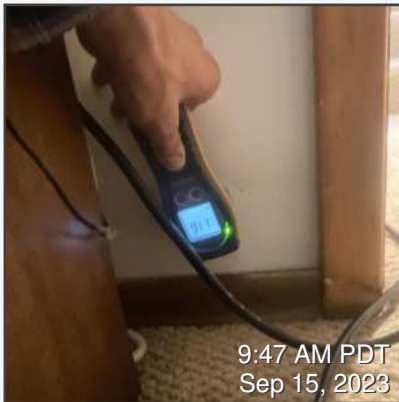
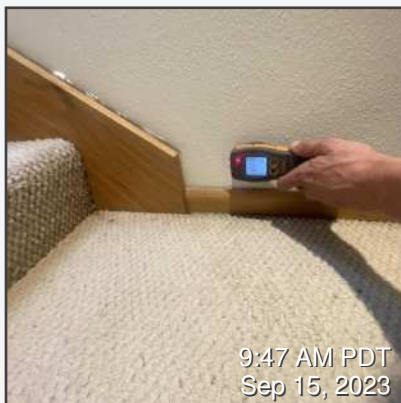
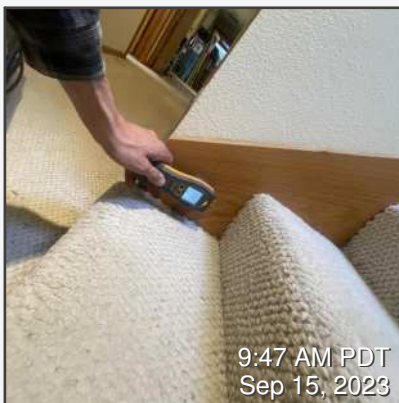
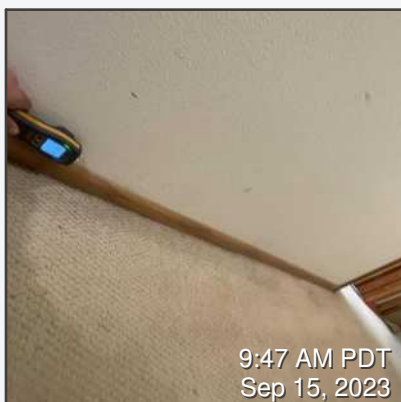
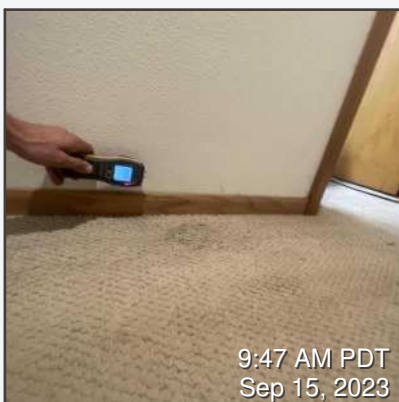
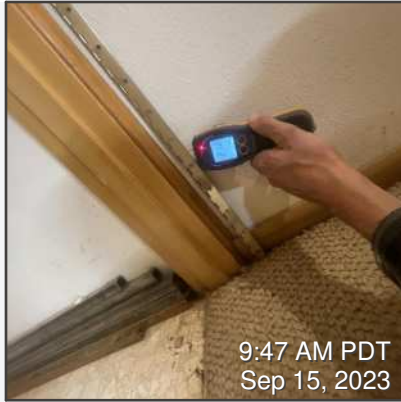
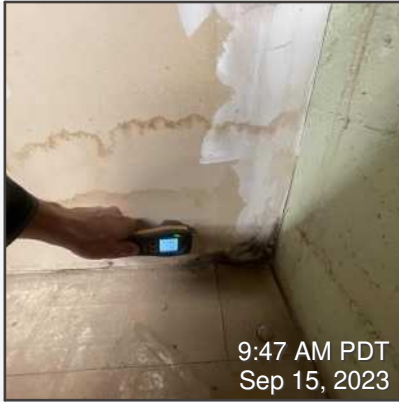
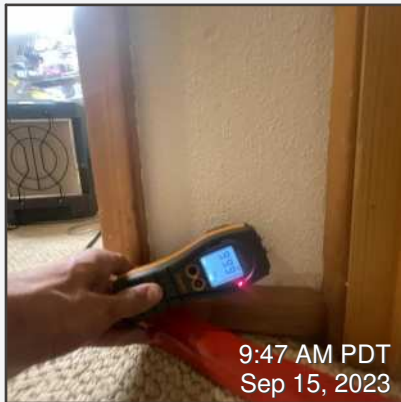
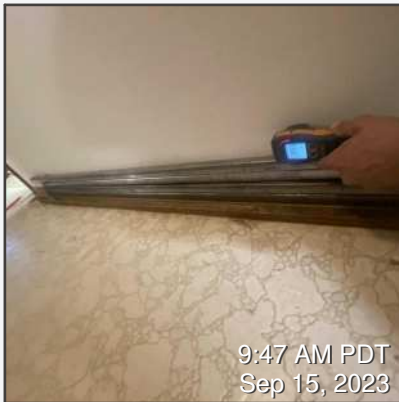
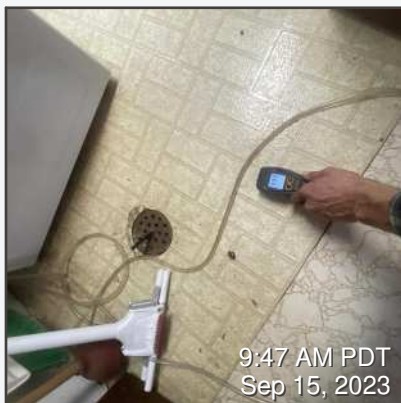
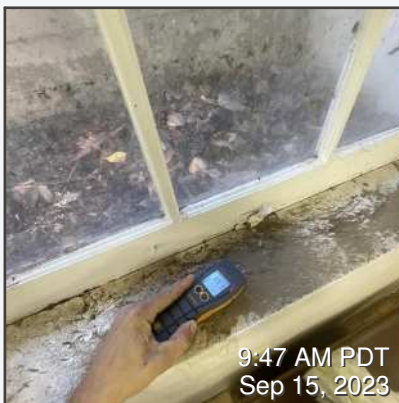
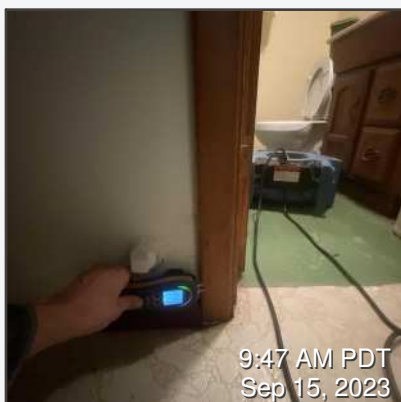
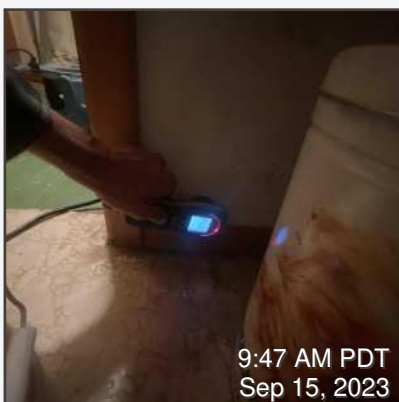
### Monitor visit 9/15/23

Arrived onsite and began monitoring moisture points through out affected areas. Most drywall through out is reading highly saturated however some areas have dried. Carpets are reading dry but will still want to move all contents and shelving off carpets to be sure it has dried out entirely. Still waiting for pack out crew to remove all contents away from affected material so we can begin demo on areas of concern.

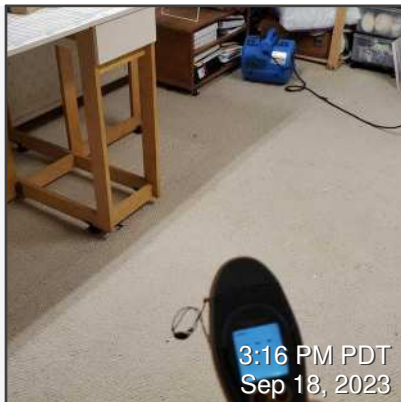
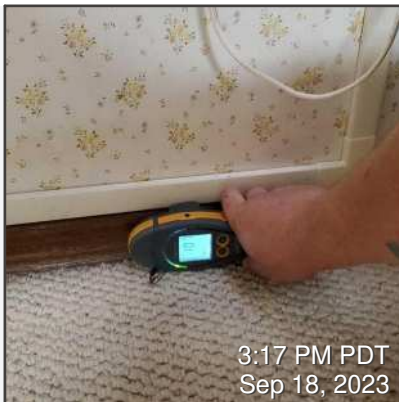
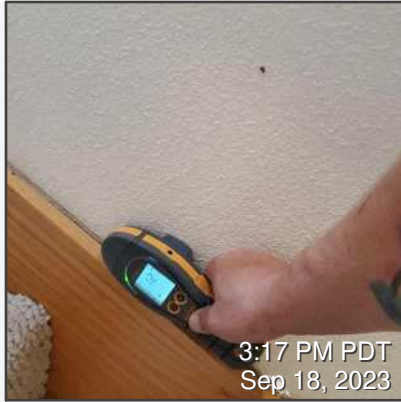
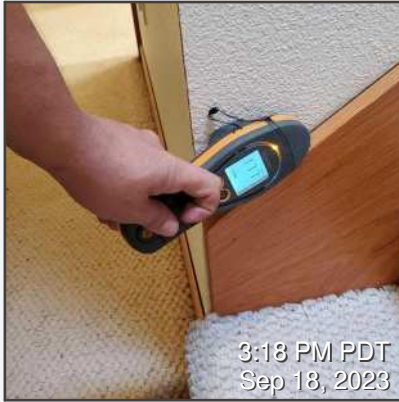
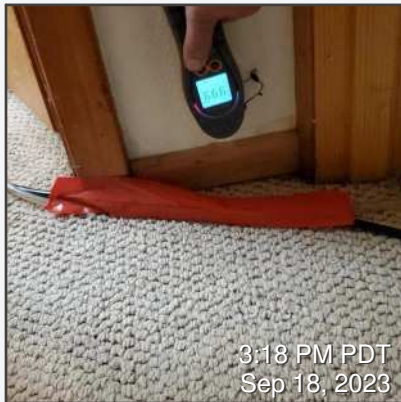
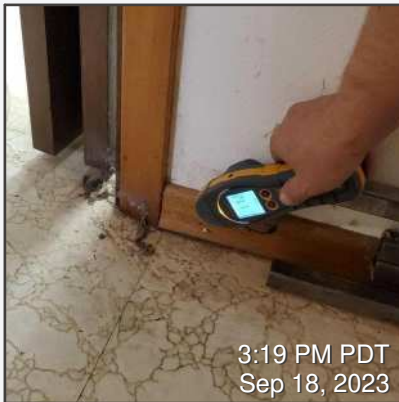
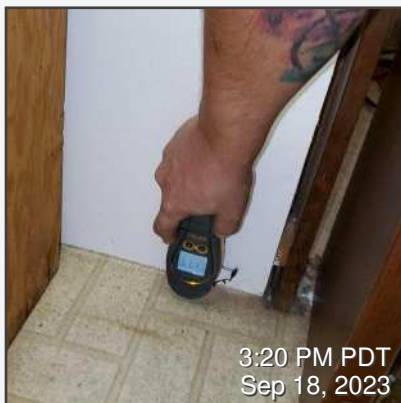
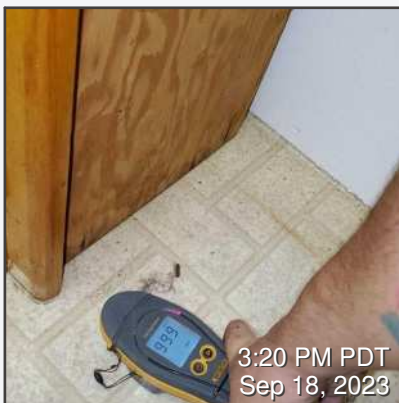
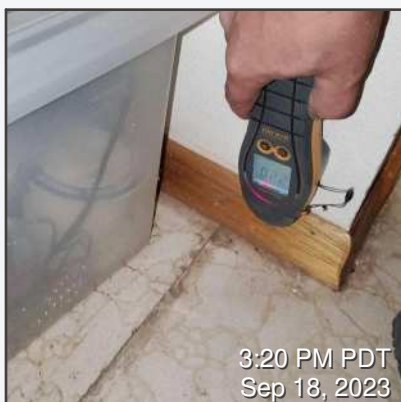
### Monitor 9/18/2023

Monitored moisture points finding materials to still be wet. Pack out of contents will begin tomorrow, once all contents are moved we will be able to begin demo. Will be back to continue monitoring.

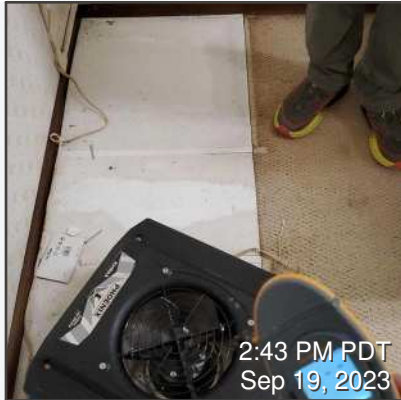
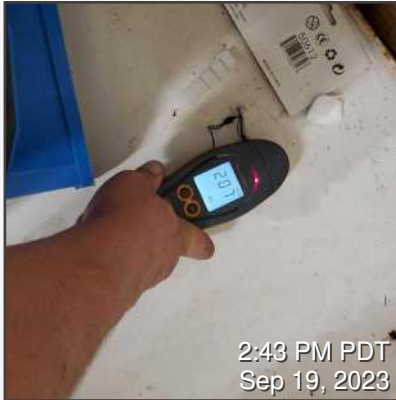
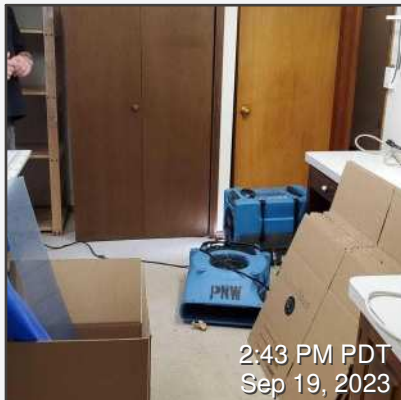
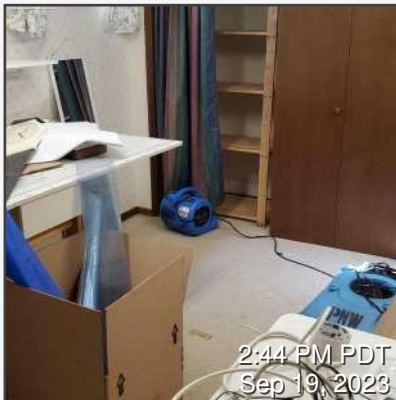
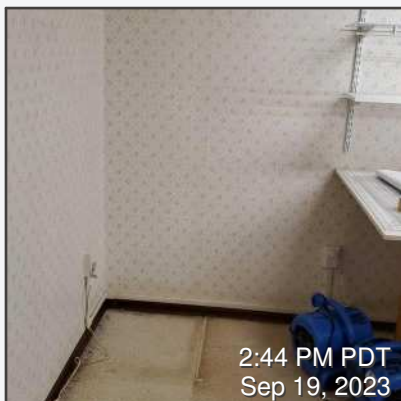
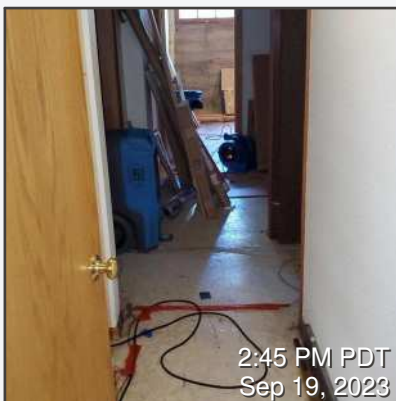
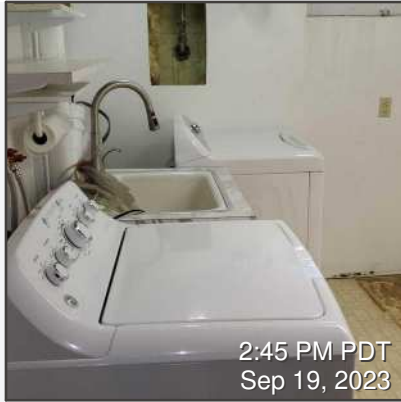
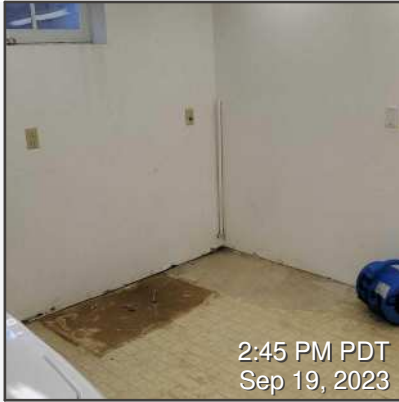
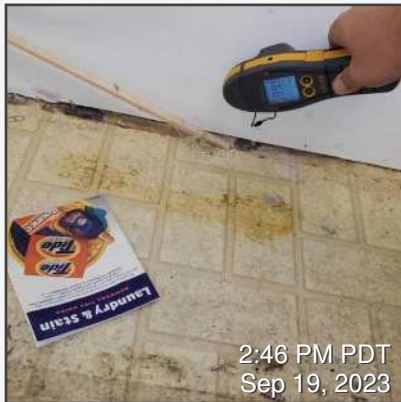
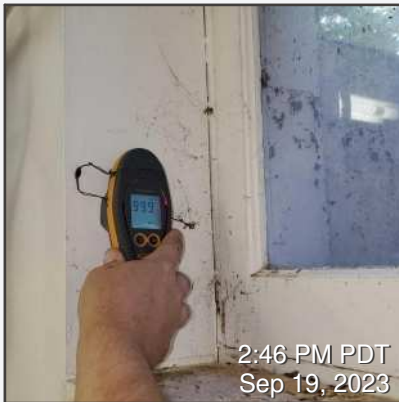
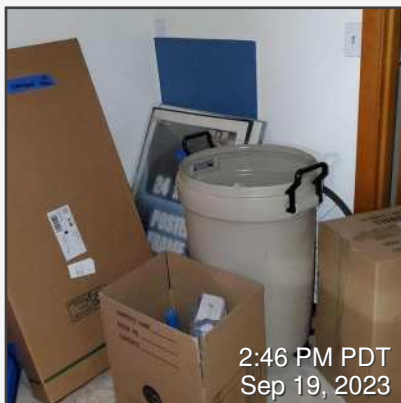
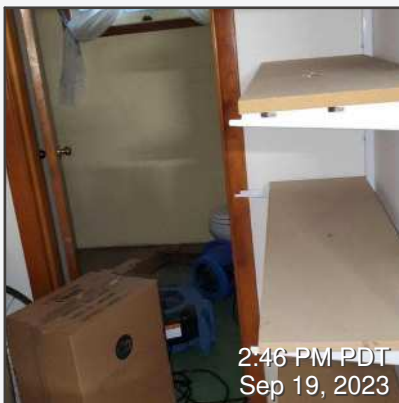
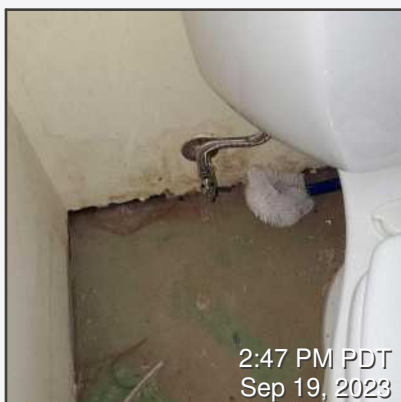
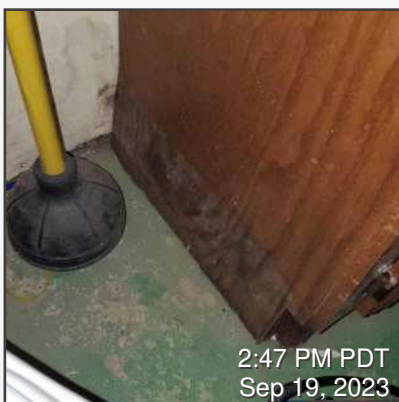
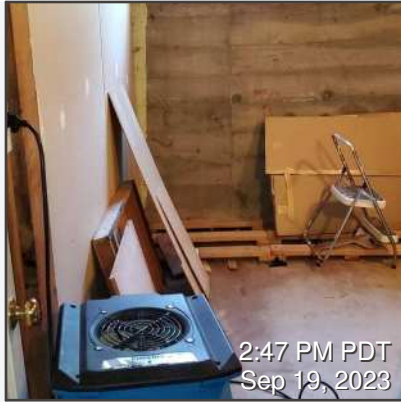
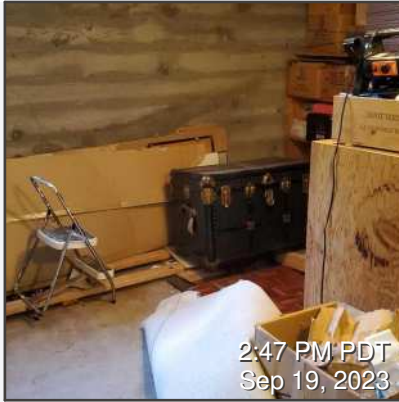
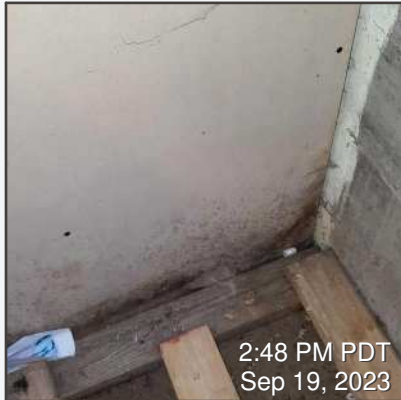
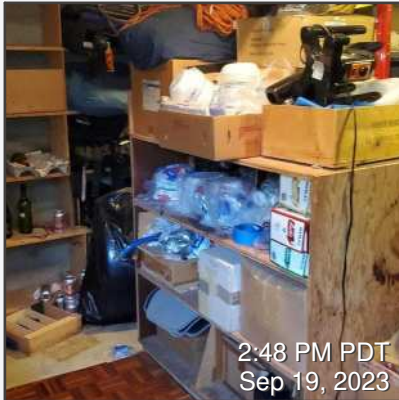
## Monitor 9/19/2023

Monitored moisture points finding materials to still be saturated. Pack out has begun. Pack out crew made good progress today. Will be back tomorrow to monitor. Could potentially start demo by the end of the week.

Still recommend 2 ft flood cuts along all walls as well as removing the carpet pad and vinyl flooring. Once all demo is complete we will perform a hepa clean, ensuring all surfaces are clean. 3 dehus and 17 air movers onsite

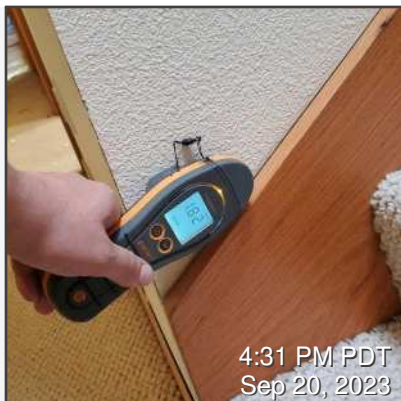
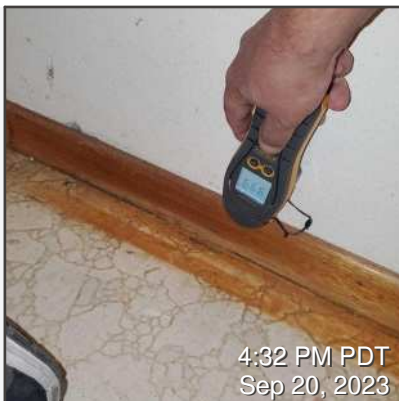
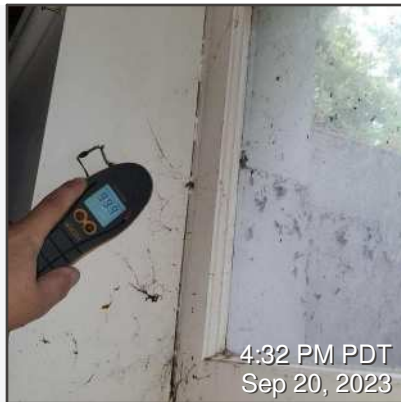
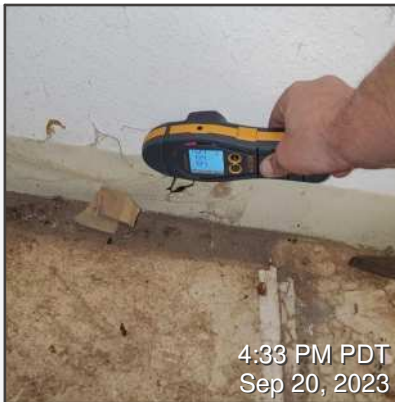
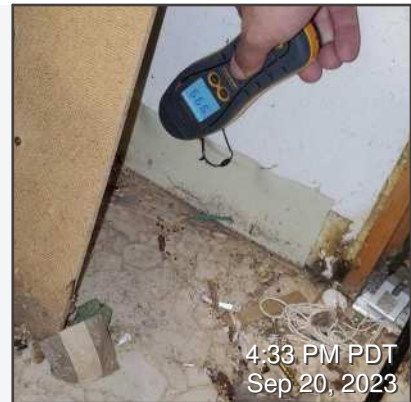
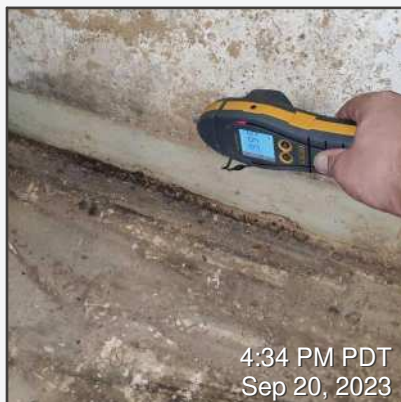
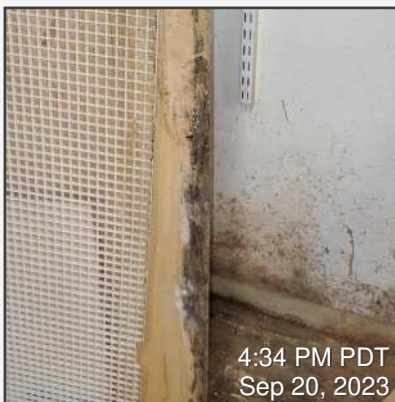
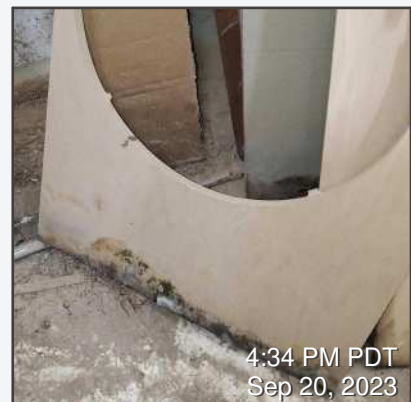
### Monitor 9/20/2023

Monitored moisture points finding materials to still be wet as well as some microbial growth once we moved some contents away from the wall. Contents crew is getting close to finishing moving contents out of the basement. Should be able to begin demo in the next day or two.

Recommend removing all carpet pad and vinyl flooring as well as making 2 ft flood cuts through out the entire basement and then performing a Hepa clean.

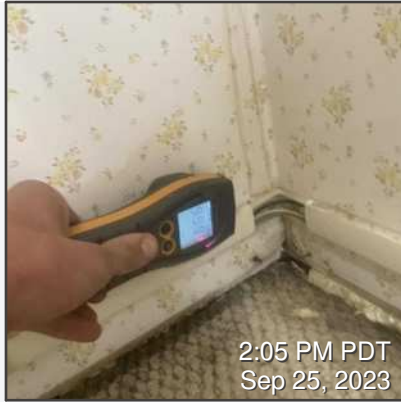
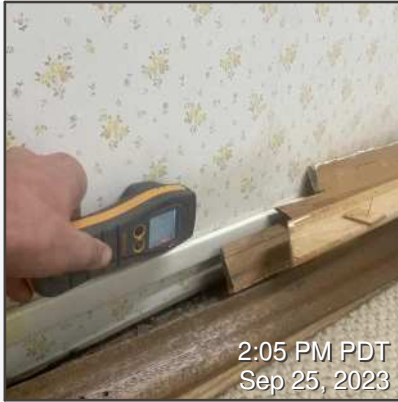
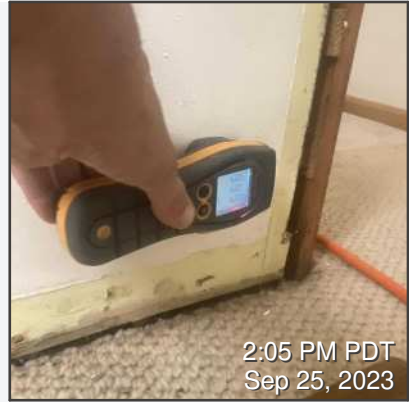
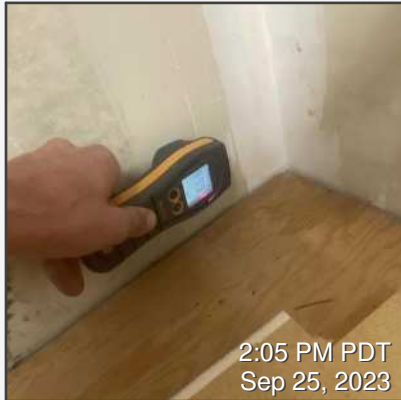
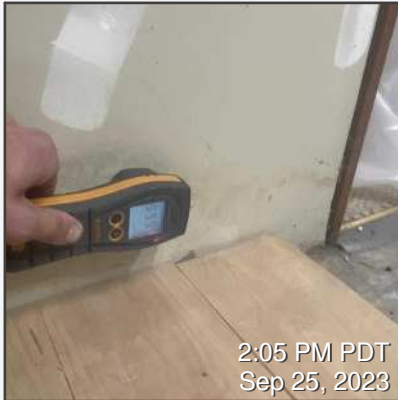
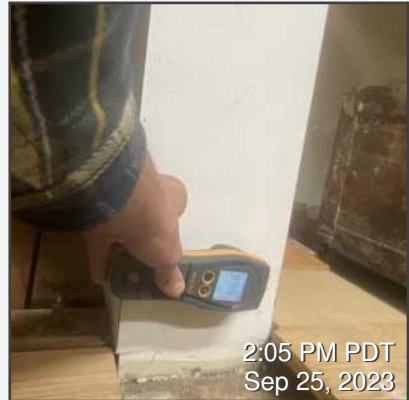
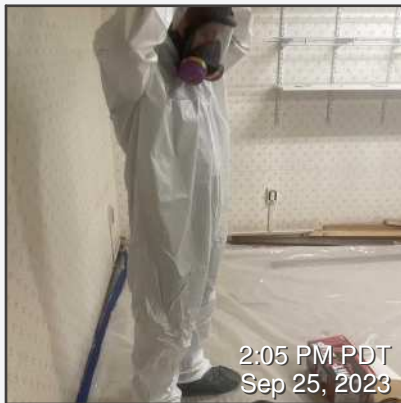
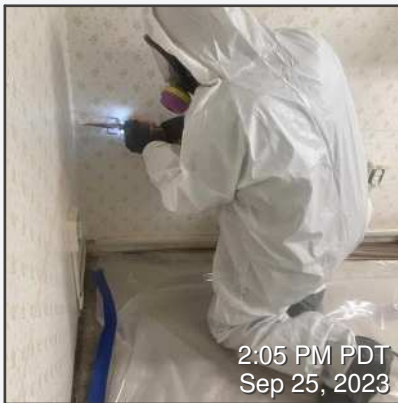
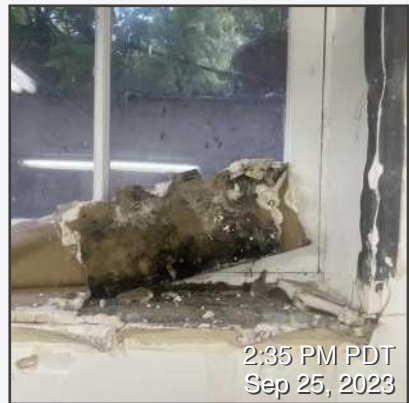
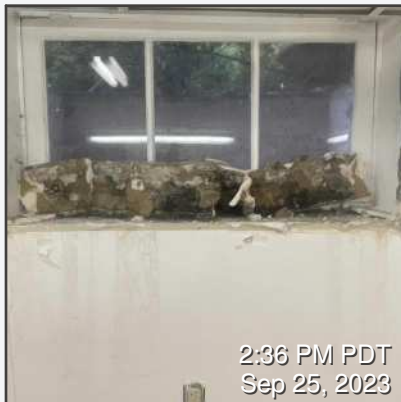
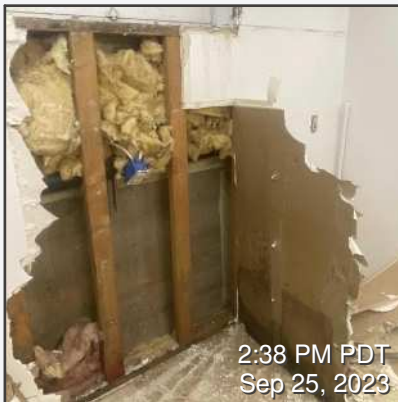
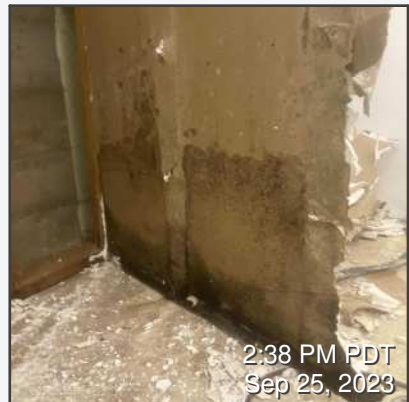
### Demo visit 9/25/23

Arrived onsite and began setting up containments on doorways we'll be working in today. Moved washer and dryer to other side of laundry room to access exterior drywall. Set up floor protection for entry way and stairs. Began removing all affected drywall and insulation in laundry, bathroom and HVAC room. Moving company is working on clearing out storage room and wood working room, those will be available to work in later in the week. pulled all fans due to scattered growth through out. 3 dehus and 2 air scrubbers on-site.
