## Notice of Intent to Remove Asbestos

## Roger Shea Project Report

Possible irrigation sprinkler burst. Basement flooded approximately 1000SF at 2 inches. EMS techs have been dispatched.  
Shut off valve and back flow valve failed.

| Sprinkler broke outside flooding the basement | Category 3 | |

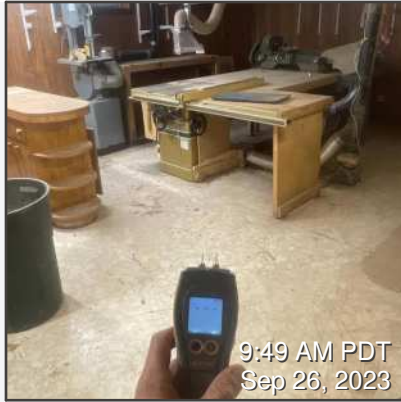
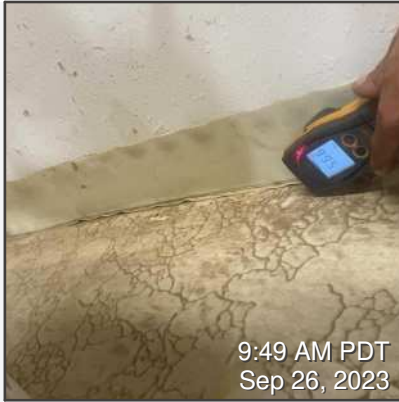
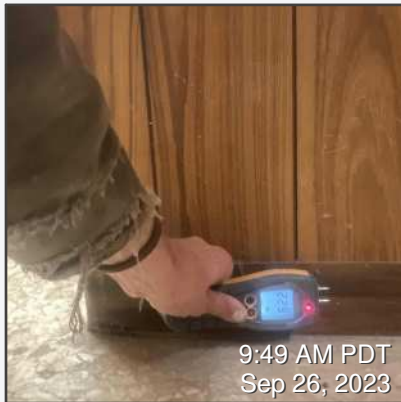
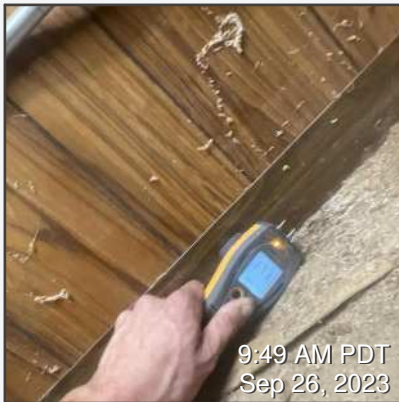
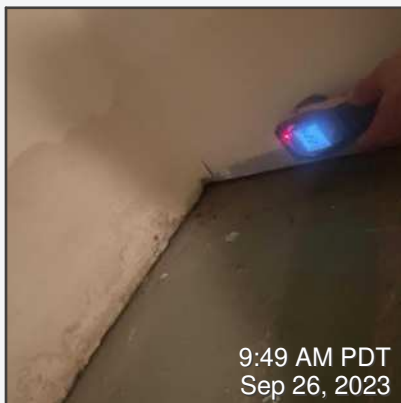
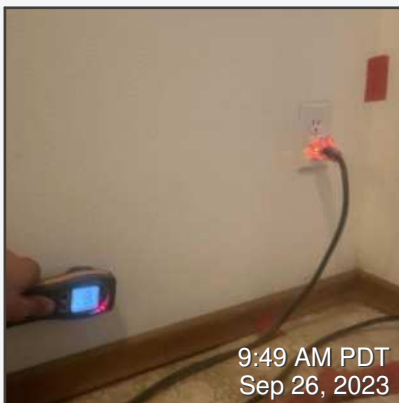
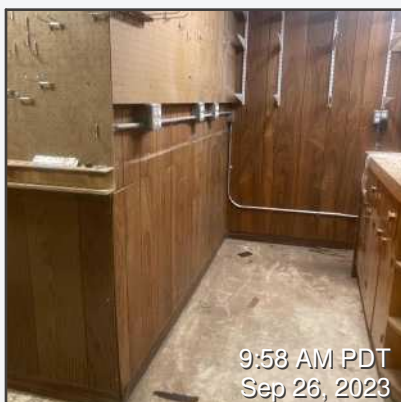
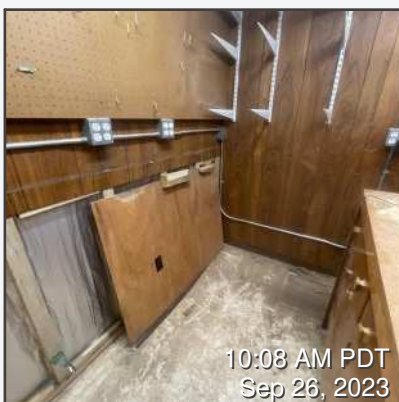
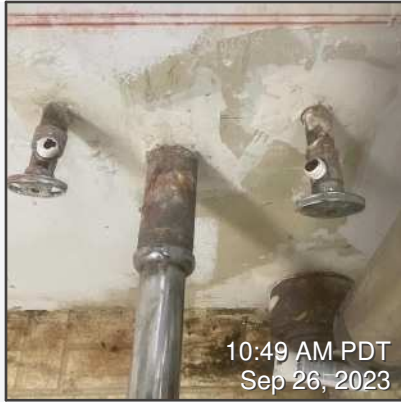
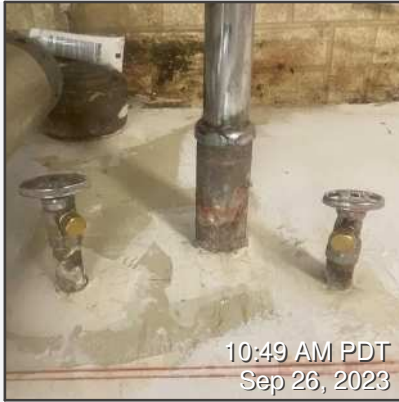
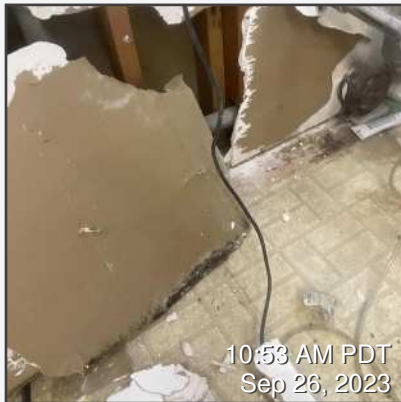
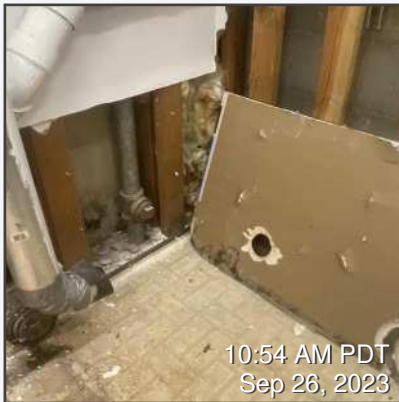
### Monitor / Demo visit 9/26/23

Arrived onsite and began monitoring moisture points through out affected areas. Finding moisture scattered through out basement. Mainly in shop, and interior hallway walls. Did 2' flood cuts through out all rooms. Tomorrow we will start on hallway and then begin our detail cleaning.

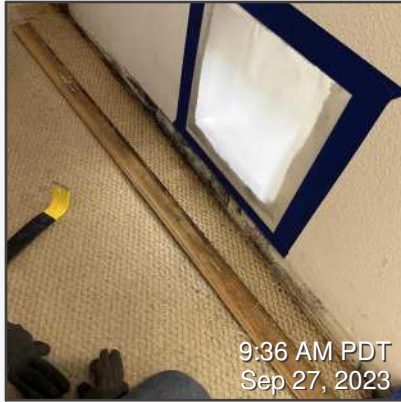
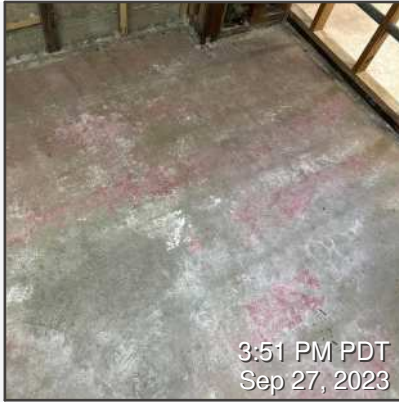
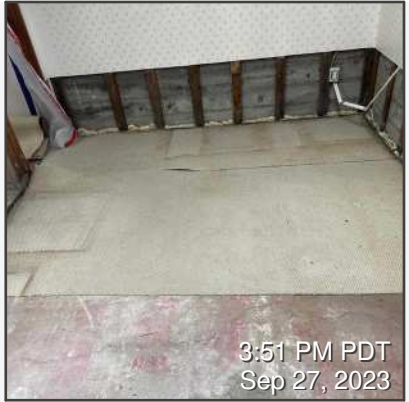
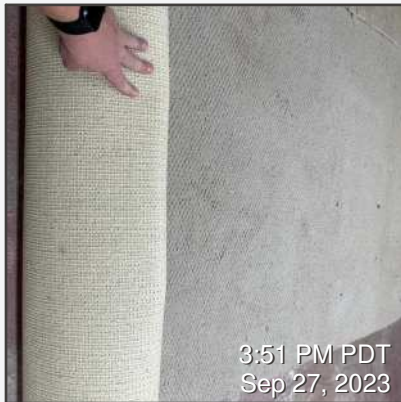
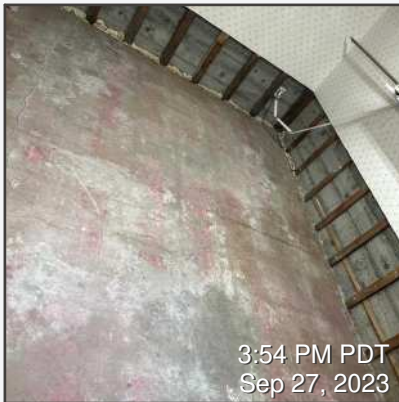
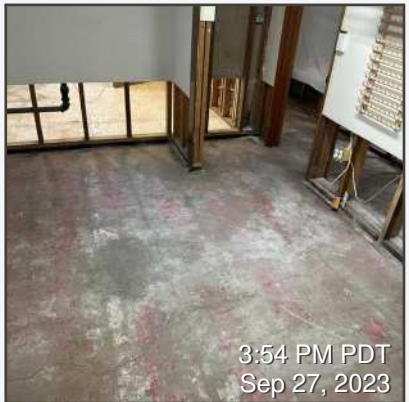
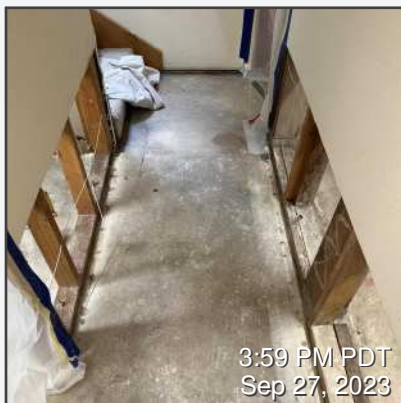
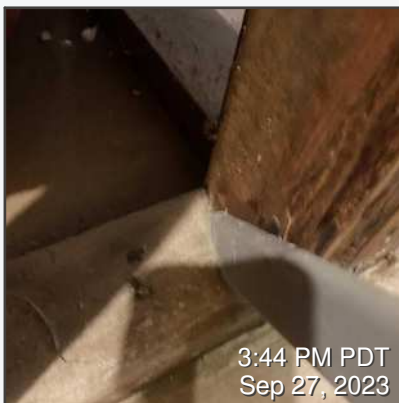
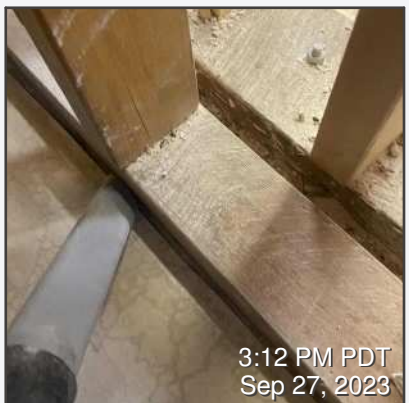
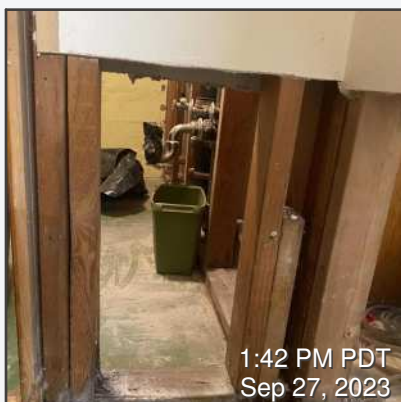
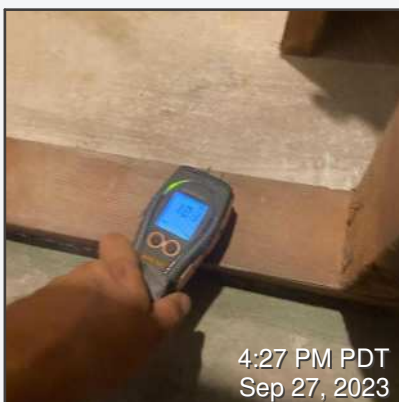
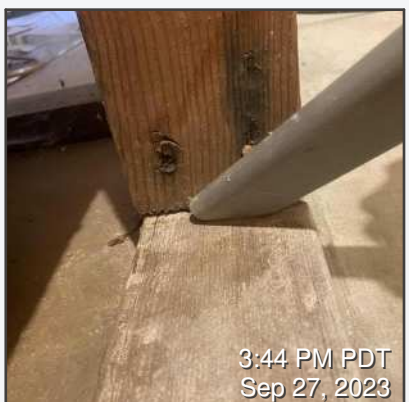
### Demo visit 9/27/2023

Finished demo in the basement and began cleaning in the storage room and wood shop. Will need to start full detail clean tomorrow, should be done by Friday and ready for rebuild.

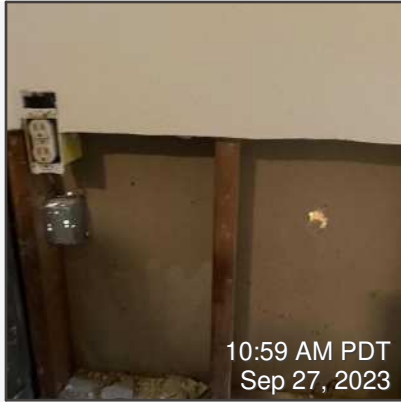
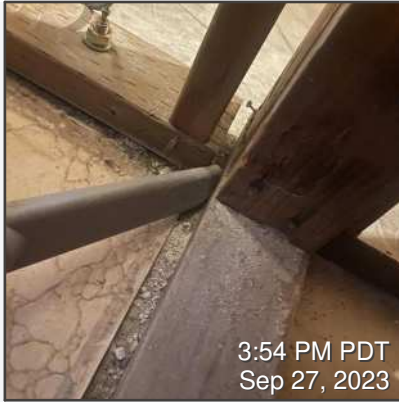
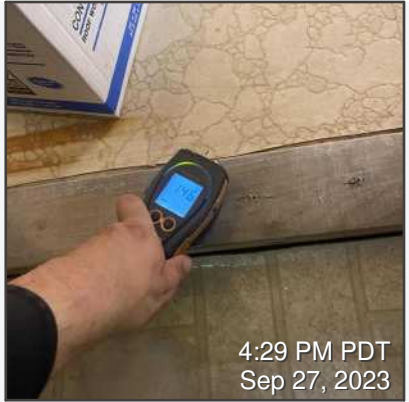
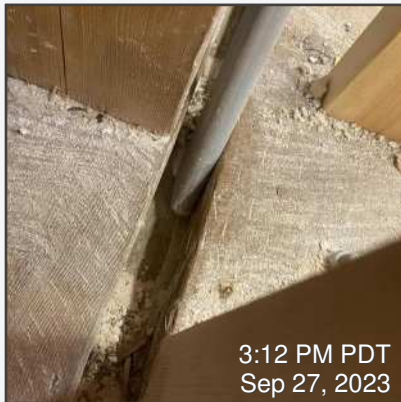
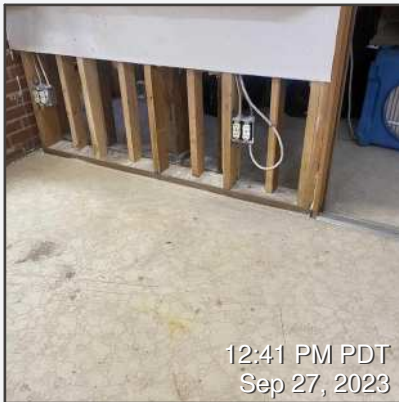
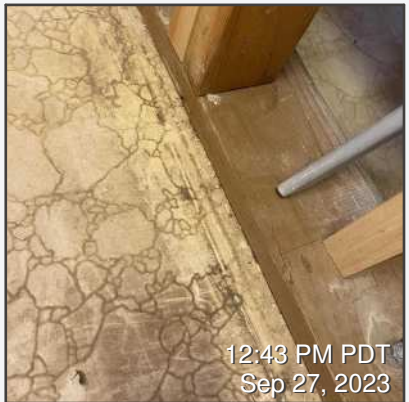
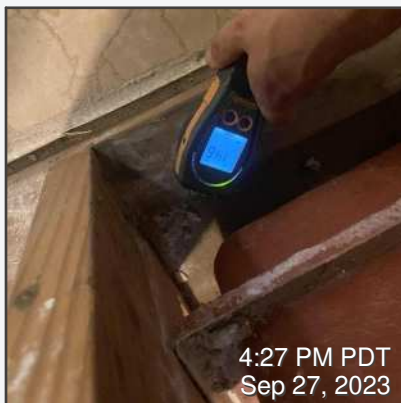
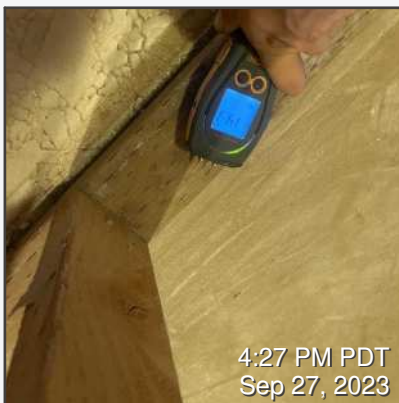
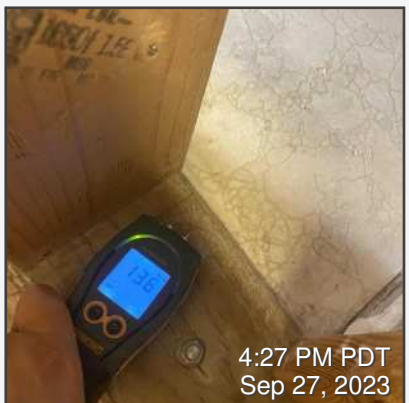
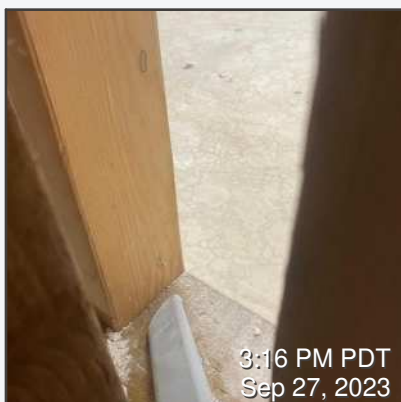
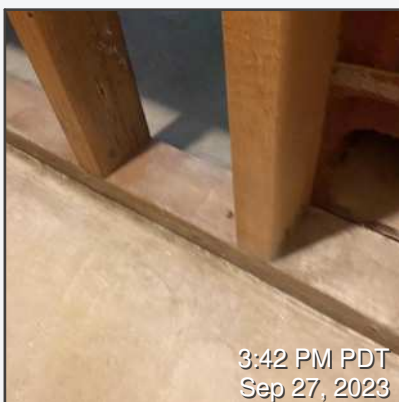
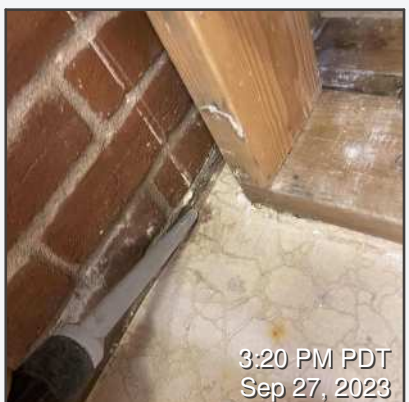
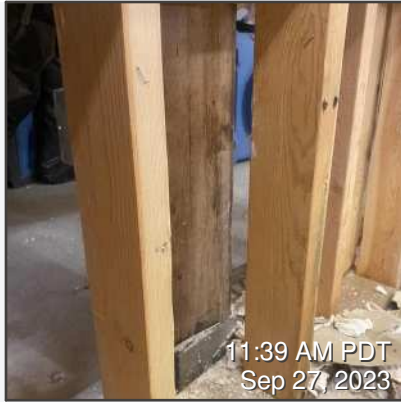
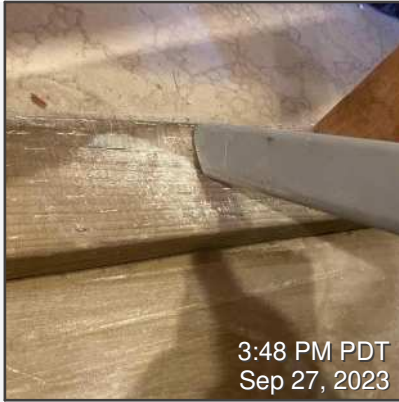
#### **Monitor/Final Detail Clean 09/28/2023**

Some areas still wet but making progress. Performed final detailed cleaning and HEPA Sandwich protocol. Return tomorrow to monitor and possibly pick up all equipment. 3 dehus 2 air scrubbers on site.
