# Asbestos Containing Materials Inspection

Good Faith Inspection

Project: 5802 NE 6<sup>th</sup> Ave.  
Vancouver, WA 98665

RE: Good Faith Asbestos Survey

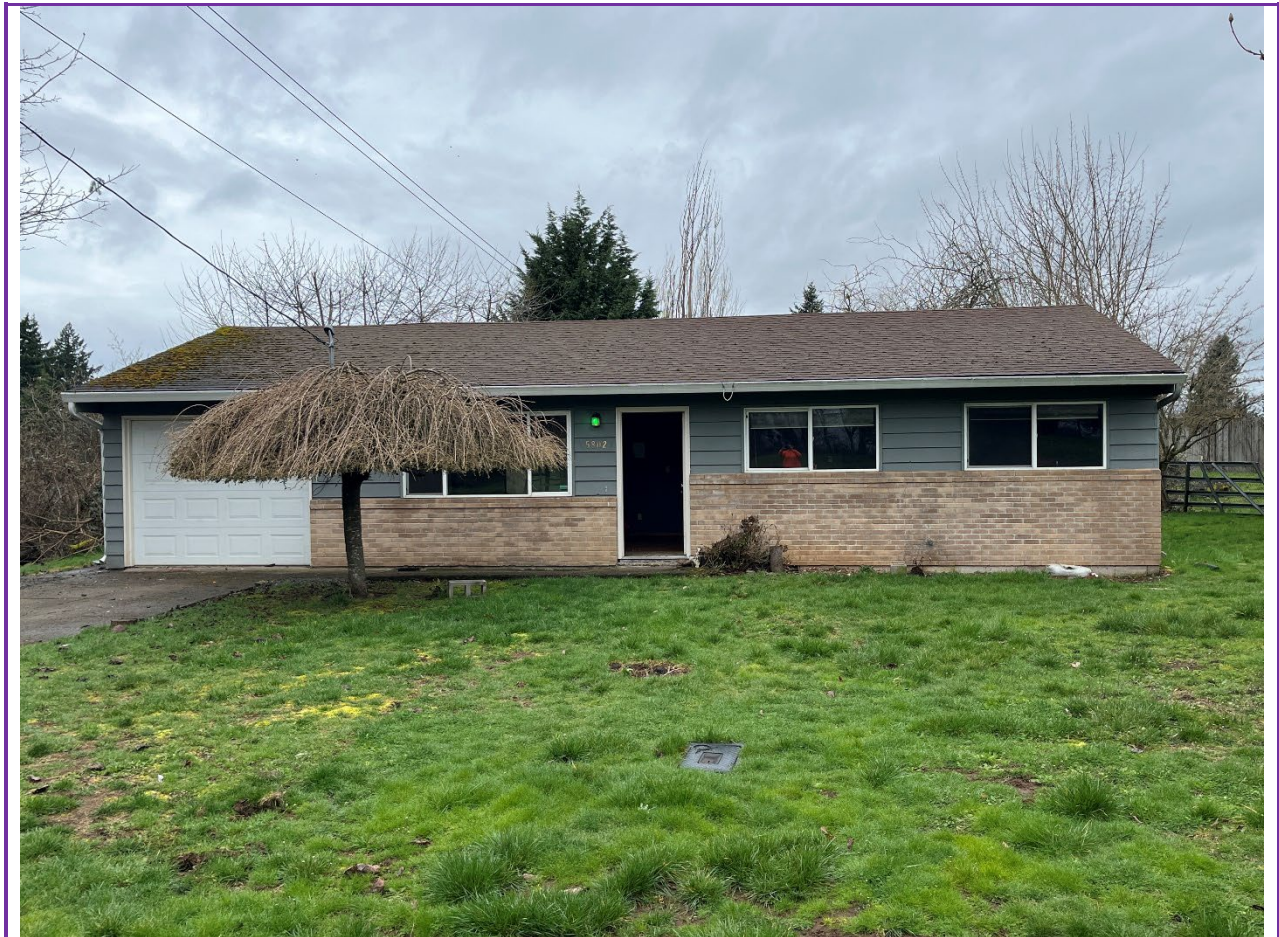
**FRONT OF STRUCTURE**

The structure was a wood framed single family residence with attached garage on a concrete foundation. The structure was built in 1962 with approximate square footage of 936 SF in the residential areas and 312 SF in the attached garage.
