Asbestos Containing Materials Inspection

Good Faith Inspection

Project: 5907 NE 6th Ave.
Vancouver, WA 98665

RE: Good Faith Asbestos Survey

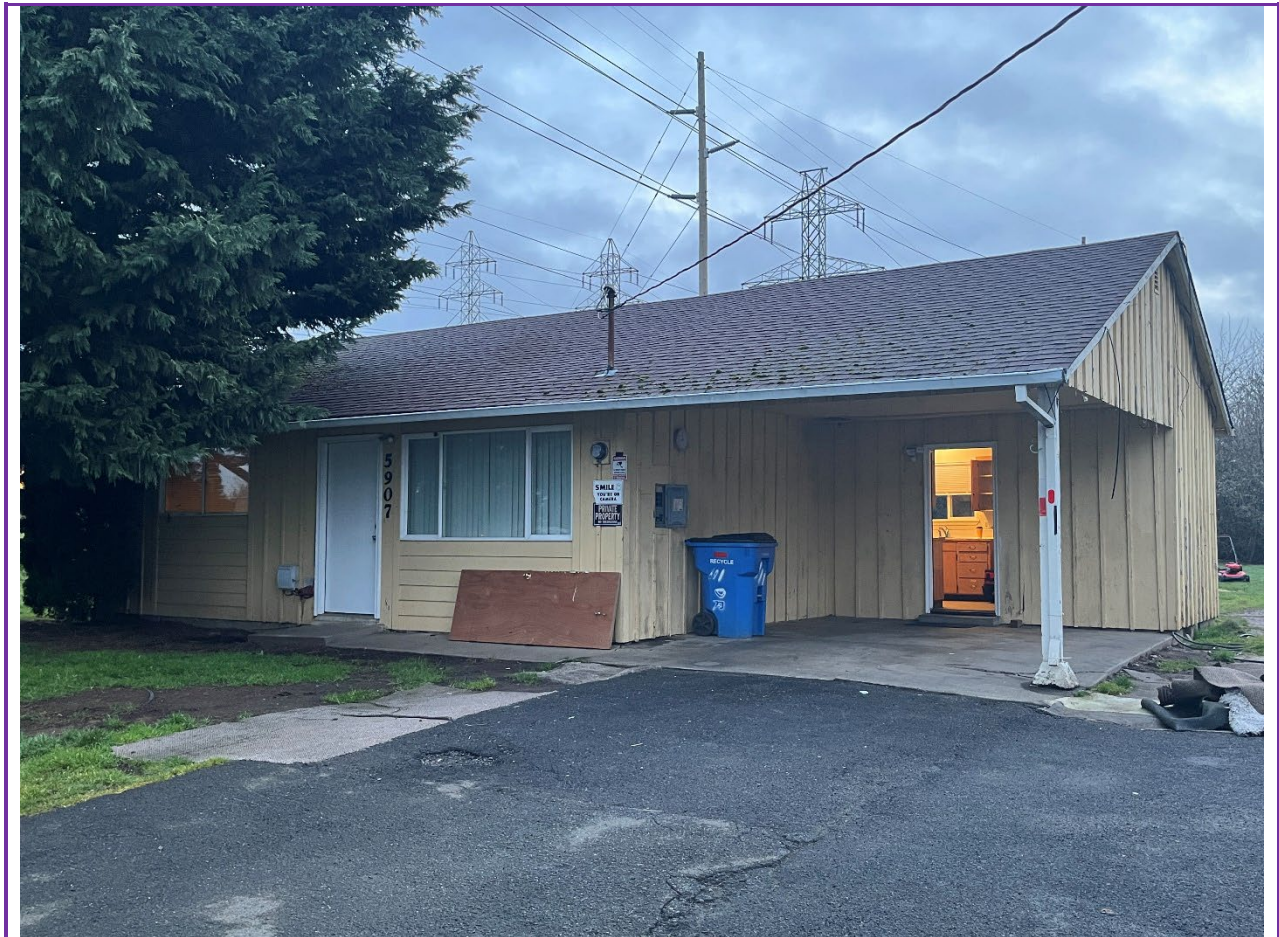
FRONT OF STRUCTURE

The structure was a wood framed one story single family residence. The structure was built on a concrete foundation and constructed in 1961. Approximate square footage of the living areas is 868 SF with square footage in the attached carport of 266 SF.
