Asbestos Containing Materials Inspection

Good Faith Inspection

Project: 3203 O Street
Vancouver, WA 98663

RE: Pre-Demolition Good Faith Asbestos Survey

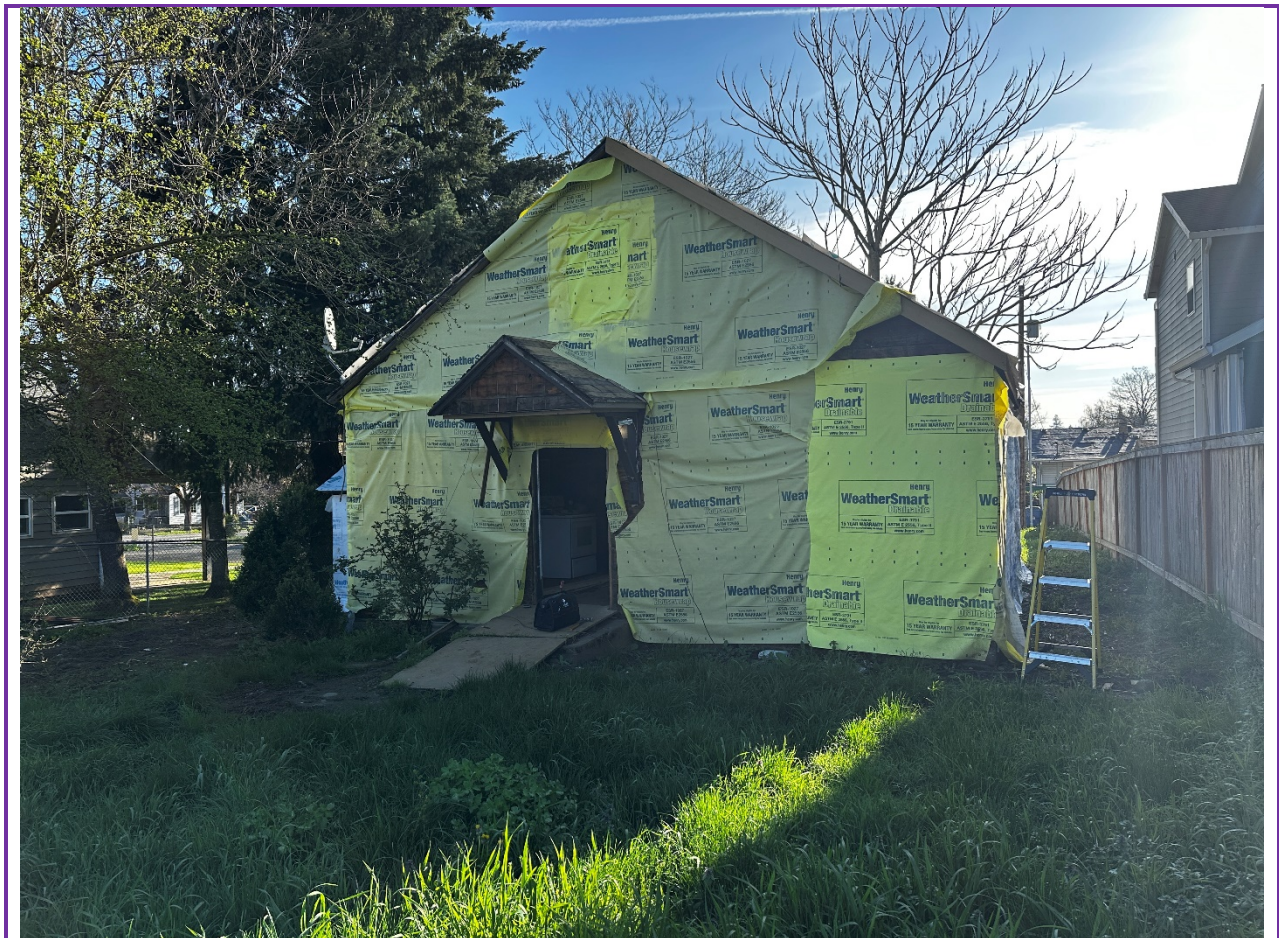
FRONT OF STRUCTURE

The structure was a wood framed single family residence. The home was on a concrete foundation with a attached lower level bonus room that is slab on grade.
