**Environmental & Hazardous Material Report
Transportation Department Main Building
Evergreen School District**

Project Location: Transportation Department
13909 NE 28th Street
Vancouver, WA 98682

Now Project Number: N22-0255

Report Deliverable Date: May 24, 2022

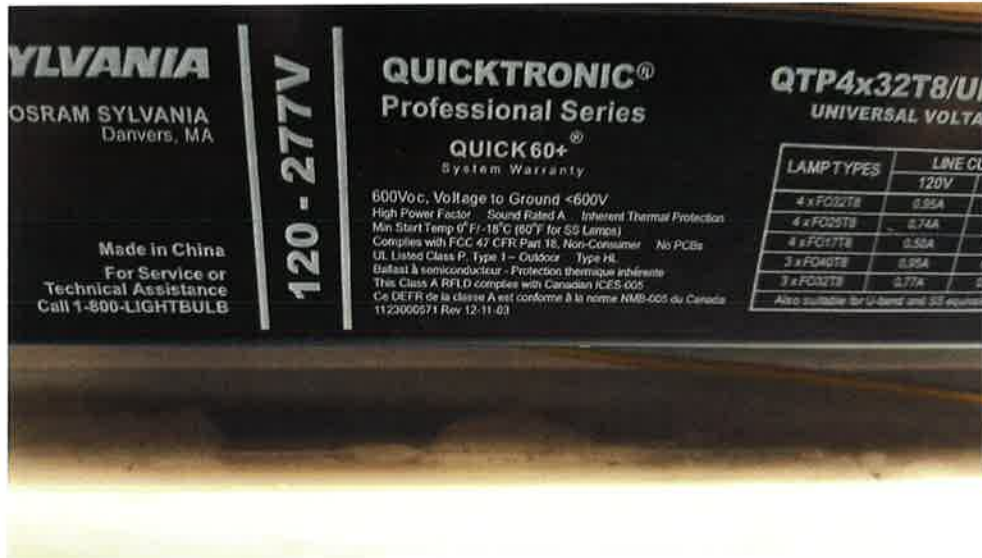
Summary of PCB Containing Light Ballasts in Fluorescent Light Fixtures

No PCB Light ballasts were identified during this investigation. The School District has a replacement program in place and only electronic ballasts were found.
