Notification of Demolition

HAZARDOUS MATERIALS INVESTIGATION SURVEY

PROPERTY KNOWN AS:
**407 S KING ST.
CENTRALIA, WA 98531**

October 27, 2022

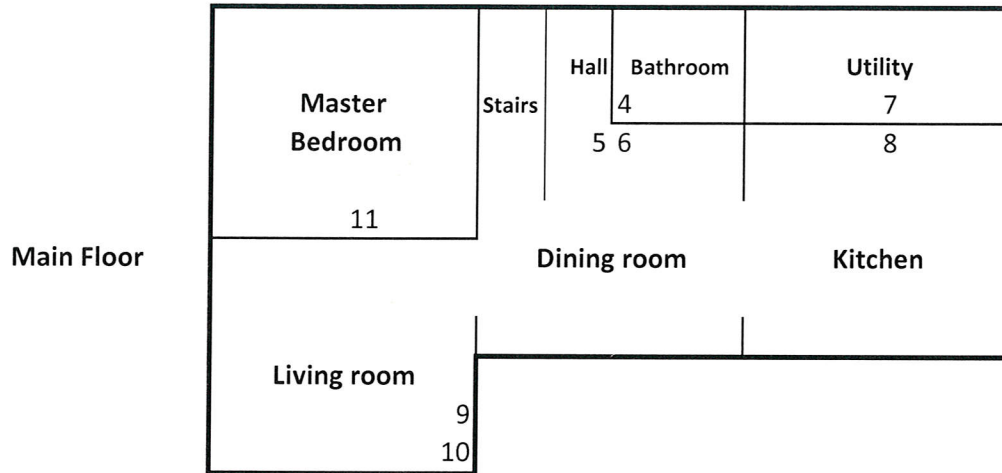
Centralia College
407 S King St.
Centralia, WA 98531

#'s = Location of samples taken

#'s = Samples positive for asbestos
