### **Notification of Demolition**

### Asbestos Containing Materials Inspection

13018 NE 71st Ave. Project:

RE: Pre-Demolition Good Faith Asbestos Survey

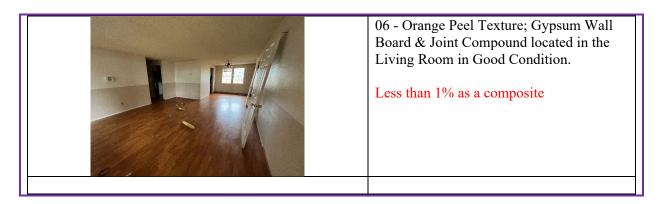
Materials found to contain asbestos in concentrations greater than one percent (>1%) as part of this investigation and estimated quantities for removal:

Sample #	Material Description	Sample Location	Friability /	Lab Result	Quantity
			Condition		
			/ Category		
06	Orange Peel Texture;	Living Room – Found	F / Good	2%	Not
	Gypsum Wall Board	throughout		Chrysotile	Quantified
	& Joint Compound			in the Joint	
				Compound.	
				Less than	
				1% as a	
				composite	
				per WRD	
				23.30.

3 Kings Environmental, Inc. recommends that any ACM or PACM to be impacted during the course of the renovation or demolition be removed by a licensed, bonded, and insured asbestos abatement firm. Removal and disposal of asbestos containing materials should only be performed by certified firms following all local, state, and federal guidelines. Should materials not noted in this report be discovered during the course of the work, stop all demolition and have the newly discovered materials tested for asbestos or treat the materials as an asbestos containing material. Be sure to notify the governing authorities and clean-air agencies prior to disturbing materials over the recordable limits.
