# Notification of Demolition

## Asbestos Survey Report

**Survey Location: 1818 54th St, Washougal, WA 98671**

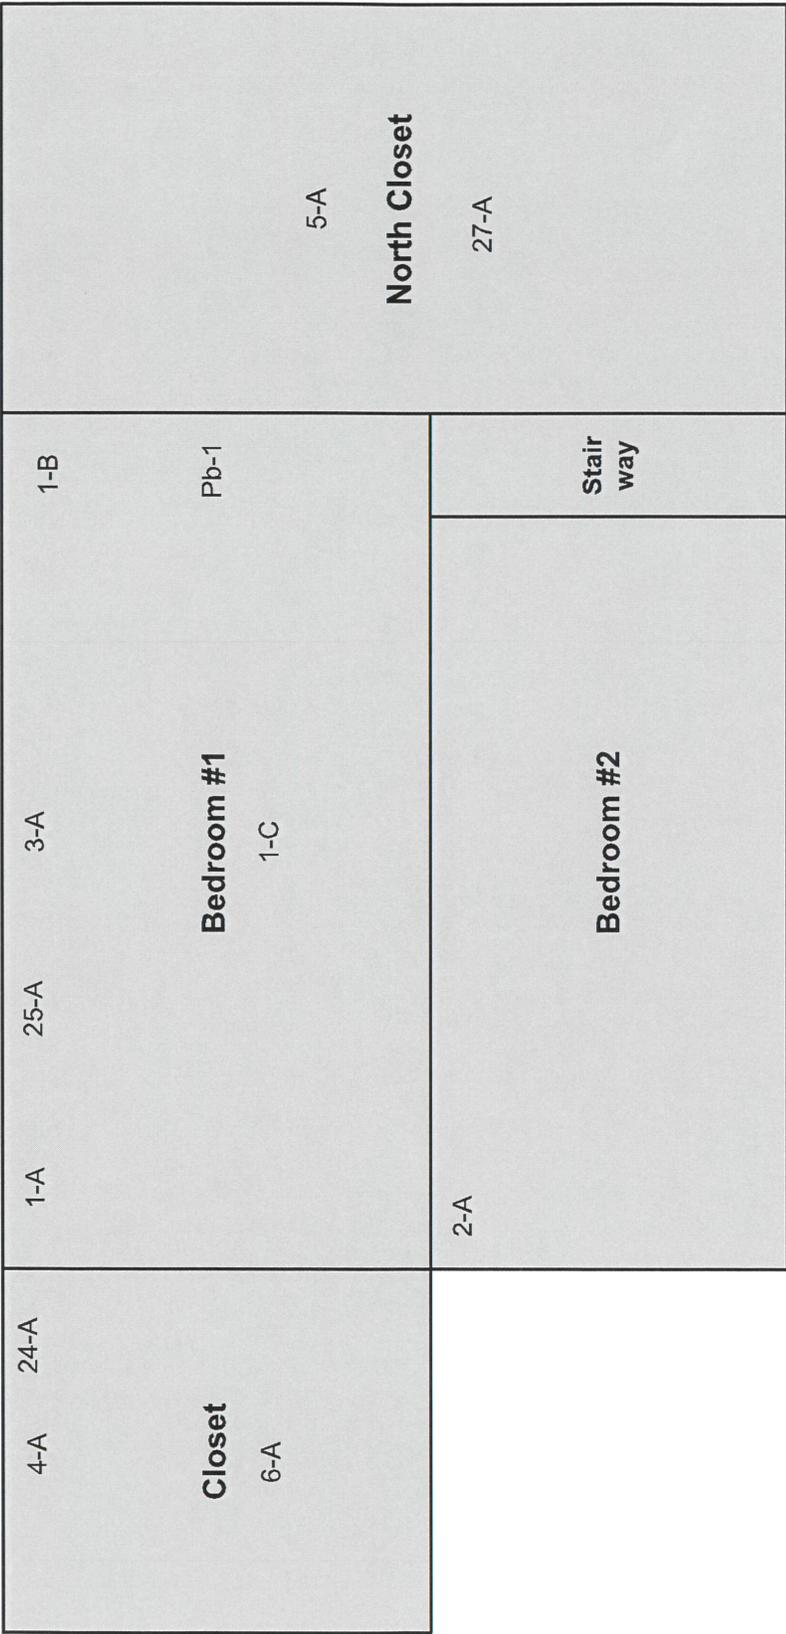
1818 54th St, Washougal, WA 98671 - 2nd Floor

Suspect Asbestos Containing Sample Locations

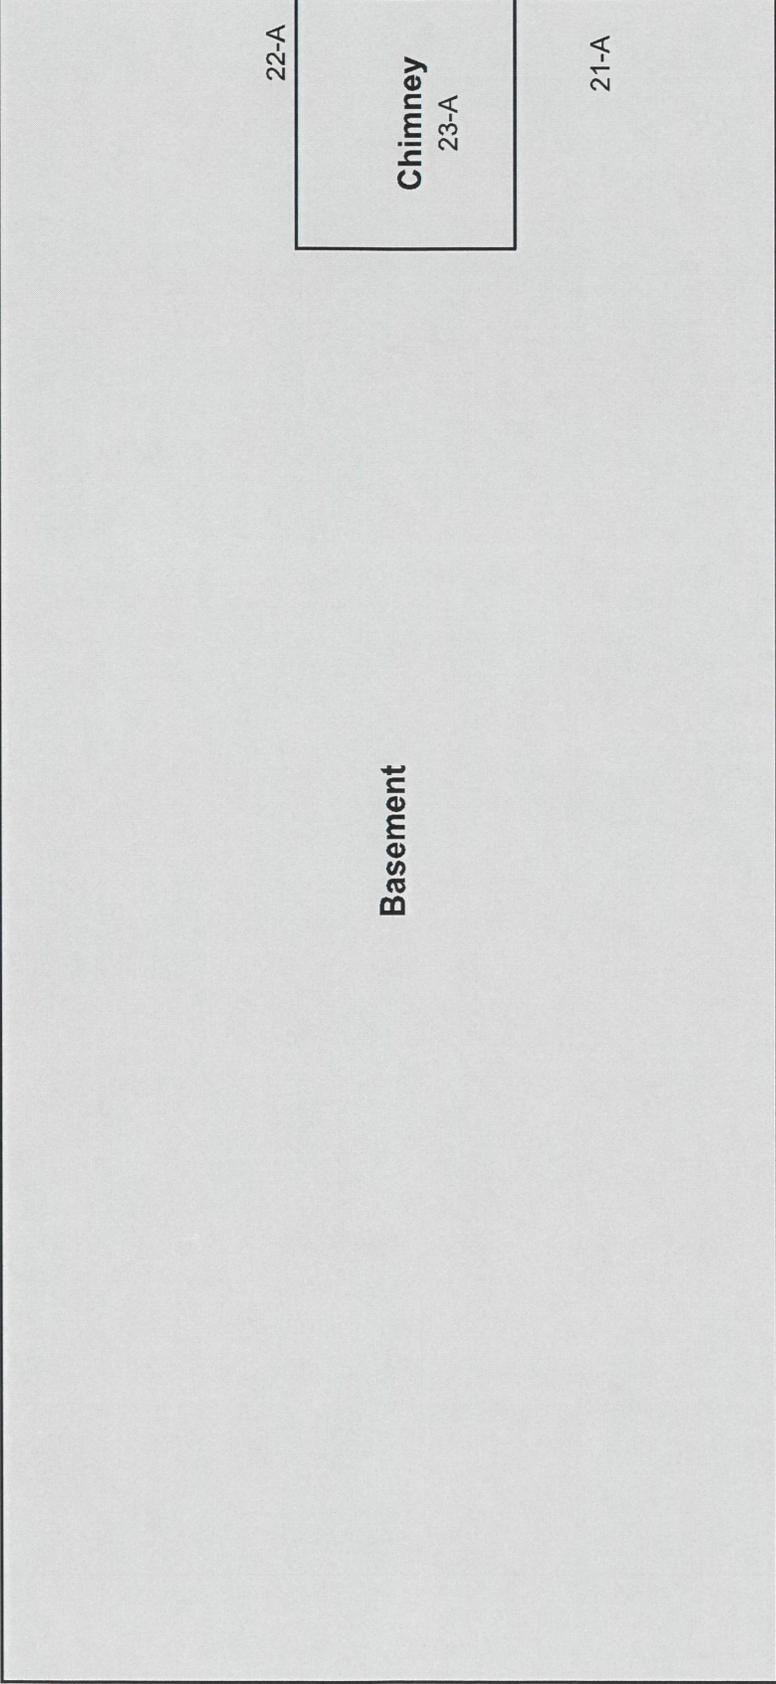
1818 54th St, Washougal, WA 98671 - Basement

Suspect Asbestos Containing Sample Locations
