## Notice of Intent to Remove Asbestos

Case #: 25-005

Site Name: Date park Condominiums

Site address: 3701 & 3701 1/2 E 18th St

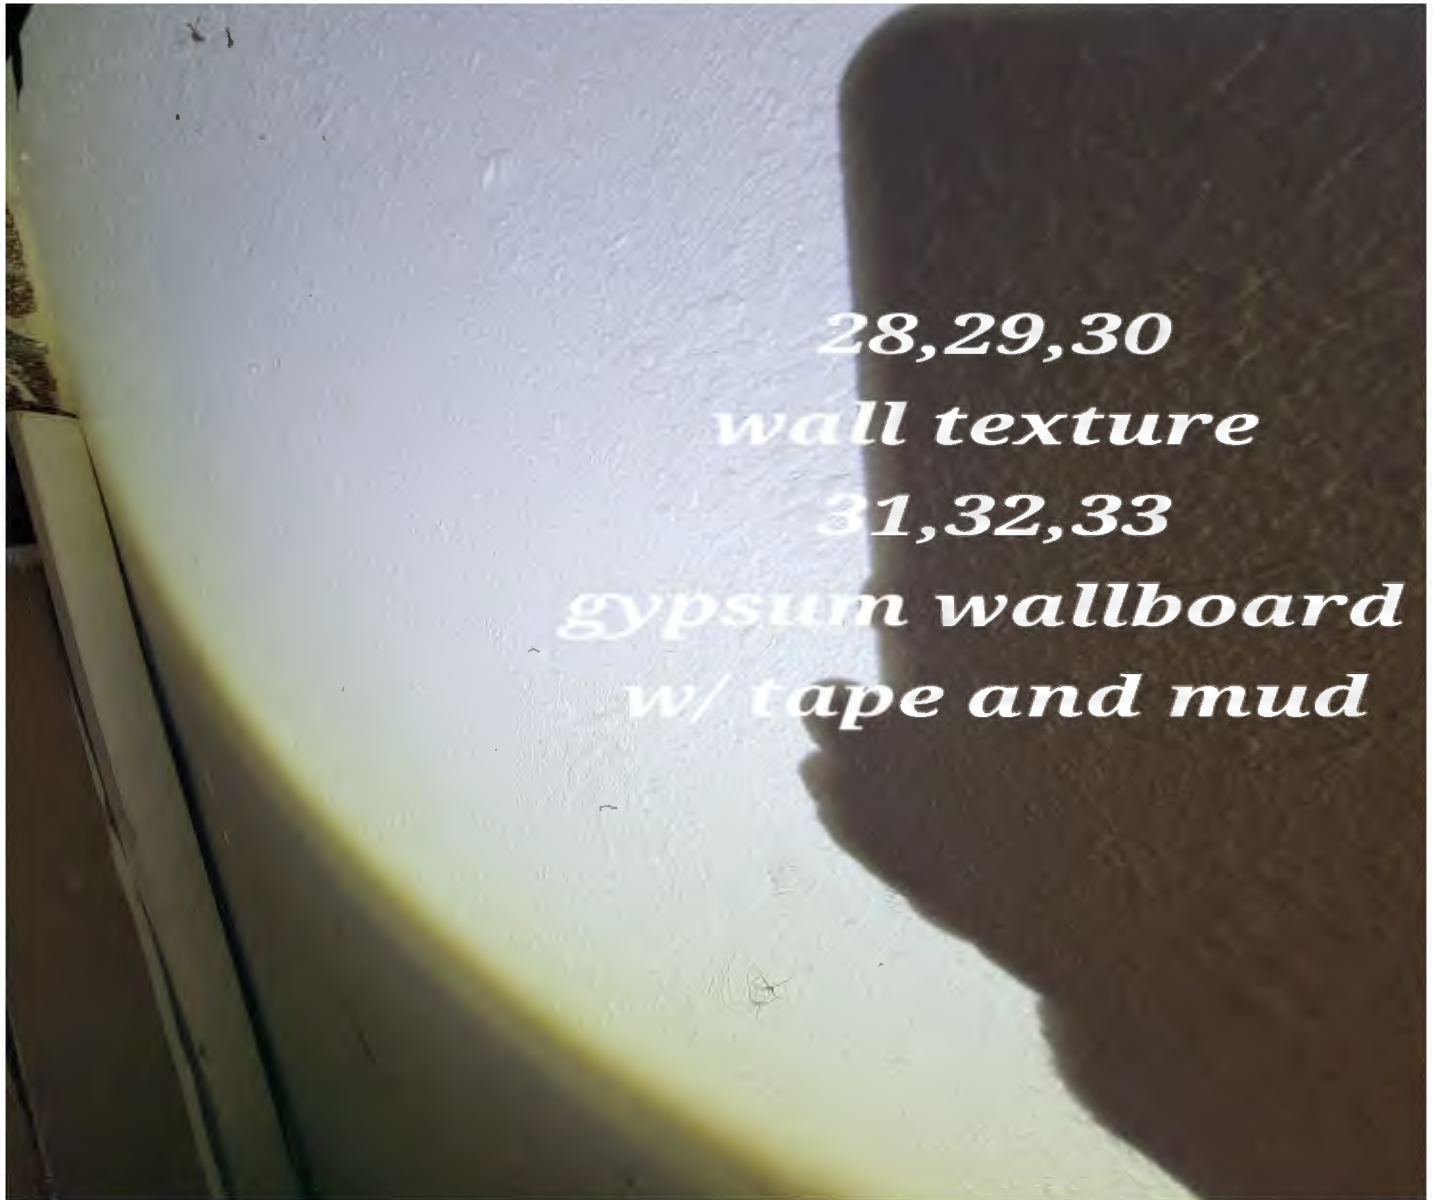
*28,29,30  
wall texture*

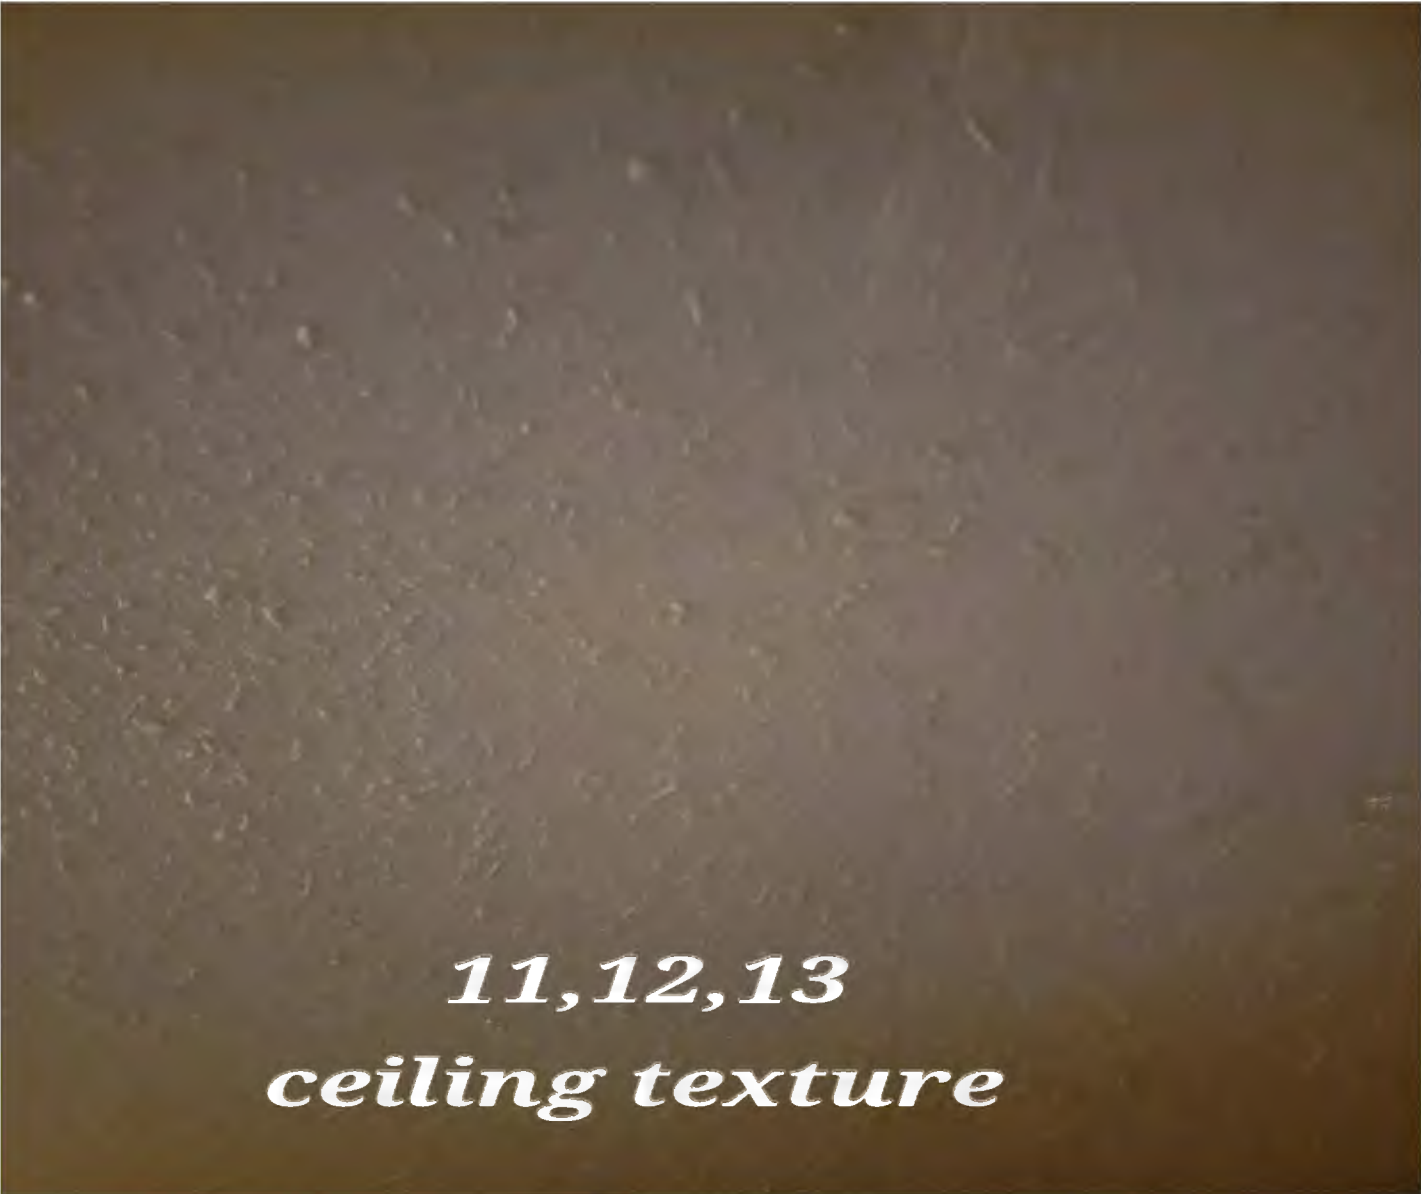
***11,12,13***  
***ceiling texture***

MATERIAL	LOCATION	RECOMMENDED RESPONSE ACTIONS
SPRAYED ON CEILING TEXTURE (WHITE)	KITCHEN MANAGERS UNIT, UNIT #1-HALLWAY, KITCHEN, SECOND FLOOR HALLWAY, SECOND FLOOR BEDROOMS ON LEFT AND RIGHT, THROUGHOUT UNIT #1, UNIT #3-ENTRY, LIVING ROOM, KITCHEN, SECOND FLOOR HALLWAY, SECOND FLOOR BEDROOMS ON LEFT AND RIGHT, THROUGHOUT UNIT #3, UNIT #2-KITCHEN, SECOND FLOOR HALLWAY, SECOND FLOOR BEDROOMS ON LEFT AND RIGHT, THROUGHOUT UNIT #2	Sprayed on ceiling texture is a friable material, which is currently in good condition and poses no health risk in its current state. It is important to keep it encapsulated with a high vehicular latex paint. Do not sand on, drill through, remove, or otherwise disturb material. Must be removed prior to renovation or demolition.

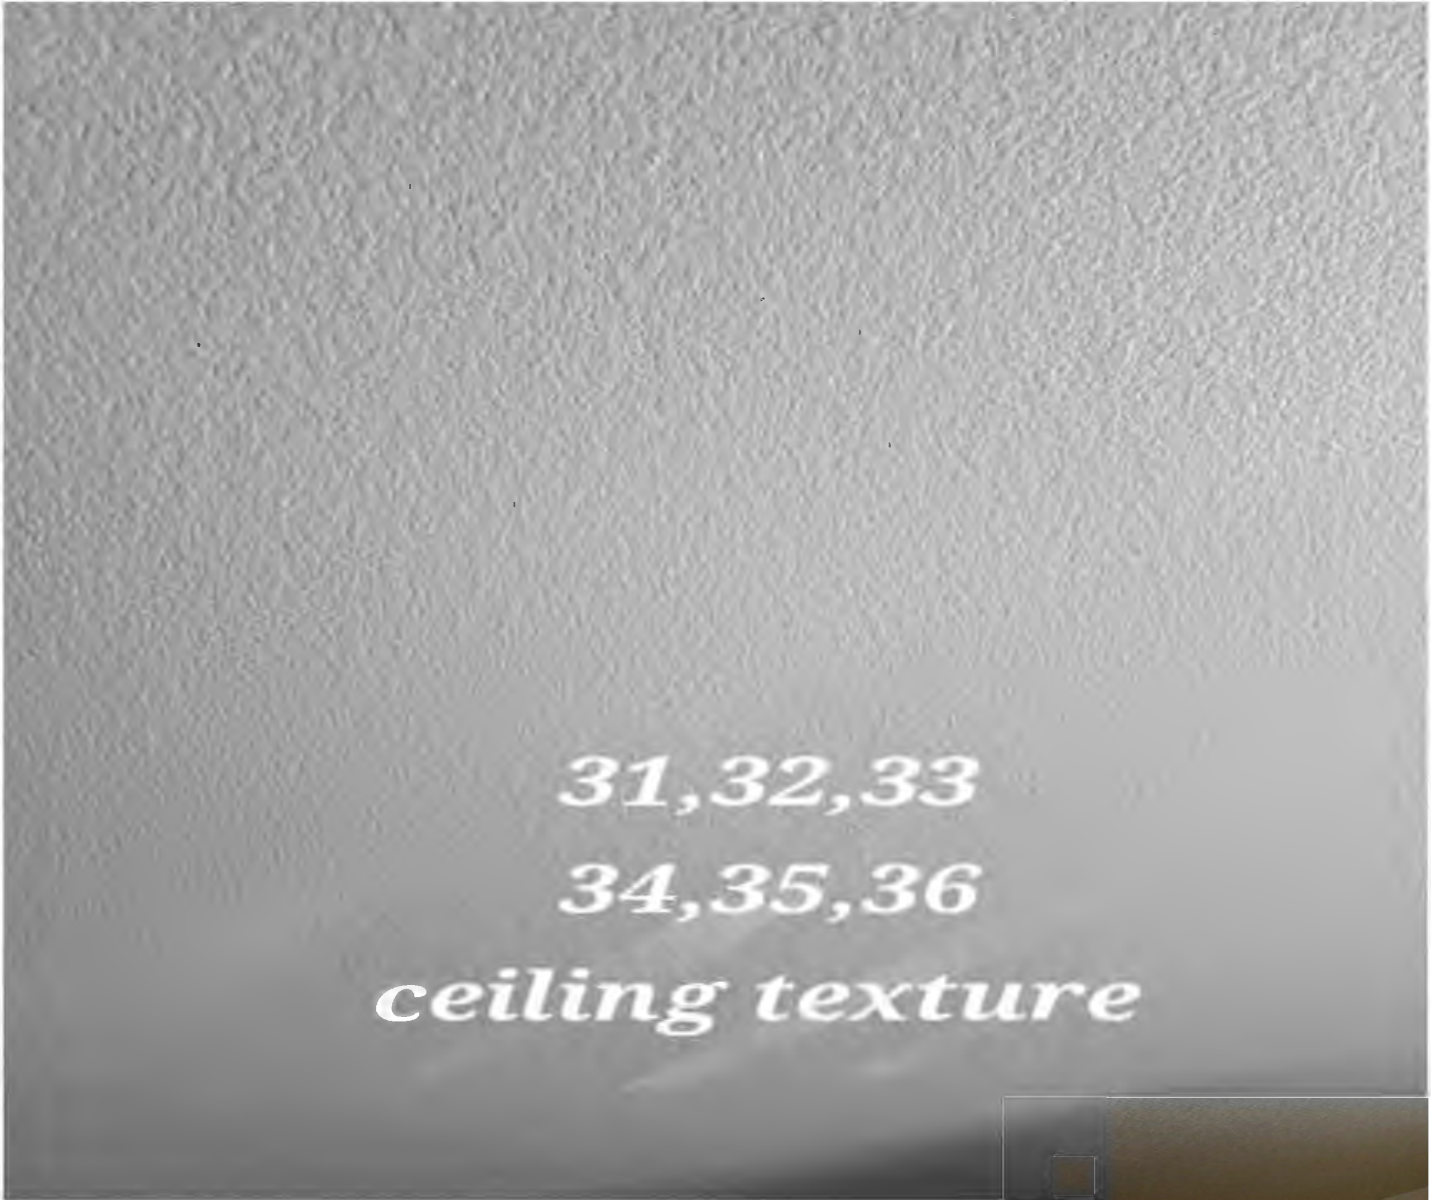
*31,32,33  
34,35,36  
ceiling texture*
